**ACCIDENT**

<b>Aircraft Type and Registration:</b>	Skyranger Swift 912S(1), G-SKSW	
<b>No &amp; Type of Engines:</b>	1 Rotax 912ULS piston engine	
<b>Year of Manufacture:</b>	2007 (Serial no: BMAA/HB/553)	
<b>Date &amp; Time (UTC):</b>	15 September 2019 at 1040 hrs	
<b>Location:</b>	High Cross airstrip, Hertfordshire	
<b>Type of Flight:</b>	Private	
<b>Persons on Board:</b>	Crew - 1	Passengers - 1
<b>Injuries:</b>	Crew - None	Passengers - None
<b>Nature of Damage:</b>	Damage to nose landing gear, engine cowling, engine, propeller, cockpit windscreen, left and right wings	
<b>Commander's Licence:</b>	Airline Transport Pilot's Licence	
<b>Commander's Age:</b>	61 years	
<b>Commander's Flying Experience:</b>	10,300 hours (of which 160 were on type) Last 90 days - 14 hours Last 28 days - 8 hours	
<b>Information Source:</b>	AAIB Field Investigation

**Synopsis**

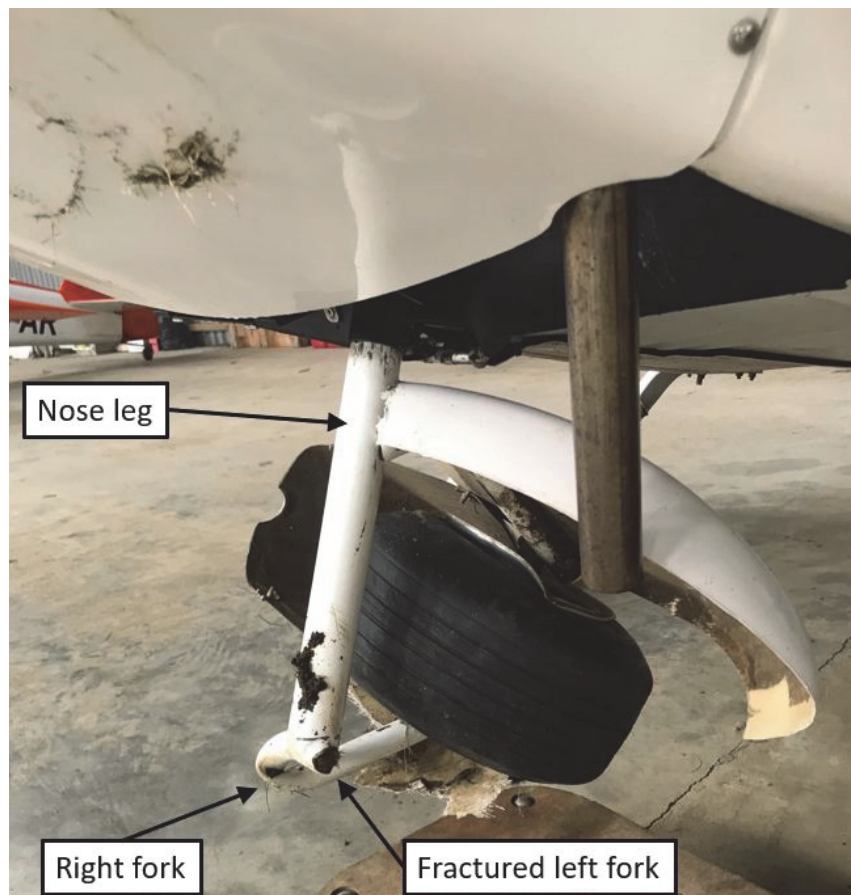
**Figure 2**

The left leg of the nose landing gear fork had failed at its welded joint with the nose landing gear down tube (Figure 2). The right leg of the fork remained attached to the down tube and had folded rearwards, with the nosewheel remaining attached to it. The nosewheel tyre was in good condition and no pre-accident defects were evident when it was examined.

Fractured nose landing gear left fork
