**SERIOUS INCIDENT**

<b>Aircraft Type and Registration:</b>	1) EMB-145EP, G-SAJK 2) Cessna P210N Pressurized Centurion, G-CDMH
<b>No &amp; Type of Engines:</b>	1) 2 Allison AE 3007/A1/1 turbofan engines 2) 1 Continental Motors TSIO-520-P piston engine
<b>Year of Manufacture:</b>	1) 1999 (Serial no: 145153) 2) 1978 (Serial no: P210-00131)
<b>Date &amp; Time (UTC):</b>	7 August 2019 at 1740 hrs
<b>Location:</b>	London Southend Airport
<b>Type of Flight:</b>	1) Commercial Air Transport (Passenger) 2) Private
<b>Persons on Board:</b>	1) Crew - 3                      Passengers - 35 2) Crew - 1                      Passengers - None
<b>Injuries:</b>	1) Crew - None                  Passengers - None 2) Crew - None                  Passengers - N/A
<b>Nature of Damage:</b>	1) None reported 2) None reported
<b>Commander's Licence:</b>	1) Airline Transport Pilot's Licence 2) Private Pilot's Licence
<b>Commander's Age:</b>	1) 39 years 2) 51 years

**Synopsis**

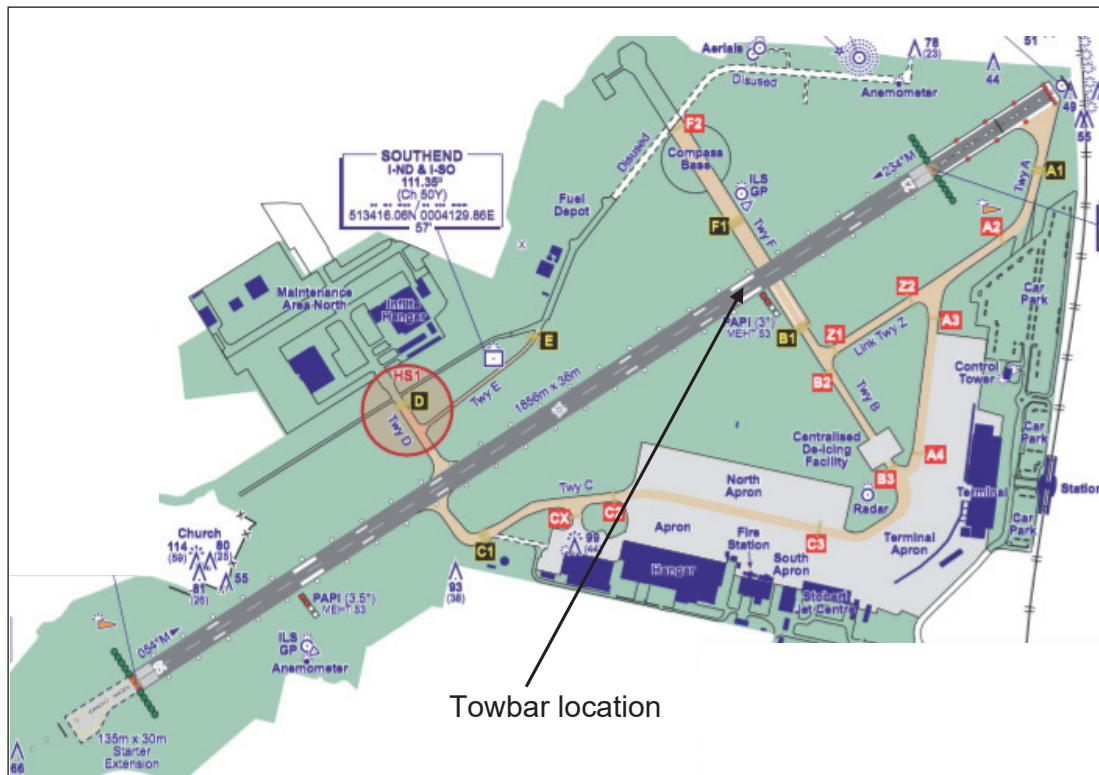
**Figure 2**

London Southend Airport Chart showing approximate location the towbar was found.
