ACCIDENT

Aircraft Type and Registration:	Grob G109B, G-KHEH	
No & Type of Engines:	1 Grob 2500 E1 piston engine	
Year of Manufacture:	1986 (Serial no: 6436)	
Date & Time (UTC):	10 June 2018 at 0959 hrs	
Location:	Near Raglan, Monmouthshire	
Type of Flight:	Training	
Persons on Board:	Crew - 2	Passengers - None
Injuries:	Crew - 2 (Fatal)	Passengers - N/A
Nature of Damage:	Aircraft destroyed	
Commander's Licence:	Private Pilot's Licence	
Commander's Age:	68 years	
Commander's Flying Experience¹:	550 hours (of which 27 were on type) Last 90 days - 7 hours Last 28 days - 2 hours	
Information Source:	AAIB Field Investigation

Synopsis

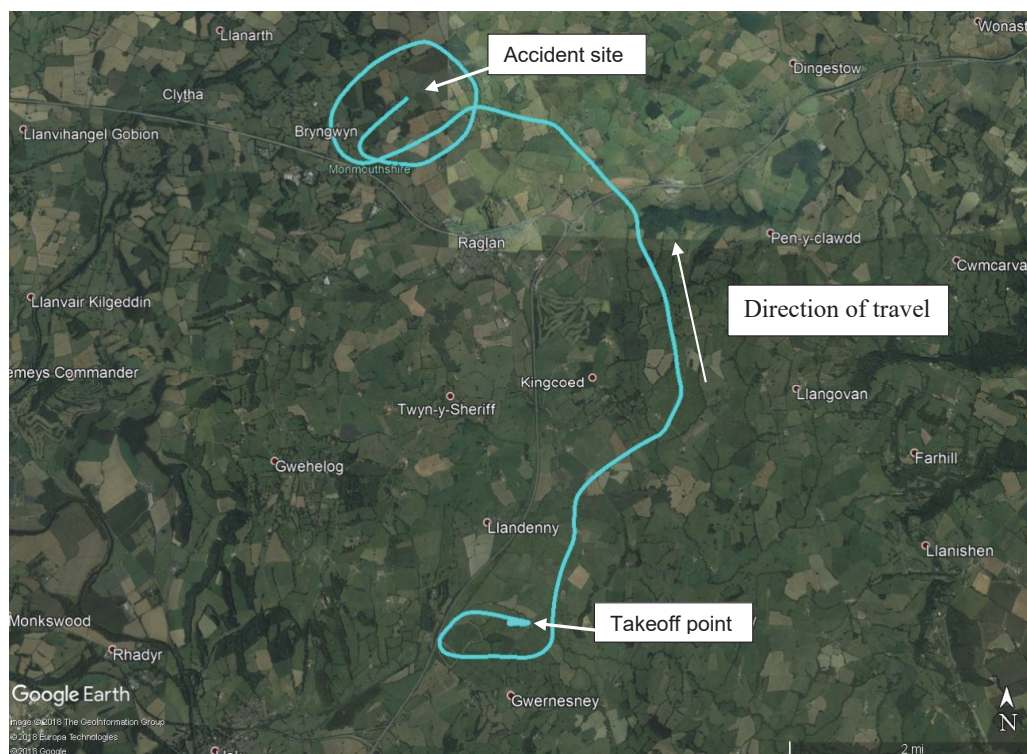
Figure 1

It is not known whether a brief took place or the details of the intended flight, but the TMG took off from Usk Airfield at about 0947 hrs with the instructor and student on board. Witnesses report seeing the aircraft shortly after this time near the town of Raglan, about 4 miles north of the airfield. Recovered flight data shows the aircraft flew an orbit over an area of fields approximately 1.5 miles to the north-west of the town, before commencing an apparent final approach for a practice force landing into a large field (Figure 1).

G-KHEH flight of 10 June 2018

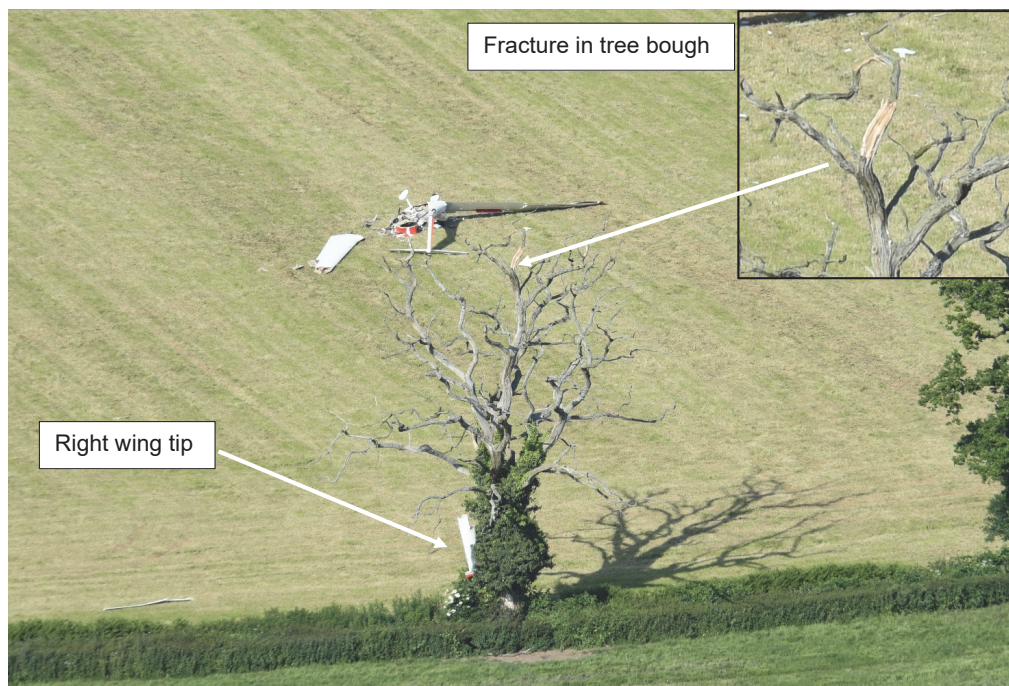
Figure 3

Accident site showing impact point with tree and wreckage
(image courtesy of South Wales Police)

The aircraft had come to rest, inverted, approximately 55 m from the hedge line. There was no post-impact fire. Impact marks showed that the aircraft had struck the ground at a steep angle, inverted. The right wing, which had separated during the impact sequence, was found close to the fuselage.

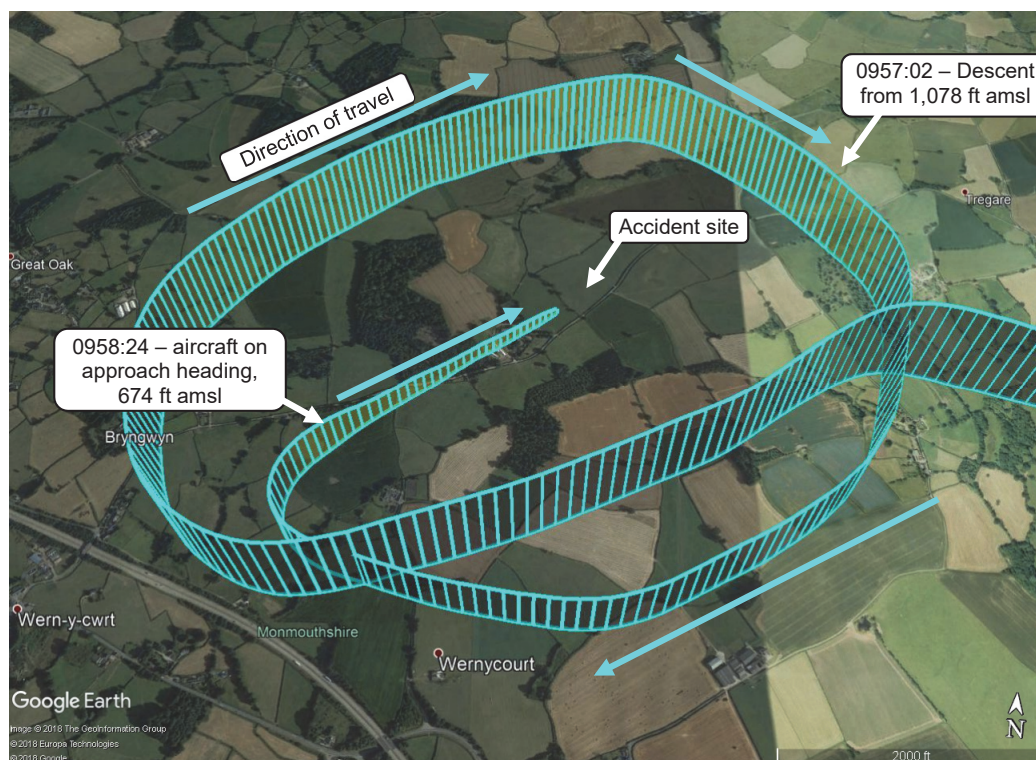
Figure 7

Upon passing abeam Raglan, the aircraft commenced a right hand circuit overhead the accident site at approximately 1,100 ft amsl (Figure 7).

At 0957:02 hrs, while on the crosswind leg, the aircraft commenced a descent which continued for the rest of the flight. Vertical speed was calculated as the rate of change of GPS altitude to ascertain the rate at which the aircraft was descending throughout the manoeuvre. A negative vertical speed represented a rate of descent; a positive vertical speed a rate of climb.

G-KHEH final stages of flight

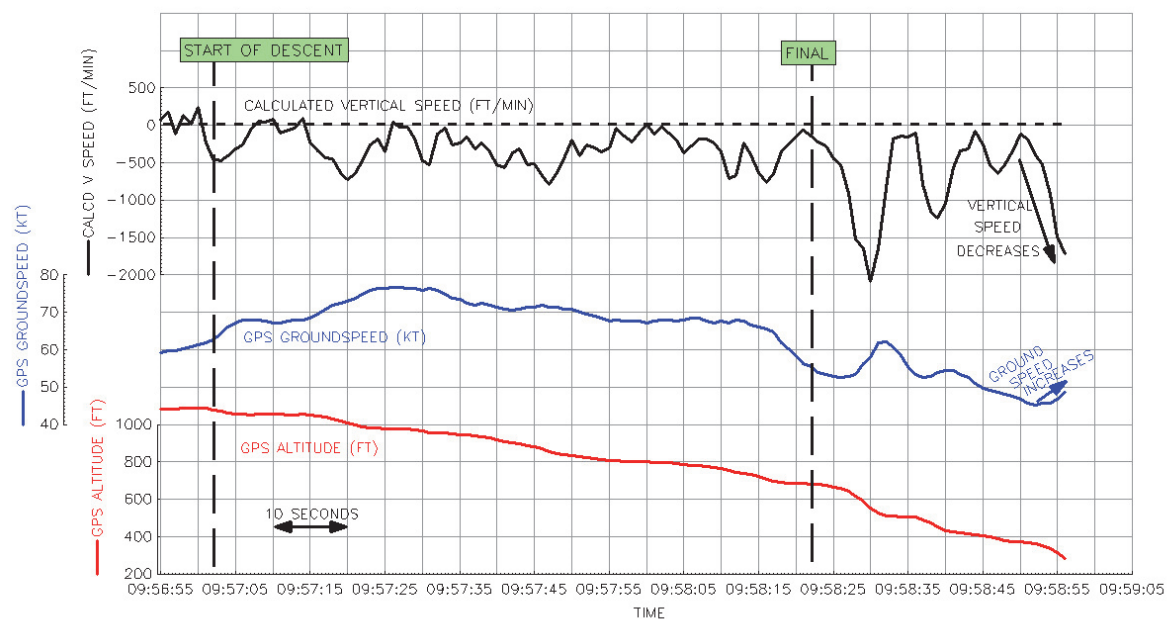
Figure 8

During the turn onto the final approach the groundspeed decreased and, shortly after becoming established on the final approach, this had reduced to about 53 kt. During the subsequent final 30 seconds of the flight, vertical and ground speeds are seen to fluctuate with the vertical speed varying between -100 and -2,000 ft/min and the groundspeed varying between 45 kt and 62 kt (Figure 7). In general, when the vertical speed decreased, the groundspeed increased and vice versa.

During the last four seconds, recorded data shows the aircraft in a descent with decreasing vertical speed and groundspeed increasing from 45 kt. The last recorded position was at 0958:56 hrs with the aircraft at 284 ft amsl (about 54 ft agl) located approximately 43 m before the tree.

G-KHEH flight data parameters for the final two minutes of flight
