ACCIDENT

Aircraft Type and Registration:	Piper PA-28-181 Cherokee Archer II, G-BSIM	
No & Type of Engines:	1 Lycoming O-360-A4M piston engine	
Year of Manufacture:	1986 (Serial no: 28-8690017)	
Date & Time (UTC):	20 August 2019 at 1355 hrs	
Location:	Branscombe Airfield, Devon	
Type of Flight:	Private	
Persons on Board:	Crew - 1	Passengers - 3
Injuries:	Crew - None	Passengers - None
Nature of Damage:	Substantial	
Commander's Licence:	Private Pilot's Licence	
Commander's Age:	30 years	
Commander's Flying Experience:	136 hours (of which 60 were on type) Last 90 days - 7 hours Last 28 days - 3 hours	
Information Source:	Aircraft Accident Report Form submitted by the pilot

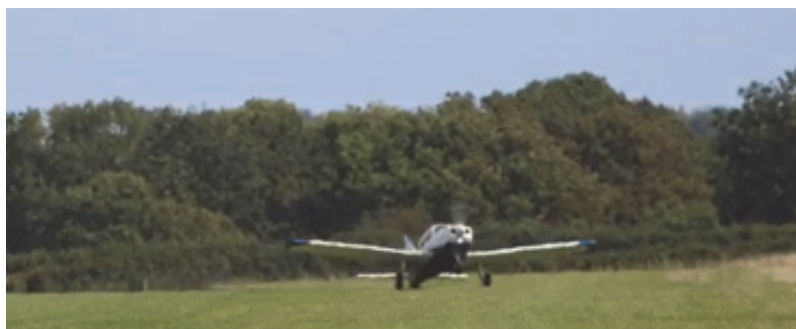
Figure 1

As the takeoff commenced the pilot's directional control of the aircraft was not steady, and the nose of the aircraft lifted at low speed. The aircraft then became briefly airborne and 'weathercocked' in to the wind and towards the airfield boundary hedge. The pitch angle continued to increase, and the aircraft sank back on to its main wheels and its tail contacted the ground, Figure 1.

G-BSIM 'weathercocked' and at a high pitch angle, during the takeoff
