**ACCIDENT**

<b>Aircraft Type and Registration:</b>	Quik GT450, G-CGNK	
<b>No &amp; Type of Engines:</b>	1 Rotax 912ULS piston engine	
<b>Year of Manufacture:</b>	2010 (Serial no: 8536)	
<b>Date &amp; Time (UTC):</b>	19 October 2019 at 0945 hrs	
<b>Location:</b>	Beccles Aerodrome, Suffolk	
<b>Type of Flight:</b>	Training	
<b>Persons on Board:</b>	Crew - 1	Passengers - 1
<b>Injuries:</b>	Crew - 1 (Minor)	Passengers - 1 (Minor)
<b>Nature of Damage:</b>	Severe damage to airframe and wing	
<b>Commander's Licence:</b>	National Private Pilot's Licence	
<b>Commander's Age:</b>	50 years	
<b>Commander's Flying Experience:</b>	2,605 hours (of which 1,000 were on type) Last 90 days - 111 hours Last 28 days - 25 hours	
<b>Information Source:</b>	Aircraft Accident Report Form submitted by the pilot

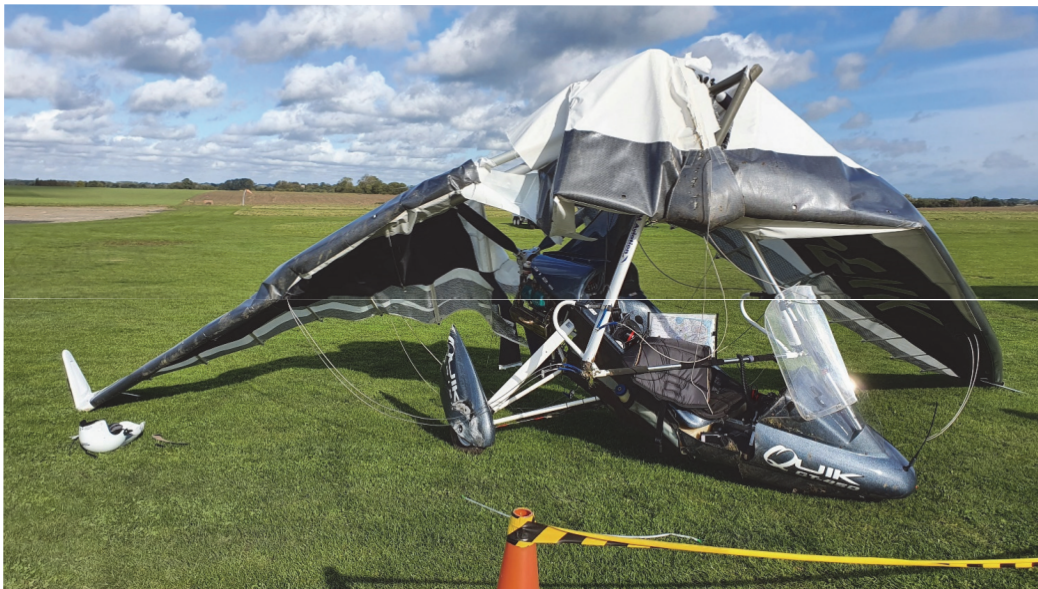
**Figure 1**

G-CGNK after being recovered from the runway
