ACCIDENT

Aircraft Type and Registration:	Learjet 45, C-GMCP	
No & Type of Engines:	2 Honeywell TFE731-20BR-1B turbofan engines	
Year of Manufacture:	2000 (Serial no: 45-126)	
Date & Time (UTC):	4 May 2019 at 2159 hrs	
Location:	Edinburgh Airport	
Type of Flight:	Commercial Air Transport (Non-Revenue)	
Persons on Board:	Crew - 2	Passengers - 2
Injuries:	Crew - None	Passengers - None
Nature of Damage:	Damage to nose landing gear leg and its support and actuating mechanism	
Commander's Licence:	Airline Transport Pilot's Licence	
Commander's Age:	50 years	
Commander's Flying Experience:	12,920 hours (of which 2,669 were on type) Last 90 days - 152 hours Last 28 days - 57 hours	
Information Source:	Aircraft Accident Report Form submitted by the pilot and further enquiries by the AAIB

Synopsis

The nose landing gear leg collapsed aft during pushback which was most likely caused by inadvertent brake application.

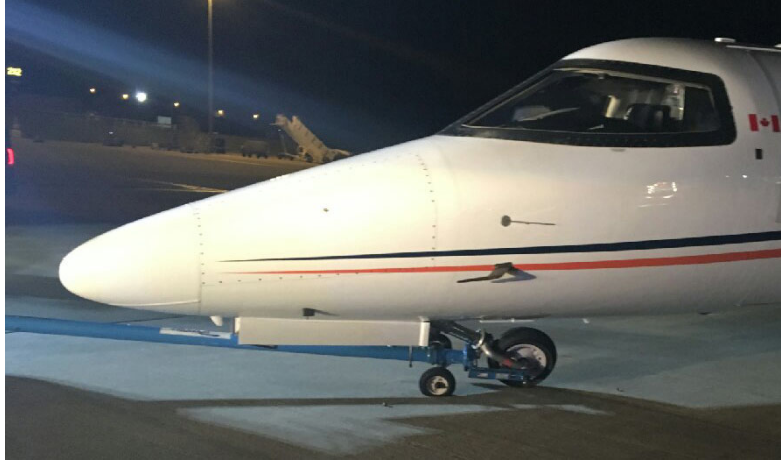
Figure 1

The flight crew started both engines at the gate. The aircraft was then pushed back using a TLD 150 Max tug¹. As the aircraft was being turned to line up on the taxiway the nose landing gear (NLG) suddenly collapsed aft and the aircraft came to rest (Figure 1). During the pushback the co-pilot had been carrying out checks and had started adjusting the position of his rudder pedals. He was bringing the pedals aft and he said there was a possibility he might have tapped the brakes but he was not aware of having done so.

The NLG on this aircraft type retracts in the forward direction. The NLG actuator is attached to the front of the nose leg at a bracket. This bracket had failed allowing the NLG to collapse aft. The bracket was examined at a metallurgical lab which revealed that it had failed due to overload. There was no evidence of material defects or fatigue.

C-GMCP nose gear collapse

The aircraft manufacturer examined photographs of the structural damage to the NLG bay and stated that this damage and the damage to the bracket was similar to the damage that occurred to a Learjet 45 (MSN 2129) at their production facility, which occurred during pushback with brake application. The manufacturer stated that it was also aware of two in-service events (Learjet 45 MSN 181 and Learjet 45 MSN 202) in which brake application during pushback resulted in the same rearward NLG collapse as in this accident.

The NLG collapse on aircraft C-GMCP was most likely caused by inadvertent brake application during pushback.
