**ACCIDENT**

<b>Aircraft Type and Registration:</b>	Cessna 441 Conquest II, EI-DMG	
<b>No &amp; Type of Engines:</b>	2 Honeywell (Garrett Airesearch) TPE 331-10-534S turboprop engines	
<b>Year of Manufacture:</b>	1980	
<b>Date &amp; Time (UTC):</b>	25 June 2019 at 0800 hrs	
<b>Location:</b>	Glasgow Prestwick Airport	
<b>Type of Flight:</b>	Private	
<b>Persons on Board:</b>	Crew - 2	Passengers - 7
<b>Injuries:</b>	Crew - None	Passengers - None
<b>Nature of Damage:</b>	Engines, propellers and right-hand nose locker door damaged	
<b>Commander's Licence:</b>	Commercial Pilot's Licence	
<b>Commander's Age:</b>	50 years	
<b>Commander's Flying Experience:</b>	4,563 hours (of which 1,035 were on type) Last 90 days - 40 hours Last 28 days - 11 hours	
<b>Information Source:</b>	Aircraft Accident Report Form submitted by the pilot and subsequent AAIB enquiries

**Synopsis**

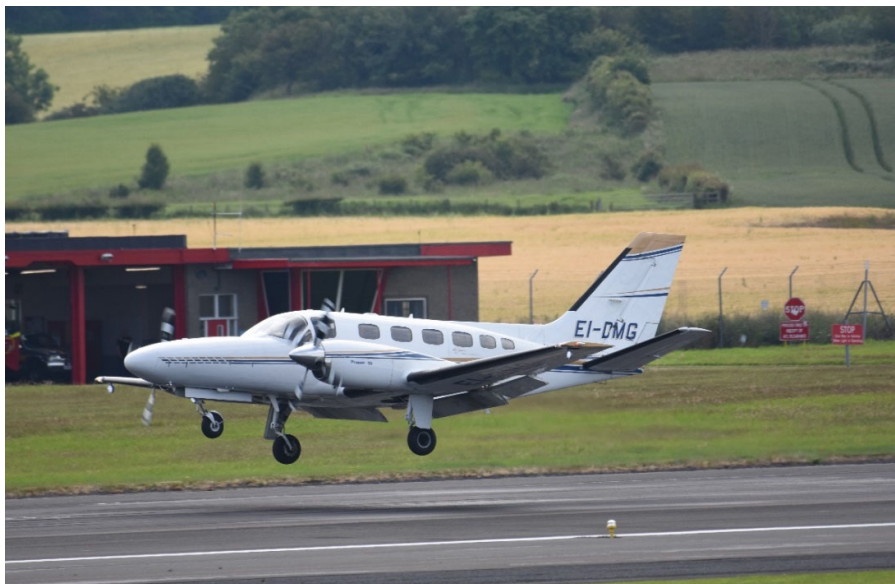
**Figure 1**

A photograph taken of EI-DMG prior to touchdown (Figure 1) shows that the nose landing gear was partially extended prior to landing.

EI-DMG nose landing gear partially extended prior to touchdown  
(image used with permission)

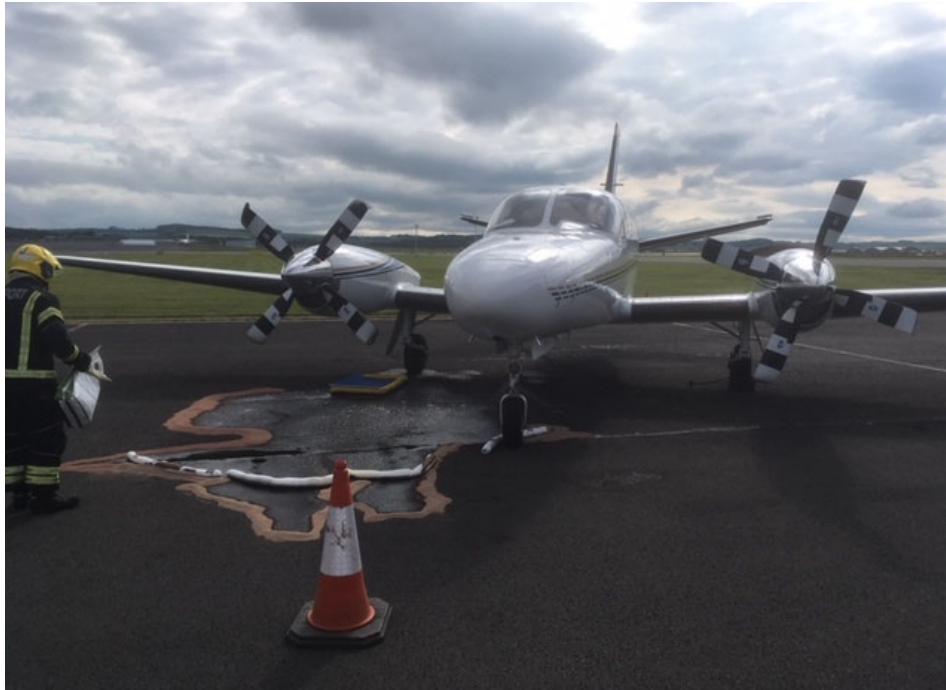
**Figure 2**

While taxiing to the parking area, a passenger alerted the commander to fuel leaking from the right engine. The taxi was expedited and the firewall shutoff valves were then activated. There were no injuries and the occupants disembarked normally without assistance. The aircraft sustained damage to the engines and propellers. Subsequent inspection of the runway showed propeller strike marks over a distance of several metres in the touchdown zone.

EI-DMG after landing showing fuel leak and damage to propellers  
(image used with permission)

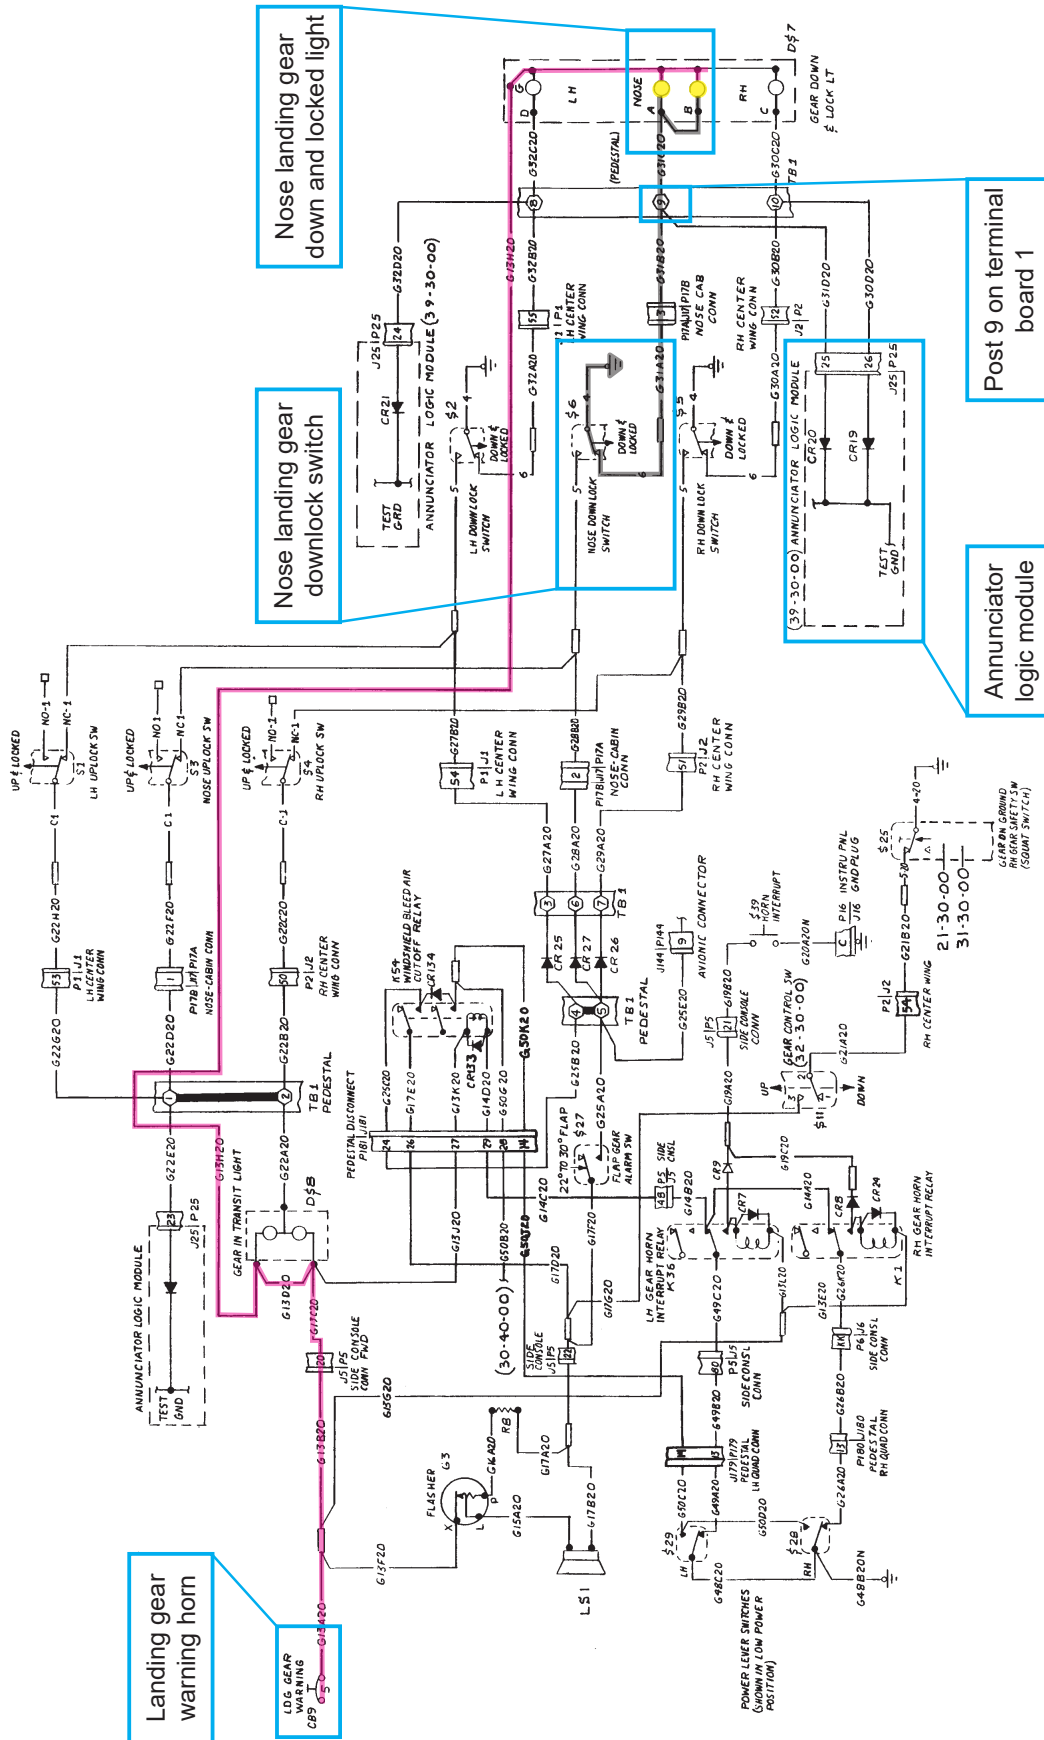
Figure 3 Landing gear and flap warning system from Cessna 441 Wiring Diagram Manual

The manufacturer confirmed that if the nose landing gear DOWN AND LOCKED light senses an electrical ground, it will illuminate regardless of the nose gear downlock switch position (Figure 3). It was therefore possible that a faulty downlock switch could provide a continual ground to the DOWN AND LOCKED light. Other potential sources of electrical ground could include an electrical short in the wire between the DOWN AND LOCKED light and the downlock switch; inadvertent grounding of post 9 on terminal board 1; incorrect wiring on terminal board 1; or a defect within, or shorted wire from, the annunciator logic module to post 9 on terminal board

The aircraft manufacturer described several possibilities which could create an erroneous ground signal at the nose landing gear DOWN AND LOCKED light causing it to illuminate even though the nose landing gear was not fully extended. It was determined that one of these, a nose landing gear downlock switch failed in the down and locked position, could also account for improper extension of the nose landing gear and absence of the landing gear warning horn activation.
