SERIOUS INCIDENT

Aircraft Type and Registration:	Agusta A109E, G-ETPI	
No & Type of Engines:	2 Pratt & Whitney Canada PW206C turboshaft engines	
Year of Manufacture:	2001	
Date & Time (UTC):	27 June 2019 at 0820 hrs	
Location:	In flight North of Seaton, Cornwall	
Type of Flight:	Private	
Persons on Board:	Crew - 2	Passengers - None
Injuries:	Crew - None	Passengers - N/A
Nature of Damage:	Loss of window	
Commander's Licence:	Commercial Pilot's Licence	
Commander's Age:	55 years	
Commander's Flying Experience:	4,736 hours (of which 847 were on type) Last 90 days - 35 hours Last 28 days - 11 hours	
Information Source:	Aircraft Accident Report Form submitted by the pilot, maintenance organisation investigation and AAIB enquiries

Synopsis

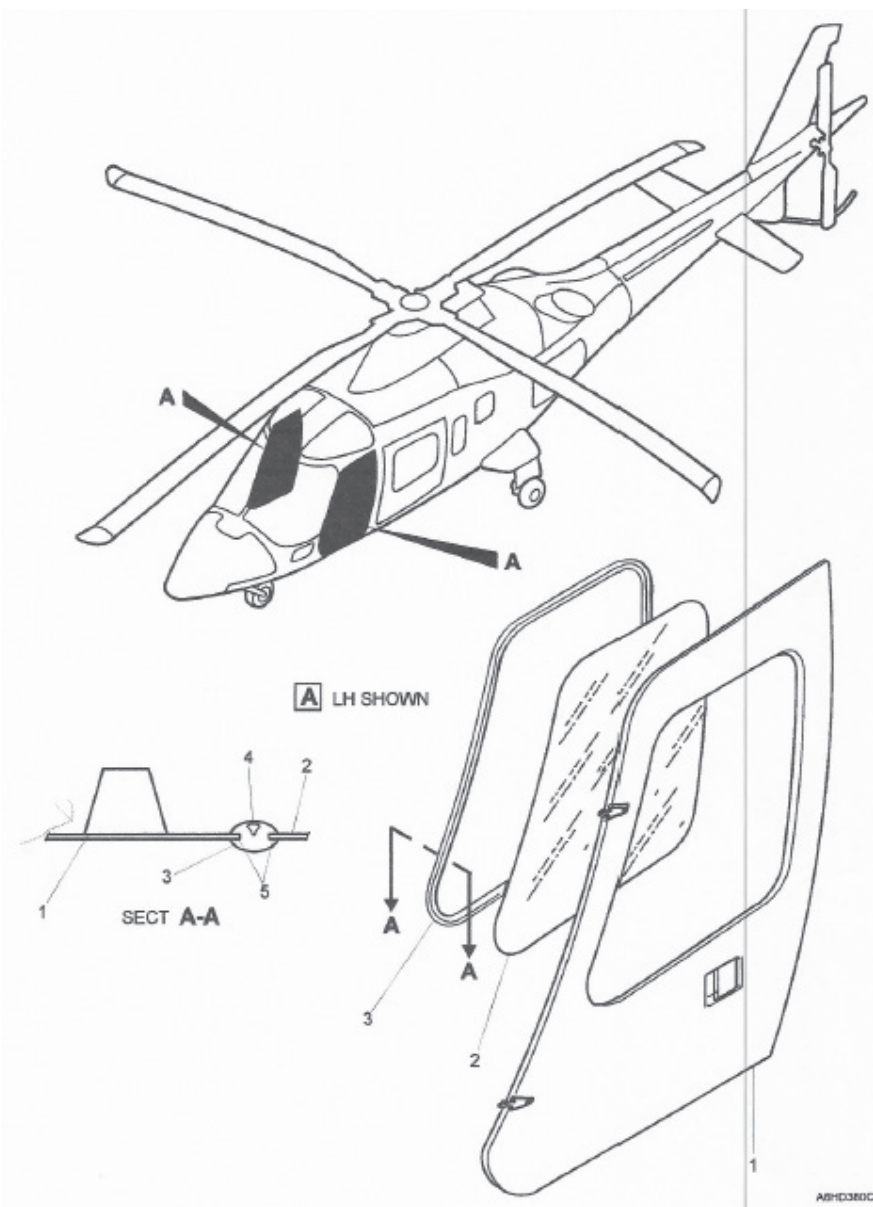
Figure 1

Illustration showing installation of A109E cockpit doors

Using an excessive amount of soap solution would have allowed the solution to migrate into the window and door grooves on the seal (item 5 in Figure 1). In the 11 weeks that

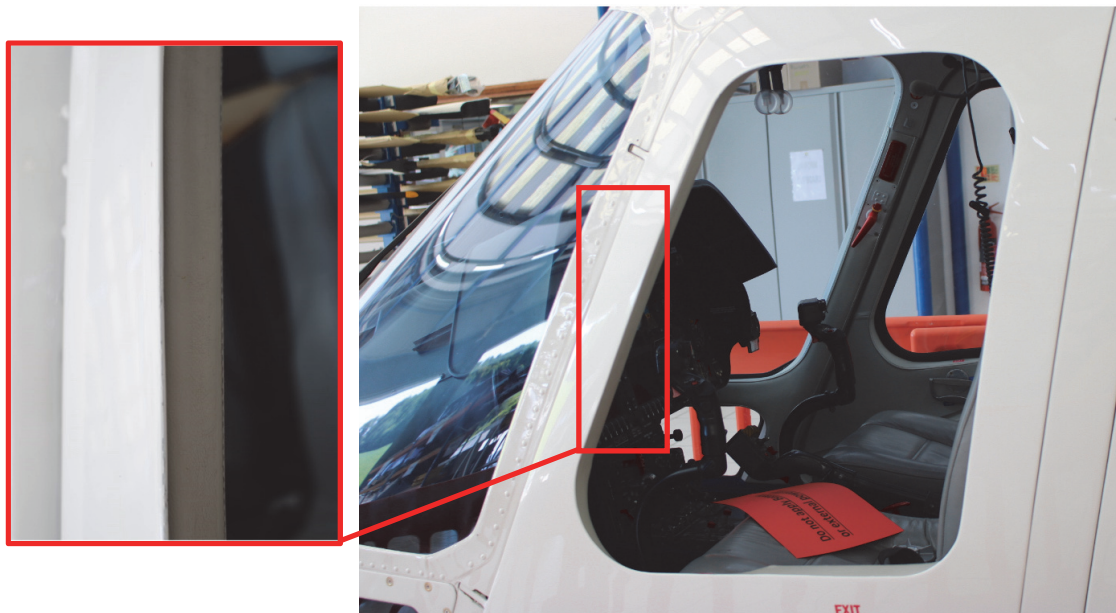
Figure 2

The left cockpit door was inspected and the associated maintenance worksheet stated that the inspection '*...did not reveal sufficient (residual) presence of adhesive on the door structure.*' The engineer performing the inspection also noted the presence of a greasy residue around the window aperture. A photograph taken during the inspection (Figure 2) shows no evidence of adhesive residue. The window and retaining seal were not recovered following the incident, so it was not possible to confirm whether sufficient adhesive had been applied to the window side of the seal.

Window aperture of left cockpit door, showing no evidence of adhesive

The A109E maintenance manual indicates the need for a thin layer of adhesive to be applied in the window and door grooves of the seal. Post-incident inspection revealed no evidence of adhesive on the left cockpit door window surround, which suggests that little or no adhesive had been applied to the corresponding seal groove during installation of the window. The window and seal were not recovered so it could not be determined whether adhesive had been applied to the window groove of the seal.

had elapsed between installation of the window and the incident, the water would likely have evaporated leaving a soapy residue. This may have acted as a lubricant, which in combination with the absence of adhesive allowed the window to separate from the cockpit door.

Following its internal safety investigation, the maintenance organisation debriefed all involved staff on the findings of the investigation. On 28 August 2019 it issued a temporary notice to all engineers informing them of the incident and requiring the installation of windows to be considered as a critical maintenance task, requiring an independent inspection to be performed during the installation of any acrylic window. The task was subsequently included on the organisation's formal list of critical maintenance tasks, when it was next updated. The details of the incident are also to be included in company continuation training, with a
