**SERIOUS INCIDENT**

| <b>Aircraft Type and Registration:</b> | Airbus A319-131, G-DBCD | |

**Synopsis**

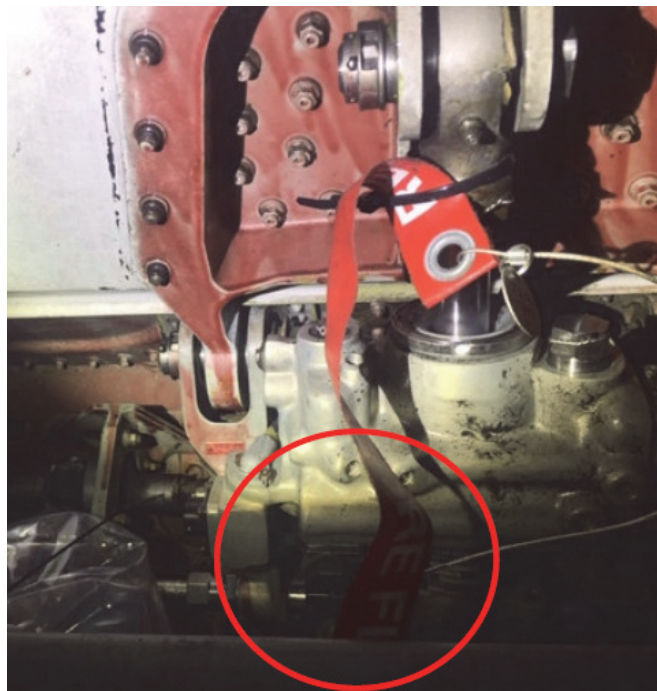
**Figure 1**

On arrival, maintenance staff inspected the aircraft and found that instead of the No 1 spoiler being deactivated it had been left in the MAINTENANCE position with the maintenance key still installed. The ‘*remove before flight*’ flag attached to the maintenance key had been cable tied to the spoiler actuator, Figure 1. In this configuration the spoiler could move away from its stowed position in an uncontrolled manner which would cause the anomalies experienced by the crew.

Spoiler maintenance key and flag as found on arrival

Following maintenance action intended to deactivate a spoiler, the aircraft departed with the spoiler in the maintenance position. This allowed the spoiler to 'float' up in the airflow causing an uncommanded roll input. The aircraft landed without further incident and the spoiler was correctly deactivated for the return flight.

The spoiler was then correctly deactivated, and the aircraft returned to Gatwick Airport without further incident.
