SERIOUS INCIDENT

Aircraft Type and Registration:	Airbus A320-214, G-EZTD	
No & Type of Engines:	2 CFM56-5B4/3 turbofan engines	
Year of Manufacture:	2009 (Serial no: 3909)	
Date & Time (UTC):	24 April 2019 at 2022 hrs	
Location:	Lisbon Airport, Portugal	
Type of Flight:	Commercial Air Transport (Passenger)	
Persons on Board:	Crew - 6	Passengers - 175
Injuries:	Crew - None	Passengers - None
Nature of Damage:	None reported	
Commander's Licence:	Airline Transport Pilot's Licence	
Commander's Age:	27 years	
Commander's Flying Experience:	4,300 hours (of which 4,100 were on type) Last 90 days - 162 hours Last 28 days - 38 hours	
Information Source:	AAIB Field Investigation

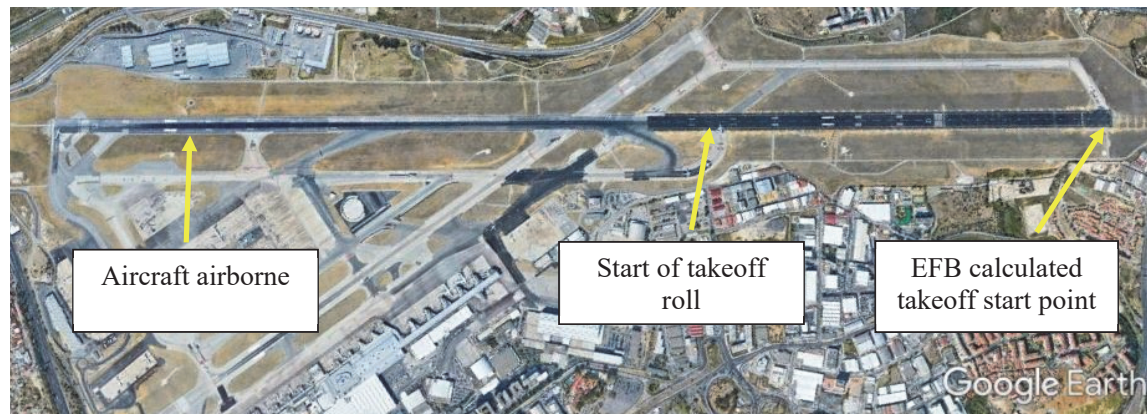
Figure 2

Image of Lisbon Airport showing the calculated and actual takeoff points

Analysis of the FDR data for the event showed that the takeoff roll was about 1,860 m long, with the aircraft becoming airborne 400 m before the upwind runway threshold, which it overflew at 100 ft climbing at about 2,700 ft/min. The airspeed at lift off was 170 KIAS.

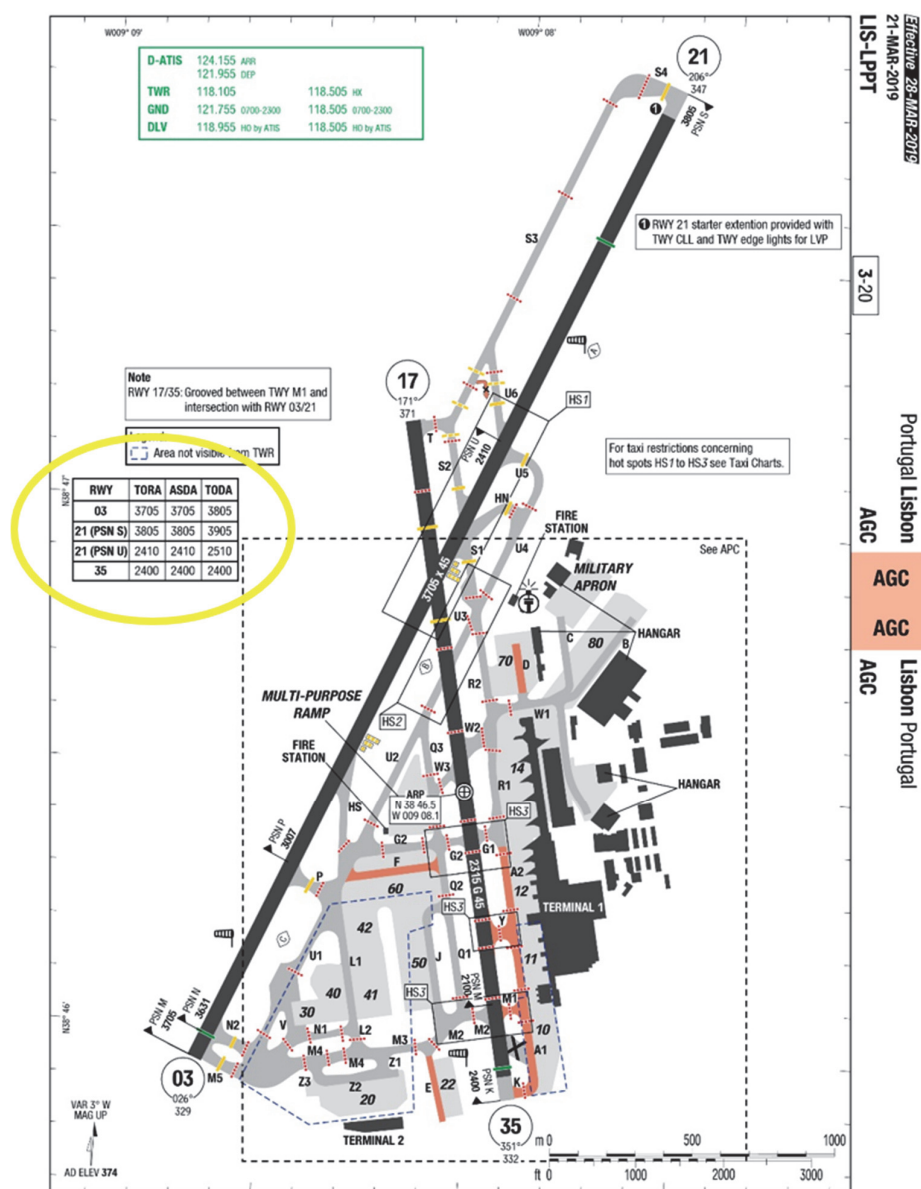
Lisbon aerodrome ground chart © LIDO

Both pilots are required to cross-check the runway distances available from the chosen intersection against the lengths displayed on the aerodrome ground chart, as shown circled in yellow in Figure 3 for Lisbon.

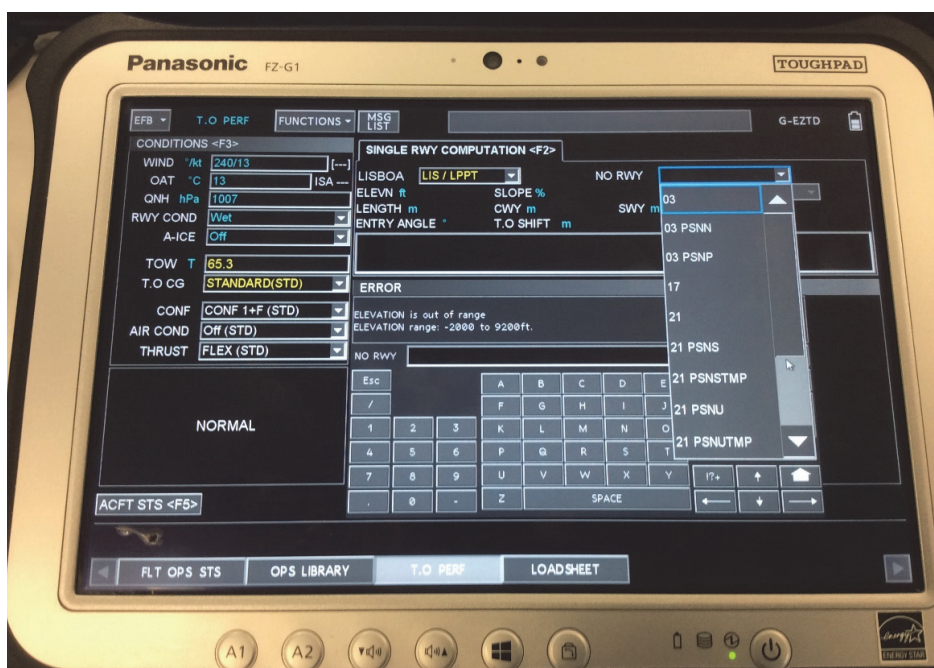
Figure 4

At the time of the incident, there was a NOTAM affecting the takeoff performance calculation (referring to an obstacle in the climb-out zone). This meant that the data supplier had inserted two further temporary selections for the two takeoff positions for Runway 21, which were labelled PSNUTMP and PSNSTMP as shown in Figure 4.

EFB dropdown menu showing the all the intersections available

The crew initially selected PSNUTMP for the performance calculation, ie intersection U5, but in discussing the likely takeoff point, they decided that they could use the S1 intersection if necessary, from which there was a lower TORA than from U5. They then performed the calculation from what they thought was the S1 intersection in the EFB selection: PSNSTMP.

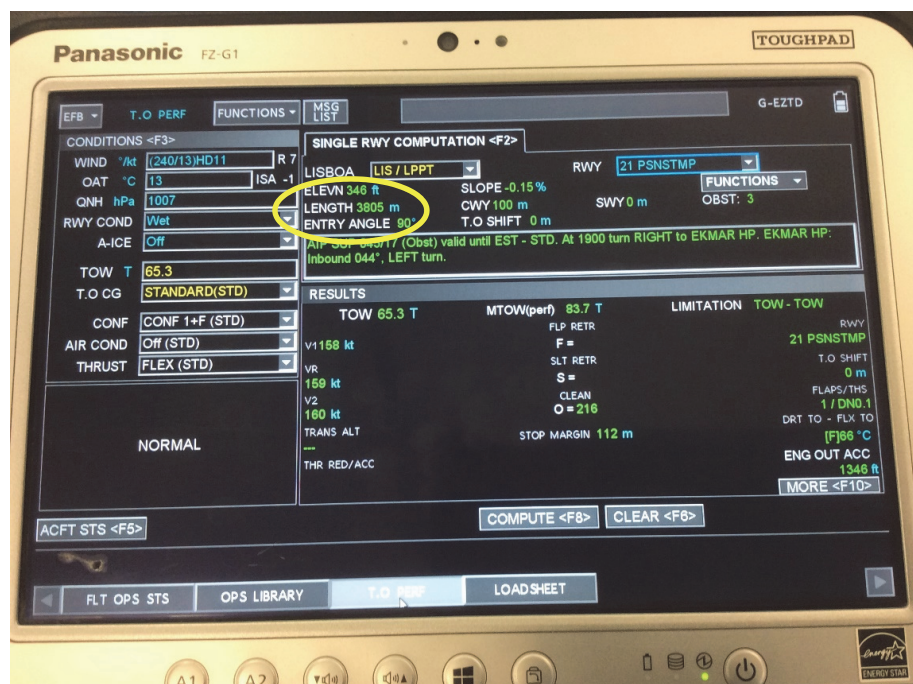
Figure 5

Performance calculation from the temporary Position S showing the distance display
