ACCIDENT

Aircraft Type and Registration:	Eurocopter EC135T1, VP-CPS	
No & Type of Engines:	2 Turbomeca Arrius 2B1A turboshaft engines	
Year of Manufacture:	1999	
Date & Time (UTC):	26 February 2019 at 1631 hrs	
Location:	Owen Roberts International Airport, Cayman Islands	
Type of Flight:	Training and search	
Persons on Board:	Crew - 3	Passengers - None
Injuries:	Crew - 3 (Minor)	Passengers - N/A
Nature of Damage:	Damage to tail boom, landing gear and transmission deck	
Commander's Licence:	Commercial Pilot's Licence	
Commander's Age:	58 years	
Commander's Flying Experience:	7,842 hours (of which 3,879 were on type) Last 90 days - 56 hours Last 28 days - 22 hours	
Information Source:	AAIB Field Investigation

Synopsis

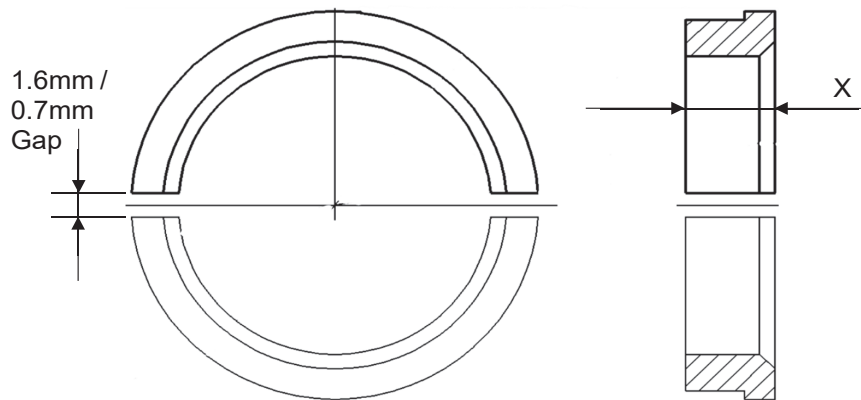
Figure 4

Compression ring segments

Two half-segments are used to remove the need to fully disassemble the actuator at the final stage of manufacture and no sealant is applied, to ensure ease of removal. The dimensional tolerances of each segment result in a gap between the segments of 1.6 mm to 0.7 mm on each side (Figure 4) when installed into the upper piston (Figure 5).

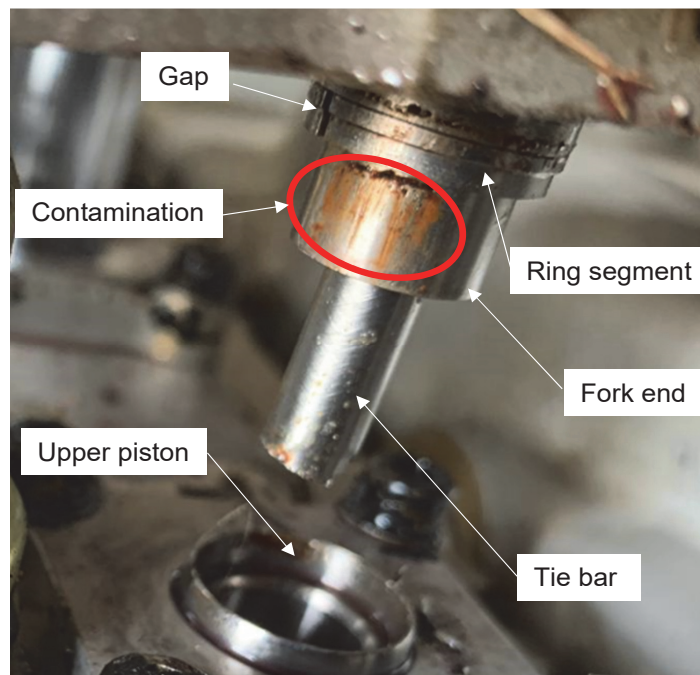
Figure 5

Compression ring segments gap

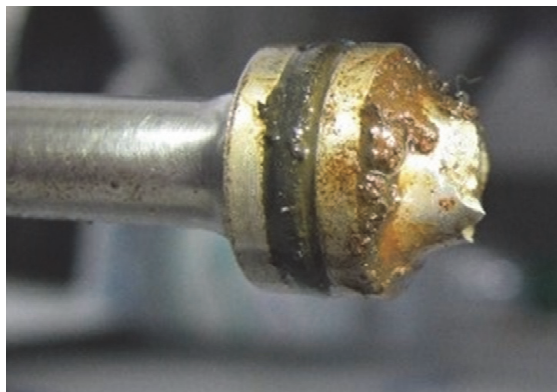
Figure 7

Analysis of the material found adjacent to the fracture on the tie bar (Figure 7) revealed a high sodium and chlorine content, amongst other chemical elements, with similar deposits found on the other actuator tie bars. There was evidence of the same material on the part of the fork end located within the upper piston (Figure 5).

Material adjacent to tie bar fracture surface

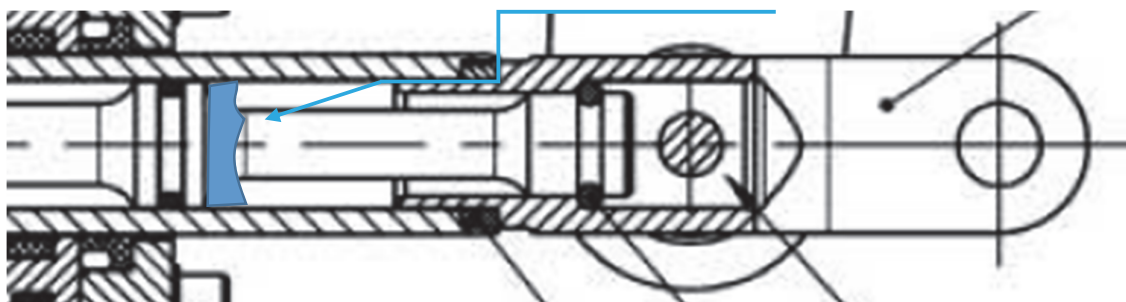
Figure 9

The combination of the installation orientation of the main rotor actuator and an unsealed gap between the compression ring segments could lead to moisture penetrating into the upper piston. This moisture would then collect by the first 'O-ring' seal at the end of the tie bar and, over time, cause the tie bar and piston to corrode. Analysis of the material found adjacent to the fracture surfaces showed elevated levels of sodium chloride. The helicopter's normal operating environment over the Cayman Islands and its waters would expose it to high levels of salt. It is likely that this deposit caused the pitting corrosion found on the surface of the tie bar. The deposit would then cause further corrosion within the material along the intercrystalline boundaries. Normal operating loads on the tie bar would cause these small intercrystalline corrosion cracks to coalesce, leading to a reduction in cross-sectional area. This would happen gradually over time, as evidenced from the light corrosion seen on the fracture face in VP-CPS. Finally, the remaining material would fail through overload.

Possible moisture ingress path (rotated)

To initiate a review of the actuator design with the equipment supplier to identify changes that could be made to prevent moisture ingress and a corrosion-initiated failure of the tie bar.
