ACCIDENT

Aircraft Type and Registration:	Airbus A330-243, G-MLJL
No & Type of Engines:	2 Rolls-Royce RB211 Trent 772B-60 turbofan engines
Year of Manufacture:	1999 (Serial no: 254)
Date & Time (UTC):	2 August 2019 at 23:54 hrs
Location:	In flight from Varadero Airport, Cuba, to Manchester Airport
Type of Flight:	Commercial Air Transport (Passenger)
Persons on Board:	Crew - 11 Passengers - 320
Injuries:	Crew - 2 (1 serious) Passengers - None
Nature of Damage:	Radome damaged
Commander's Licence:	Airline Transport Pilot's Licence
Commander's Age:	46 years
Commander's Flying Experience:	12,136 hours (of which 5,300 were on type) Last 90 days - 205 hours Last 28 days - 93 hours
Information Source:	Aircraft Accident Report Form submitted by the pilot

Synopsis

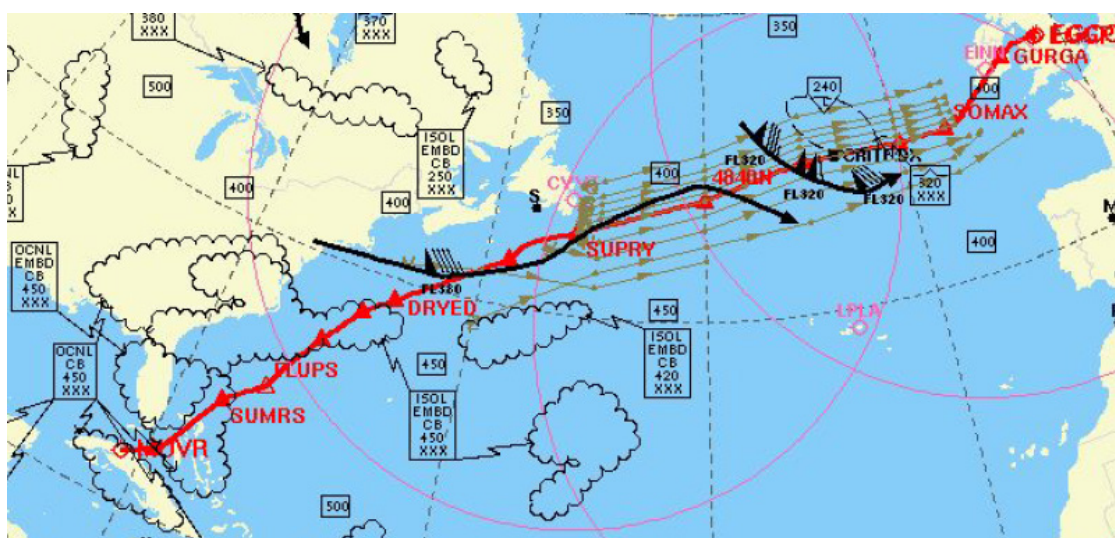
Figure 1

The significant weather forecast chart for the flight (Figure 1) indicated that occasional, isolated and embedded cumulonimbus (CB) clouds could be expected until passing waypoint DRYED, approximately 2 hours and 30 minutes into the flight. The presence of CB clouds implies a risk of thunderstorms and hail as well as moderate or severe turbulence and icing.

North Atlantic Significant Weather Chart valid 00 UTC 3 Aug 2019
