**ACCIDENT**

<b>Aircraft Type and Registration:</b>	1) Boeing 737-73S, EI-SEV 2) Boeing 737-33A, G-GDFB
<b>No &amp; Type of Engines:</b>	1) EI-SEV: 2 CFM56-7B turbofan engines 2) G-GDFB: 1 CFM56-3B2 turbofan engine, 1 CFM56-3C1 turbofan engine
<b>Year of Manufacture:</b>	1) EI-SEV: 1999 (Serial no: 29078) 2) G-GDFB: 1992 (Serial no: 25743)
<b>Date &amp; Time (UTC):</b>	30 April 2019 at 0647 hrs
<b>Location</b>	Stand 24, East Midlands Airport
<b>Type of Flight:</b>	Positioning flight (non-revenue)
<b>Persons on Board:</b>	1) Crew - 2                      Passengers - None 2) Crew - None                Passengers - N/A
<b>Injuries:</b>	1) Crew - None                Passengers - None 2) Crew - N/A                 Passengers - N/A
<b>Nature of Damage:</b>	1) Right winglet partially detached 2) Damage to underside of right horizontal stabiliser
<b>Commander's Licence:</b>	1) Airline Transport Pilot's Licence 2) N/A

**Synopsis**

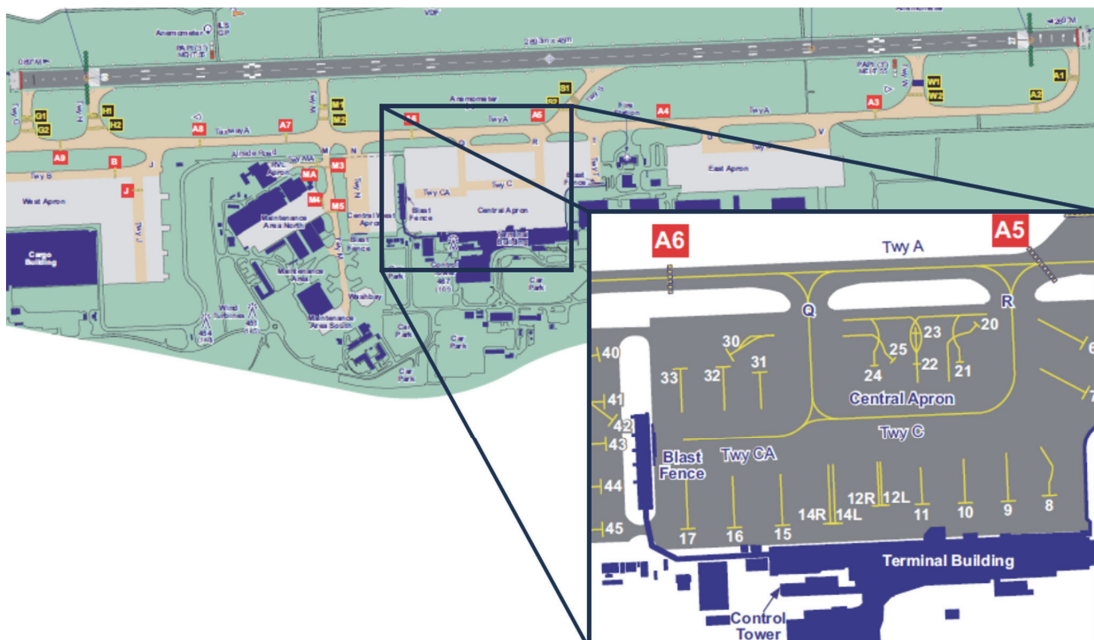
Figure 1

Due to the poor weather and their elevated position in the control tower, air traffic controllers could not see the aircraft, taxiway or apron. G-GDFB was not painting on the Controllers' Surface Movement Radar (SMR) display. With no other information about stand occupancy available to them, ATC were unaware that S24 was occupied. Accordingly, the ground movements controller cleared EI-SEV to taxi the shortest route to S22 which was via Quebec (Q), the western entry point to the apron (Figure 1). The EMA ATC Final Investigation Report into the accident concluded that:

*'The poor visibility rendered the parked aircraft on stand 24 invisible to ATC. Had visibility been better, ATC would have had an opportunity to visually acquire the obstruction and offer a different route.'*

East Midlands Airport Chart with zoomed image of the Central Apron

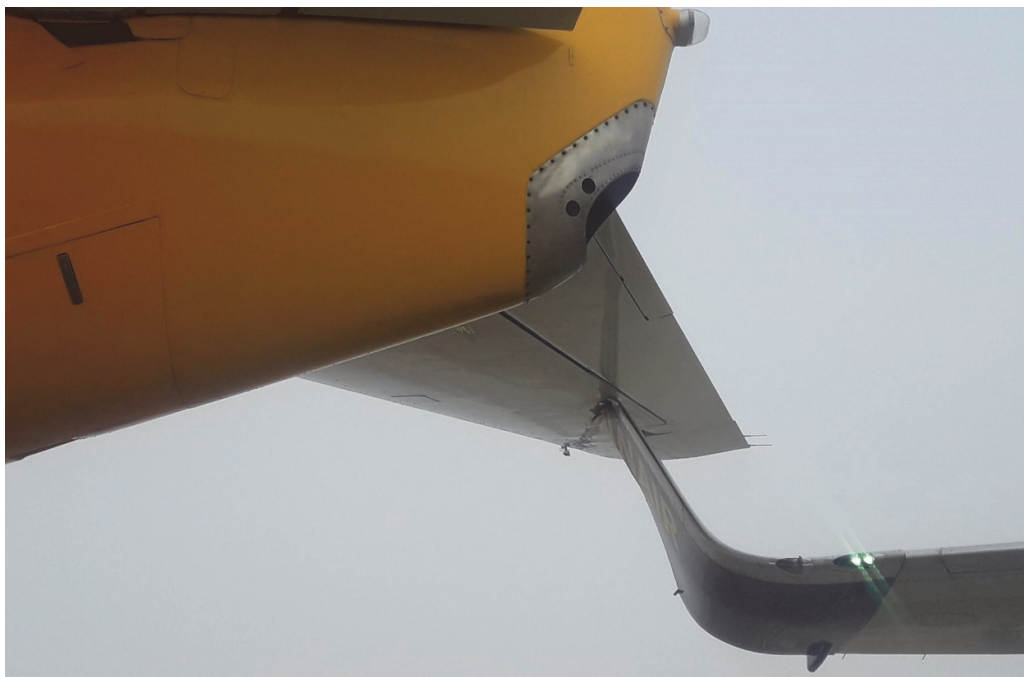
**Figure 3**

As EI-SEV crossed behind G-GDFB the commander brought the aircraft to a slow walking pace and the co-pilot monitored the right wing tip. From his perspective it appeared to be clear, but as they overlapped EI-SEV’s winglet struck G-GDFB’s right horizontal stabiliser (Figure 3). The commander brought the aircraft to a halt and reported the collision to ATC.

EI-SEV’s winglet in contact with right horizontal stabiliser of G-GDFB

The aircraft was traveling slowly and the co-pilot was visual with both EI-SEV's winglet and G-GDFB's stabiliser. From his perspective, it appeared that the winglet would remain clear of the other aircraft's tail. That the aircraft collided demonstrated that visually judging relative distance between two objects at range is prone to error.

The airport operator closed Stand 22 pending a safety review and conducted a survey of parking stands across the airport to identify any similar aircraft taxi-separation hazards.

The operators of both aircraft alerted their EMA-based flight crew to the hazard of reduced separation when using Stands 20 to 25.

The operator of EI-SEV issued a Company NOTAM to alert its pilots to the reduced separation hazard on Stands 20 to 25 at EMA.

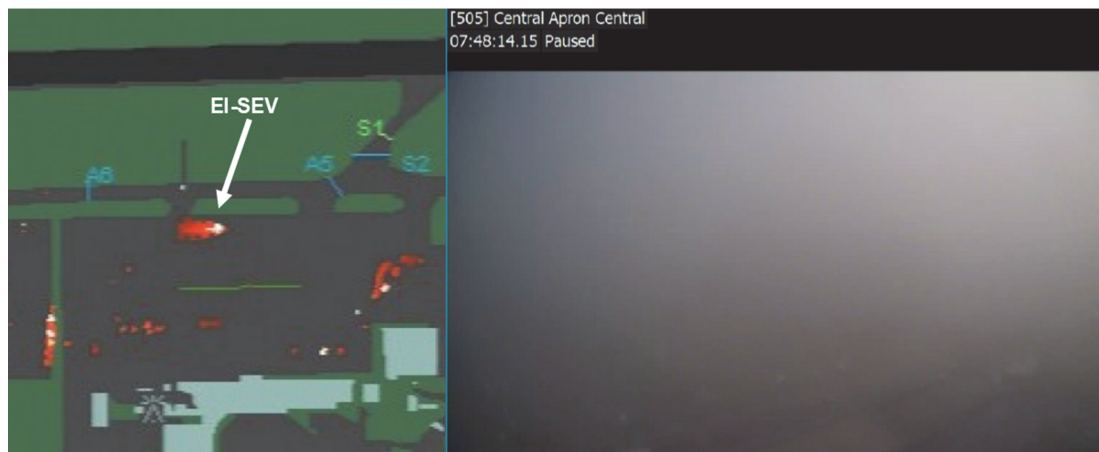
**Figure 4**

Airport CCTV and SMR footage revealed that, in the conditions prevailing at the time, neither system was capable of alerting the ATC controllers to the collision risk. The CCTV view of the apron was obscured by fog and the SMR was not designed to show stationary targets (Figure 4). The EMA ATC report noted that:

*'The East Midlands Surface Movement Radar (SMR) does not show stationary objects or parked aircraft...When aircraft are taxiing they display but as they stop, either to park or to hold, they disappear from SMR...in times of poor visibility [SMR] becomes the 'eyes' of the controller. More modern SMRs show stationary targets and would have shown the aircraft parked on stand 24... Whilst it cannot be guaranteed that a better SMR/ASMGCS<sup>1</sup> system would have prevented the collision, it would have provided the controller with much needed information as to the presence of an obstruction on [EI-SEV's] taxi route.'*

Screenshots of the SMR display (left) and the Central Apron CCTV camera (right)

Prior to this accident the airport operator had started scoping for the procurement of an improved SMR or an ASMGCS installation.
