**INCIDENT**

<b>Aircraft Type and Registration:</b>	DHC-8-402 Dash 8, G-ECOC	
<b>No &amp; Type of Engines:</b>	2 Pratt & Whitney Canada PW150A turboprop engines	
<b>Year of Manufacture:</b>	2007 (Serial no: 4197)	
<b>Date &amp; Time (UTC):</b>	13 December 2018 at 2105 hrs	
<b>Location:</b>	En route from Aberdeen to Birmingham	
<b>Type of Flight:</b>	Commercial Air Transport (Passenger)	
<b>Persons on Board:</b>	Crew - 4	Passengers - 77
<b>Injuries:</b>	Crew - None	Passengers - None
<b>Nature of Damage:</b>	None	
<b>Commander's Licence:</b>	Airline Transport Pilot's Licence	
<b>Commander's Age:</b>	46 years	
<b>Commander's Flying Experience:</b>	7,655 hours (of which 7100 were on type) Last 90 days - 204 hours Last 28 days - 49 hours	
<b>Information Source:</b>	Aircraft Accident Report Form submitted by the pilot

**Synopsis**

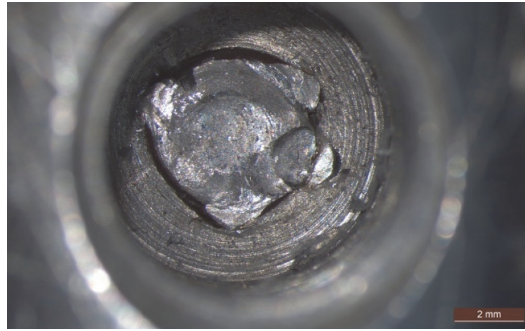
**Figure 4**

Following the incident on 13 December 2018, the oxygen cylinder assembly was removed from the aircraft and taken to a laboratory for further analysis. The regulator was removed from the bottle and a visual examination revealed debris blocking the crew oxygen supply line port (Figure 4).

Debris blocking port with regulator partially disassembled

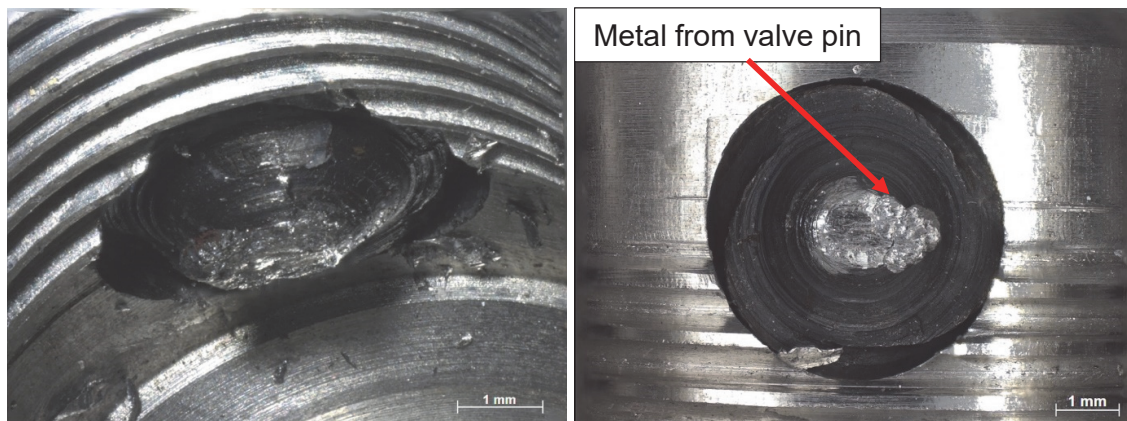
**Figure 5**

The regulator was fully dismantled, and abrasion damage was observed to the valve pin when viewed through the low-pressure relief valve port ([3] in Figure 3). The valve body was sectioned at right angles to the port and further visual examination of the debris revealed that it was threaded. Energy dispersive x-ray (EDX) analysis of the metal attached to the end of the debris confirmed that the debris had damaged the valve pin (Figure 5). EDX analysis of the debris showed it to be a low alloy steel containing chromium and molybdenum, whereas the valve pin and the regulator body are manufactured from a corrosion-resistant steel.

Debris blocking port (regulator sectioned)

Examination of the outer end of the debris using a scanning electron microscope (SEM) showed that the surface had been extensively mechanically damaged by contact with another body. Analysis of undamaged areas of the surface showed a fracture surface consistent with torsional overload in shear. An attempt was made to remove the debris using a screw extractor, however the debris was too hard to drill using a standard drill bit.

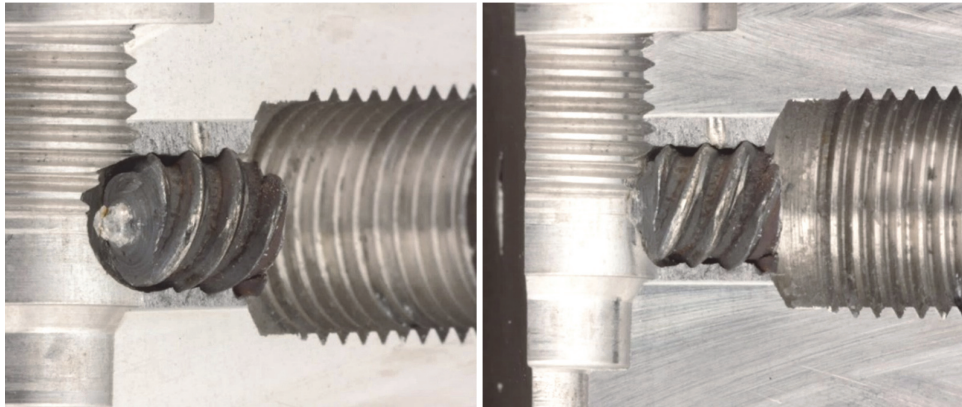
**Figure 6**

The regulator body was further sectioned along the axis of the port and revealed the debris to have a left-hand thread and that it had cut into the smooth bore section of the crew oxygen supply port (Figure 6). The debris was tapered and was approximately 6 mm in length.

Debris blocking port [7] (regulator sectioned)

It is possible that a screw extractor tool had been inserted into the crew oxygen supply port at some point and turned until it contacted the valve pin and cut into the wall of the port. If torque continued to be applied to the tool it would result in overload failure of the tool in shear. The subsequent damage to the fracture surface may have been the result of attempts to remove the debris. With the debris in place normal oxygen flow would have been restricted but it did not fully block the port therefore allowing, over time, for the system pressure to read normally on the flight deck gauge.

operator has changed the 'first flight' procedure to include a momentary flow of oxygen to ensure that the system can maintain pressure whilst supplying a flow.

The Operations Manual for the Flight Deck Fixed Oxygen Checks has been updated to include a one-second flow of oxygen to ensure that system pressure is maintained during the first flight check.
