**SERIOUS INCIDENT**

<b>Aircraft Type and Registration:</b>	1) Airbus A320, OE-IHD 2) Saab-Scania SS340B, G-LGNK
<b>No &amp; Type of Engines:</b>	1) 2 International Aero Engines IAE 2500 S 2) 2 General Electric Co CT7-9B turboprop engines
<b>Year of Manufacture:</b>	1) 2008 (Serial no: 3270) 2) 1990 (Serial no: 340B-185)
<b>Date &amp; Time (UTC):</b>	12 February 2019 at 1900 hrs
<b>Location:</b>	London Stansted Airport
<b>Type of Flight:</b>	1) Commercial Air Transport (Passenger) 2) Commercial Air Transport (Passenger)
<b>Persons on Board:</b>	1) Crew - 7                      Passengers - 180 2) Crew - 3                      Passengers - 18
<b>Injuries:</b>	1) Crew - None                  Passengers - None 2) Crew - None                  Passengers - None
<b>Nature of Damage:</b>	1) None 2) None
<b>Commander's Licence:</b>	1) Airline Transport Pilot's Licence 2) Airline Transport Pilot's Licence
<b>Commander's Age:</b>	1) 41 years 2) 42 years

**Synopsis**

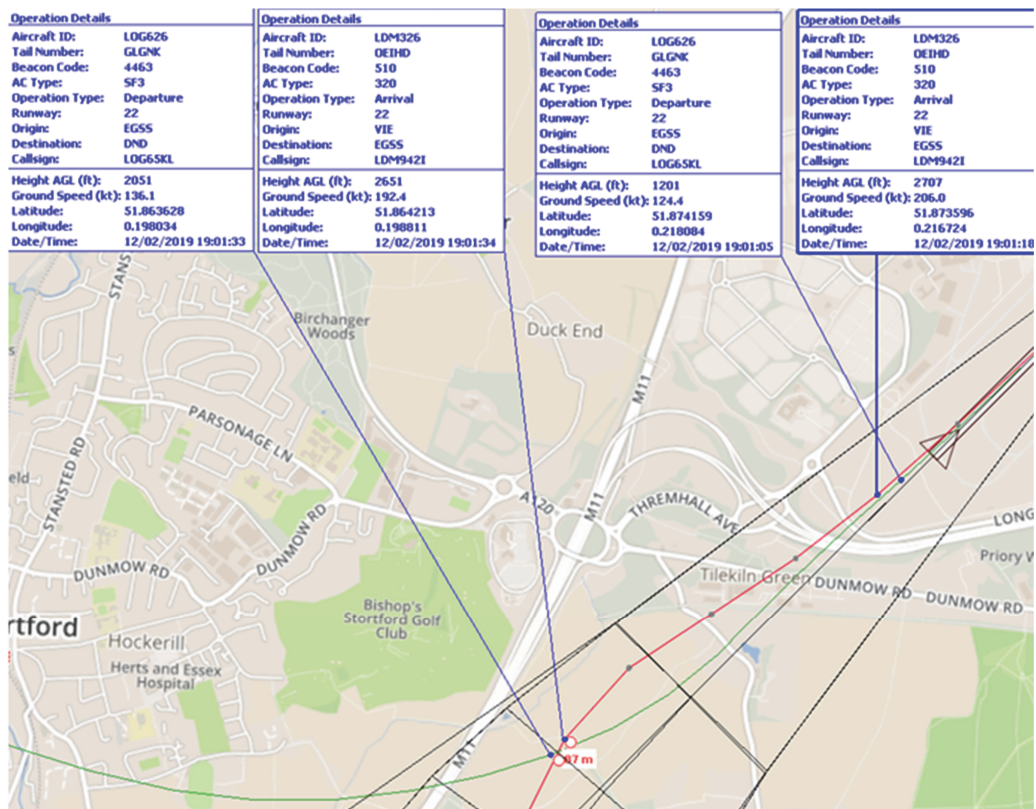
**Figure 1**  
ATC Radar information

The radar and ATC transponder data from both aircraft were analysed. A digest of the analysis showing the closest point of approach is shown in Figure 1. The aircraft passed 87 m apart laterally and 600 ft vertically. A 3D representation is at Figure 2.

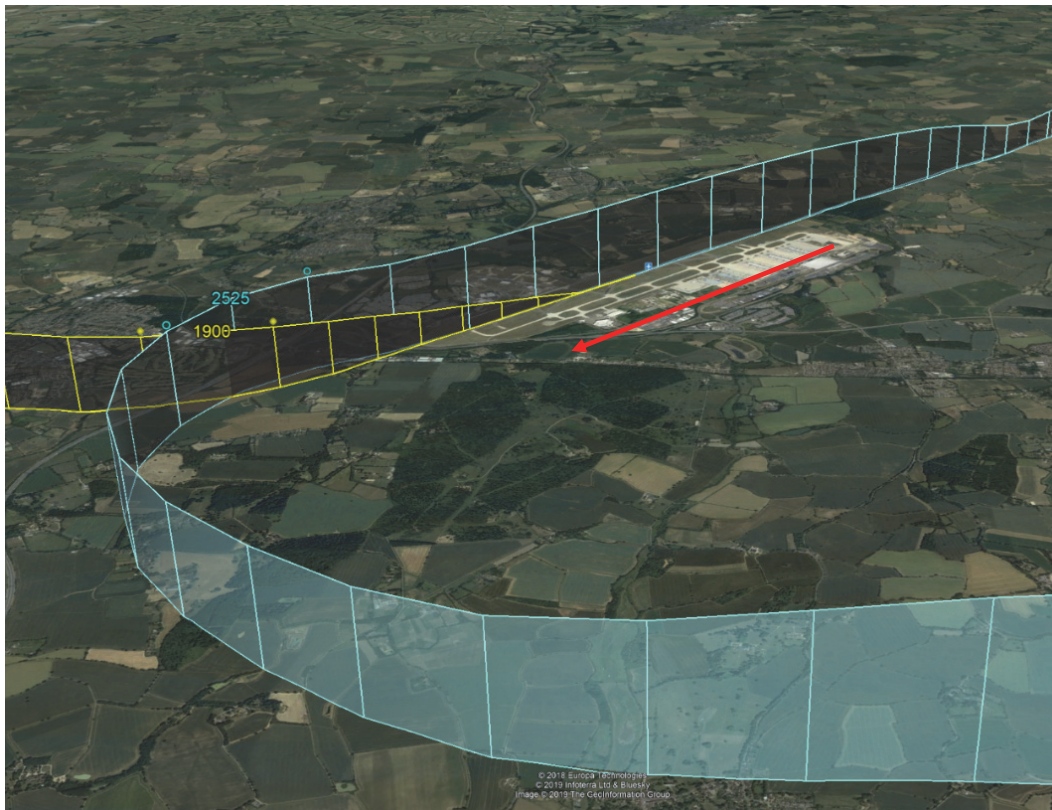
**Figure 2**

3D Tracks with the red arrow indicating the direction of travel  
G-LGNK in yellow, OE-IHD in blue with altitudes based on 1013 mb
