ACCIDENT

Aircraft Type and Registration:	Midget Mustang, G-AWIR
No & Type of Engines:	1 Continental Motors Corp O-200-A piston engine
Year of Manufacture:	1973 (Serial no: PFA 1315)
Date & Time (UTC):	21 July 2019 at 1630 hrs
Location:	Woods near Spanhoe Airfield, Northamptonshire
Type of Flight:	Private
Persons on Board:	Crew - 1 Passengers - None
Injuries:	Crew - 1 (Serious) Passengers - N/A
Nature of Damage:	Destroyed
Commander's Licence:	Private Pilot's Licence
Commander's Age:	56 years
Commander's Flying Experience:	677 hours (of which 10 were on type) Last 90 days - 71 hours Last 28 days - 16 hours
Information Source:	Aircraft Accident Report Form submitted by the pilot

Synopsis

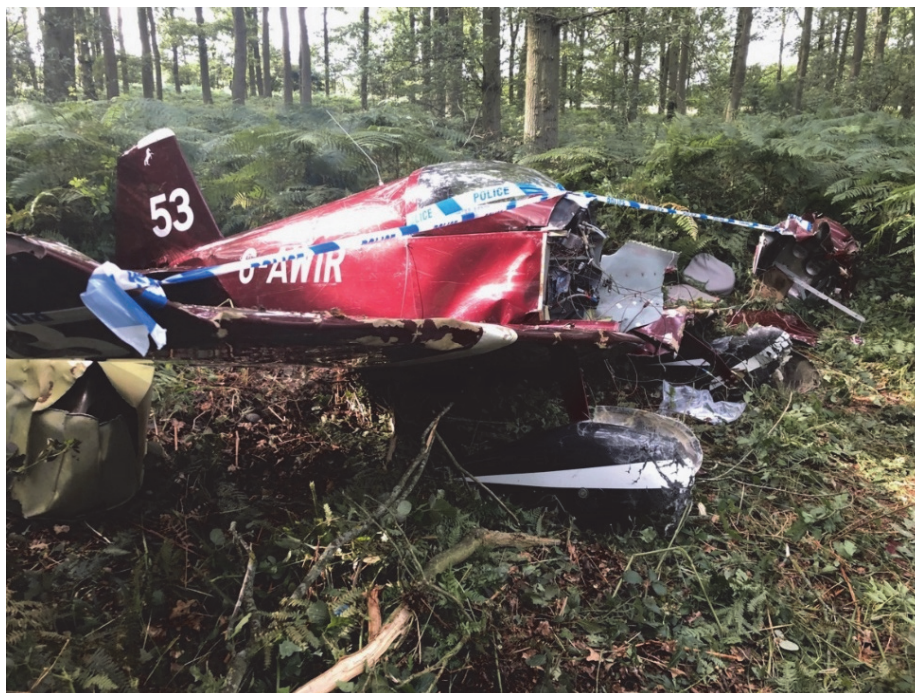
Figure 1
Aircraft post-accident

The pilot was flying from Leicester Airfield to Sibson Airfield and on the way, he flew over Spanhoe Airfield to check the windsock and decide whether he was going to land there to visit friends. He flew overhead at approximately 600 to 700 ft and then pulled up and banked left. The next thing he remembers is hitting the tree canopy. The pilot sustained serious injuries and the aircraft was destroyed, Figure 1.

It seems most likely that the final manoeuvre increased the aircraft's stall speed to, or beyond the aircraft's airspeed which caused it to stall and the pilot to lose control of the aircraft with limited height available to recover before the aircraft struck the trees.
