## ACCIDENT

<b>Aircraft Type and Registration:</b>	Hummerchute, G-CJTI
<b>No &amp; Type of Engines:</b>	1 Rotax 582 piston engine
<b>Year of Manufacture:</b>	2016 (Serial no: 472)
<b>Date &amp; Time (UTC):</b>	18 September 2019 at 1828 hrs
<b>Location:</b>	Freeby, Leicestershire
<b>Type of Flight:</b>	Private
<b>Persons on Board:</b>	Crew - 1                      Passengers - 1
<b>Injuries:</b>	Crew - 1 (Minor)          Passengers - 1 (Serious)
<b>Nature of Damage:</b>	Damage to the trike's metal frame
<b>Commander's Licence:</b>	National Private Pilot's Licence
<b>Commander's Age:</b>	69 years
<b>Commander's Flying Experience:</b>	30 hours (of which 30 were on type) Last 90 days - 0 hours Last 28 days - 0 hours
<b>Information Source:</b>	Aircraft Accident Report Form submitted by the pilot and further enquires by the AAIB

## Synopsis

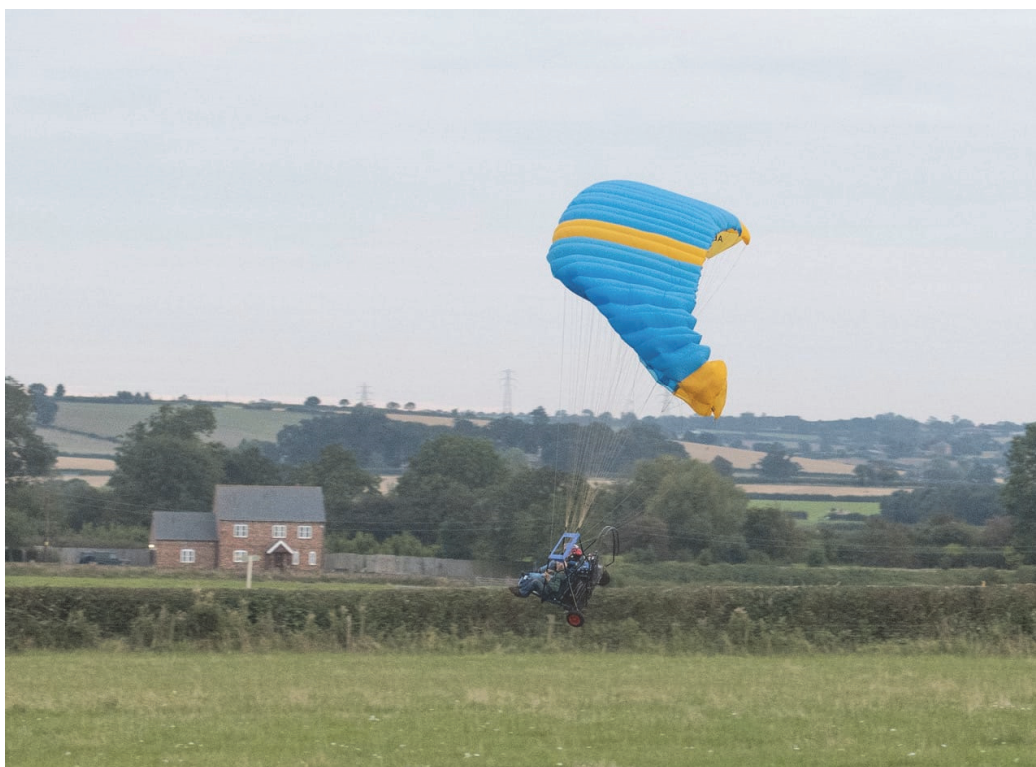
**Figure 2**  
G-CJTI as it lifted off the ground and rolled left

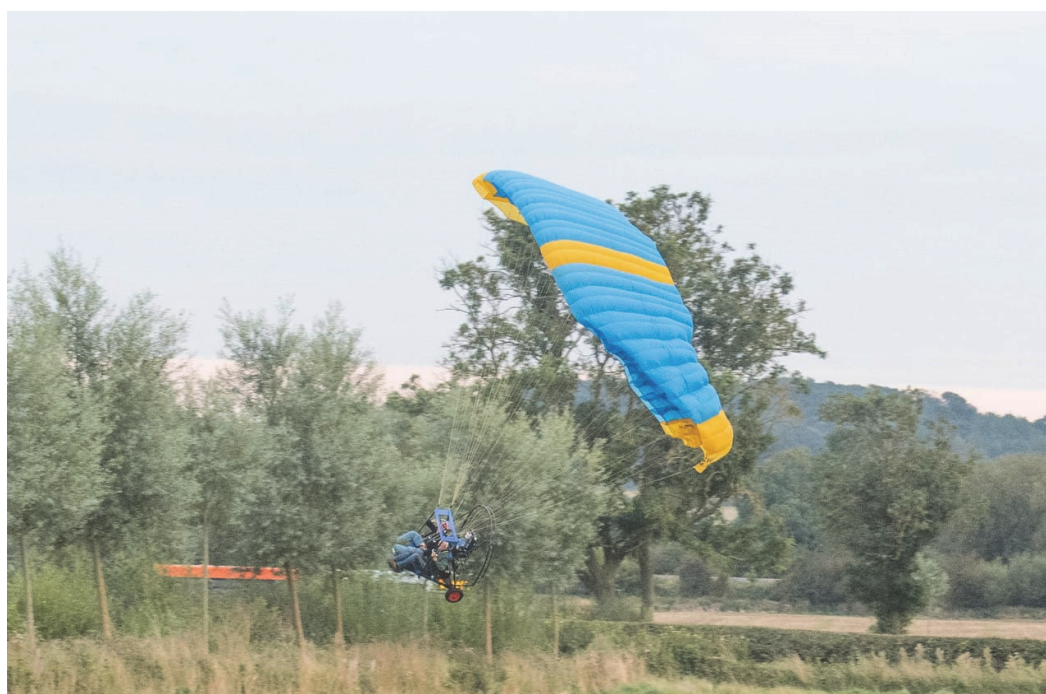
**Figure 3**  
G-CJTI rolling left before colliding with bushes
