Fatal man overboard from the single-handed creel fishing boat *May C* (SY213) at Loch Carnan, Outer Hebrides, Scotland on 24 July 2019

SUMMARY

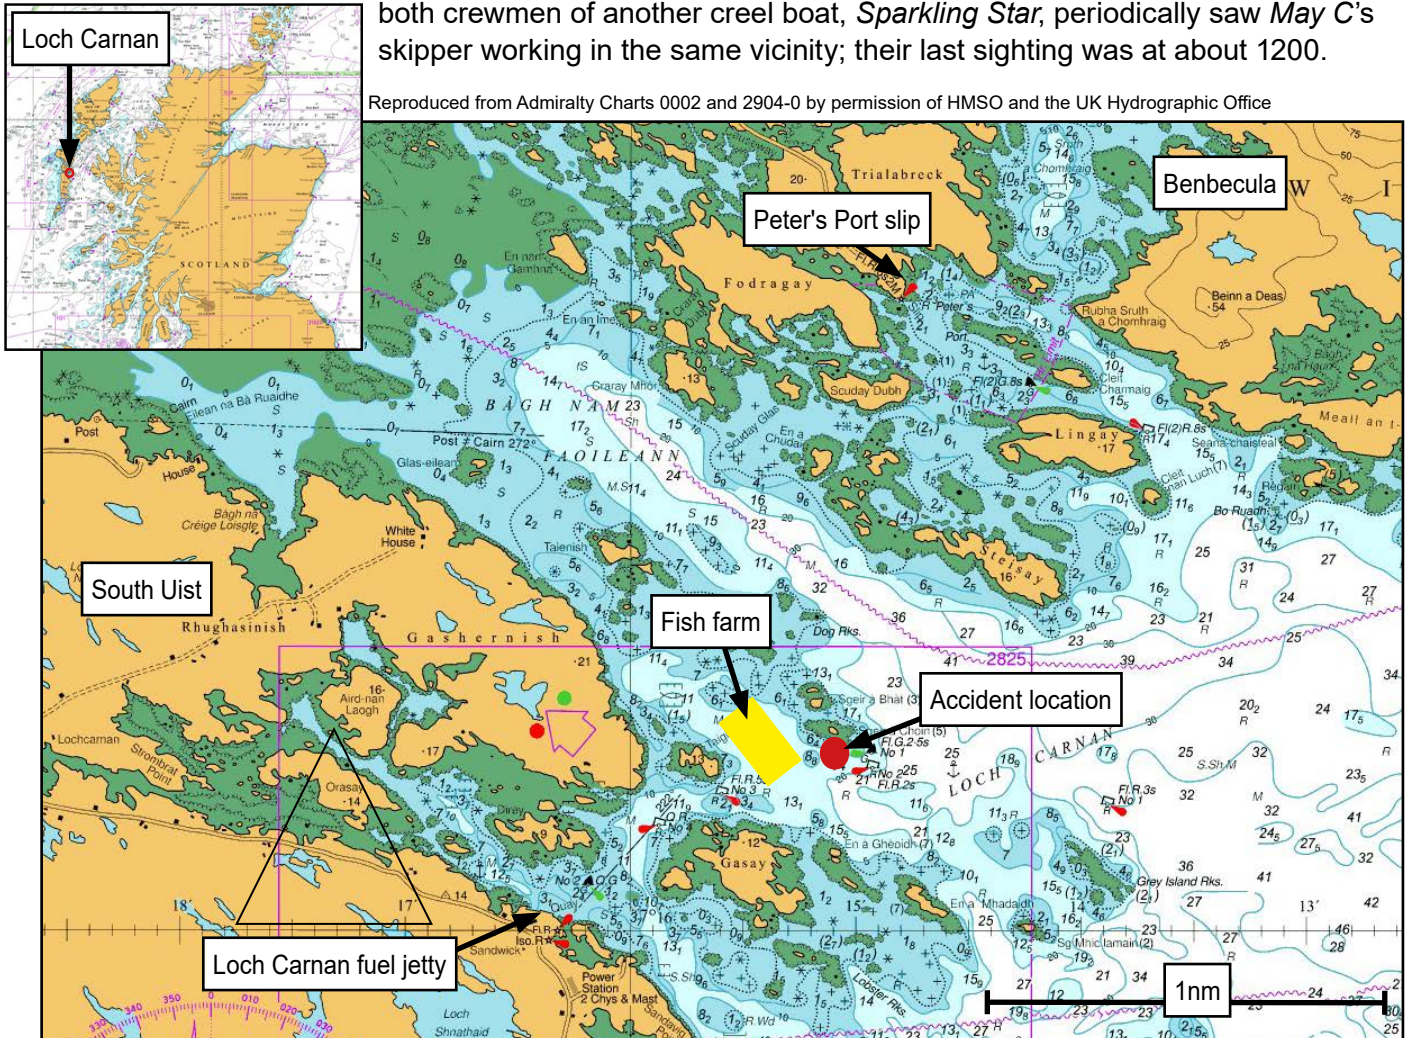
Figure 1: Chart showing accident location, Peter's Port, the fish farm and Loch Carnan fuel jetty

At about 0600 on 24 July 2019, *May C*'s skipper left home and, 20 minutes later, arrived at Peter's Port, Benbecula (**Figure 1**) where the boat was kept on a swinging mooring. The weather was overcast, there was a gentle south-westerly breeze and the sea temperature was 14°C. After rowing out to *May C* in his tender with his bait and provisions for the day, the skipper started the engine, departed from the mooring and headed across to Loch Carnan (**Figure 1**) to start tending his creels. During the morning,

May C's skipper did not respond to the CPR, and on the advice of the coastguard *Sparkling Star*'s crew took the skipper to Loch Carnan fuel jetty (**Figure 1**), where an ambulance was waiting; CPR continued during the short crossing. After examination by an ambulance paramedic at the fuel jetty, *May C*'s skipper was declared deceased.

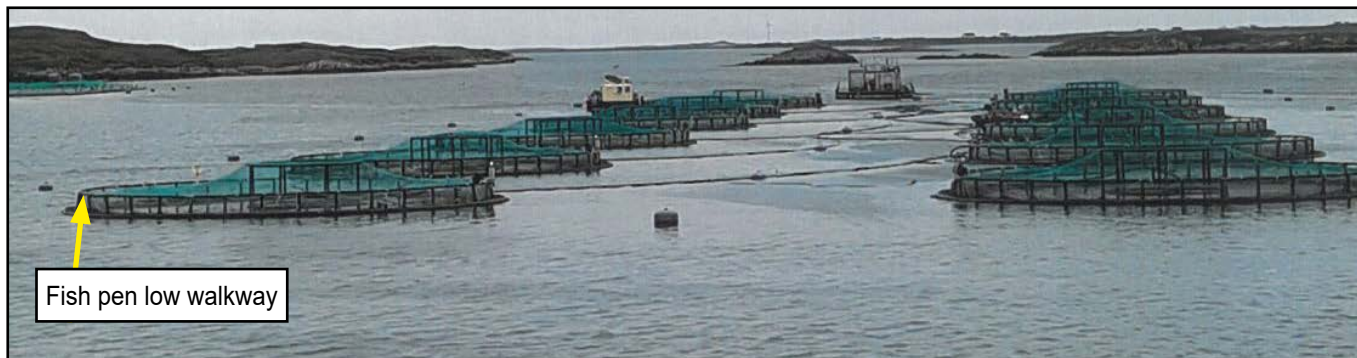
Figure 2: Fish farm pens

Sparkling Star's crew rigged a rope under the skipper's arms to keep his head above water and then manoeuvred him alongside a nearby fish farm cage, where they managed to lift him on to its low walkway (**Figures 1 and 2**) and commence cardio pulmonary resuscitation (CPR).

All fishing vessels should have an effective method of recovering someone out of the water. The initiative of *Sparkling Star's* crew to rescue the skipper and lift him out of the water at the nearby fish farm pens was commendable. However, the difficulty they experienced was a salutary reminder that *Sparkling Star* did not have an effective means for recovering an unconscious person from the water.

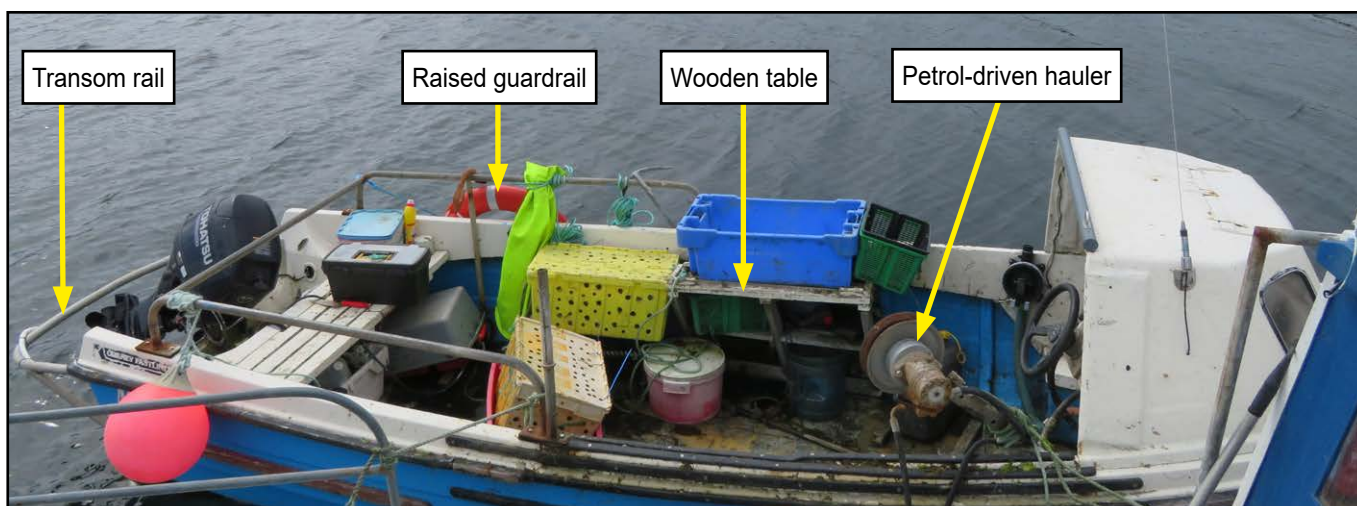
Figure 3: *May C* fittings

May C was a UK-registered 5.79m fibreglass fishing boat built in 1989 that was used for creel fishing, mainly catching velvet crab. *May C* was fitted with a raised guardrail, a petrol-driven hydraulic hauler for heaving in creels on the starboard side, and a wooden baiting table on the port side (**Figure 3**). *May C* was propelled by a 25 horse power outboard engine that was protected by a transom rail (**Figure 3**); the engine was operated, and could be raised and lowered, using controls at the cuddy near the bow.

Crouching at the transom would have been hazardous as the skipper would have been outside the raised guardrail, the safety barrier designed to prevent him from falling overboard. Probably weakened after around 6 hours of strenuous physical effort tending 144 creels, it is most likely that the skipper fell overboard while attending to the raised engine.

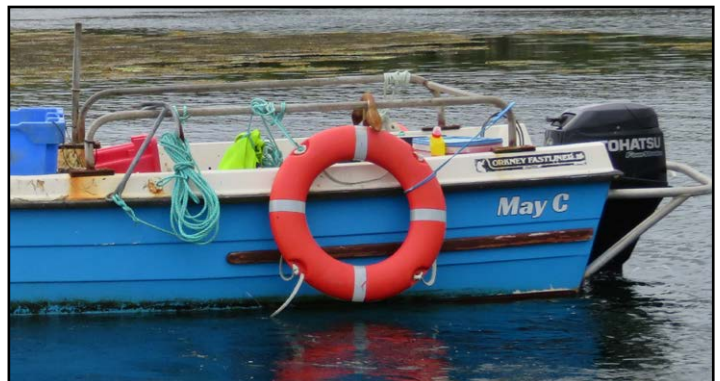
Figure 4: Lifebuoy rigged as a means of self rescue

The surveyor's inspection report included a deficiency requiring the '*man overboard means of recovery to be defined*'. In response to this deficiency, the skipper rigged a tyre, later replaced by a lifebuoy, over the port side to aid self-rescue (**Figure 4**). The lifebuoy was held just above the waterline by an elastic strap. This arrangement would allow someone in the water to reach up and release the elastic strap, causing the lifebuoy to drop into the water for use as a foothold for climbing back on board.

Once *May C*'s skipper had fallen overboard, without a PFD his chances of survival were very low. The weed growth on *May C*'s hull near the lifebuoy was undisturbed, indicating that the skipper had made no attempt to self-rescue. The skipper was also still wearing his boots when he was found, suggesting he had not tried to kick them off, probably because he had fallen unconscious very soon after entering the

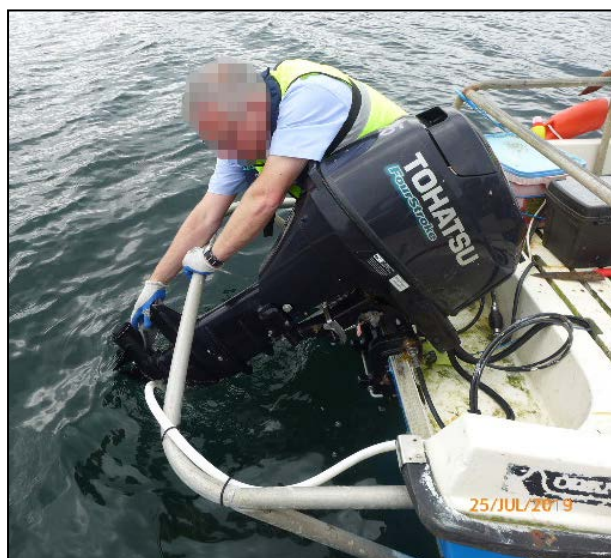
Figure 5: Reconstruction of outboard motor propeller being cleared

When underway, *May C*'s engine would be lowered and running continuously, so it was very unusual that the boat was found with the engine stopped and in the raised position. It was highly unlikely to have been raised for a mechanical repair as the engine started and ran normally after the accident and, although there was a box of tools on board, the motor's cowling was in place. Therefore, the most likely explanation was that the skipper had raised the engine to remove weed, or some other obstruction such as a rope or fishing line, which was fouling the propeller. The presence of a knife near the stern underpins this analysis. To reach the outboard's propeller, the skipper would have had to climb over the raised guardrail and crouch on the narrow transom, as illustrated at **Figure 5**. Although the propeller was not fouled when the boat was found, the skipper might have lost his balance when trying to climb inboard over the guardrail after clearing the propeller.
