ACCIDENT

Aircraft Type and Registration:	DJI Matrice 210 RTK (UAS, registration n/a)	
No & Type of Engines:	4 electric motors	
Year of Manufacture:	2018 (Serial no: 0N4DF6L021005)	
Date & Time (UTC):	20 October 2018 at 1340 hrs	
Location:	Manchester Piccadilly Gardens	
Type of Flight:	Emergency services operations	
Persons on Board:	Crew - N/A	Passengers - N/A
Injuries:	Crew - N/A	Passengers - N/A
Nature of Damage:	Extensive damage to the airframe, batteries and cameras	
Commander's Licence:	N/A	
Commander's Age:	44 years	
Commander's Flying Experience:	19 hours (of which 1 was on type) Last 90 days - 14 hours Last 28 days - 5 hours	
Information Source:	Aircraft Accident Report Form submitted by the pilot

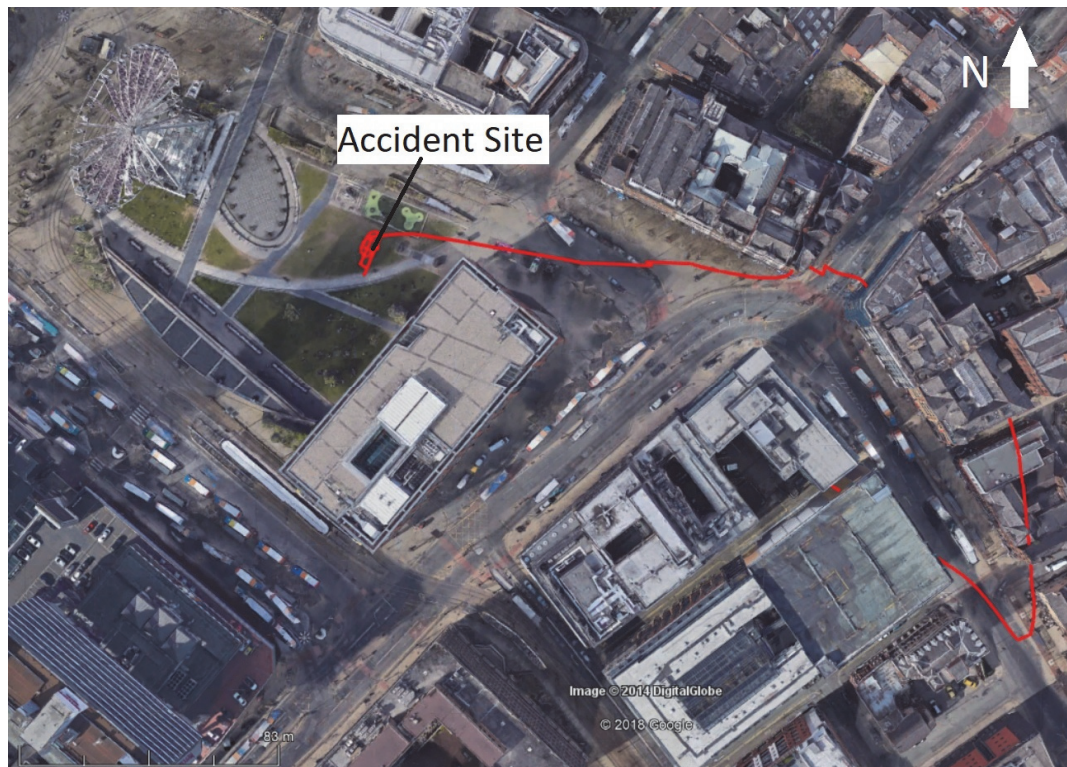
Figure 1

Plot of flight path of the flight

The accident flight started at 1325 hrs. The pilot was operating the aircraft up to heights of 79.2 m (260 ft) above the takeoff point. At 1340 hrs, while the aircraft was in a static hover at a height of about 168 ft (51.2 m) above the takeoff point, it started suddenly to descend and slew uncontrollably sideways, and hit the ground. The pilot briefly noticed the solid green battery indicator switch to flashing red; the observer noticed a BATTERY SYSTEM ERROR which flashed up on the RC. At the time of the sudden descent, the RC indicated that the battery voltage was 21.9 VDC with an estimated flight time remaining of 12 minutes and 9 seconds. The airframe and batteries, as well as both cameras incurred extensive damage. The aircraft did not hit any other persons or property on impact.

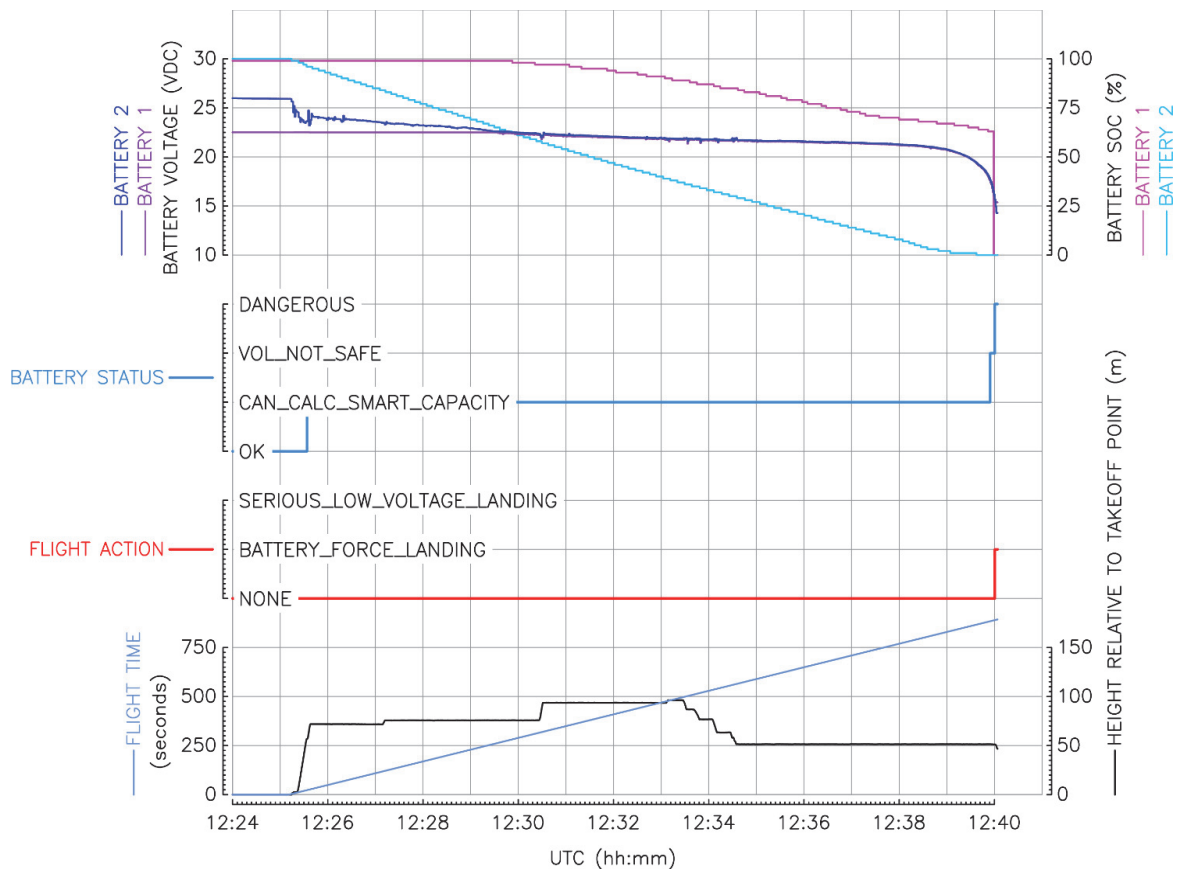
Figure 2

Plot of salient recorded data for the flight

The initial analysis by the manufacturer confirmed that the battery firmware was the latest version (v01.00.00.71). The log file from the aircraft recorded the battery voltages at the start of the flight as 22.5 VDC for battery 1 and 26.0 VDC for battery 2, yet, the SOC was 99% for battery 1 and 100%¹ for battery 2. Once airborne, the aircraft only drew current from battery 2 until the voltage matched that of battery 1; both batteries then discharged uniformly (Figure 2).

9.5 seconds before the end of the data, both batteries had a recorded voltage of 17.6 VDC. However, battery 1 had an SOC of 68% and battery 2 had an SOC of 0%. Seven seconds later, when battery 1 was fully discharged with an SOC recorded of 0% at 15.4 VDC, the aircraft initiated an automatic landing while at a height of 51.2 m (168 ft) above the take-off point.

The end of data, at 1240:03 hrs, with the aircraft at a height of 46.7 m (153 ft) above the takeoff point, marks the time at which the aircraft lost all power and it descended uncontrollably to the point of impact.
