ACCIDENT

Aircraft Type and Registration:	DJI Matrice 210 (UAS, registration n/a)	
No & Type of Engines:	4 electric motors	
Year of Manufacture:	2018 (Serial no: 0GODF4R023001)	
Date & Time (UTC):	4 September 2018 at 1451 hrs	
Location:	Tilbury Docks, Essex	
Type of Flight:	Emergency services operation	
Persons on Board:	Crew - N/A	Passengers - N/A
Injuries:	Crew - N/A	Passengers - N/A
Nature of Damage:	Destroyed	
Commander's Licence:	N/A	
Commander's Age:	42 years	
Commander's Flying Experience:	11 hours (of which 11 were on type) Last 90 days - 2 hours Last 28 days - 2 hours	
Information Source:	Aircraft Accident Report Form submitted by the pilot and further enquiries by the AAIB

After about six minutes into the flight, a battery low voltage condition was detected by the UAS causing it to enter an automatic landing mode. Shortly afterwards, while the aircraft was 20 m above the ground, it powered down and the electric motors stopped, causing it to fall to the ground. An investigation of this and similar accidents was conducted by the manufacturer which found that the batteries' State of Charge (SOC) was indicating an erroneously high level of charge remaining. Safety actions we

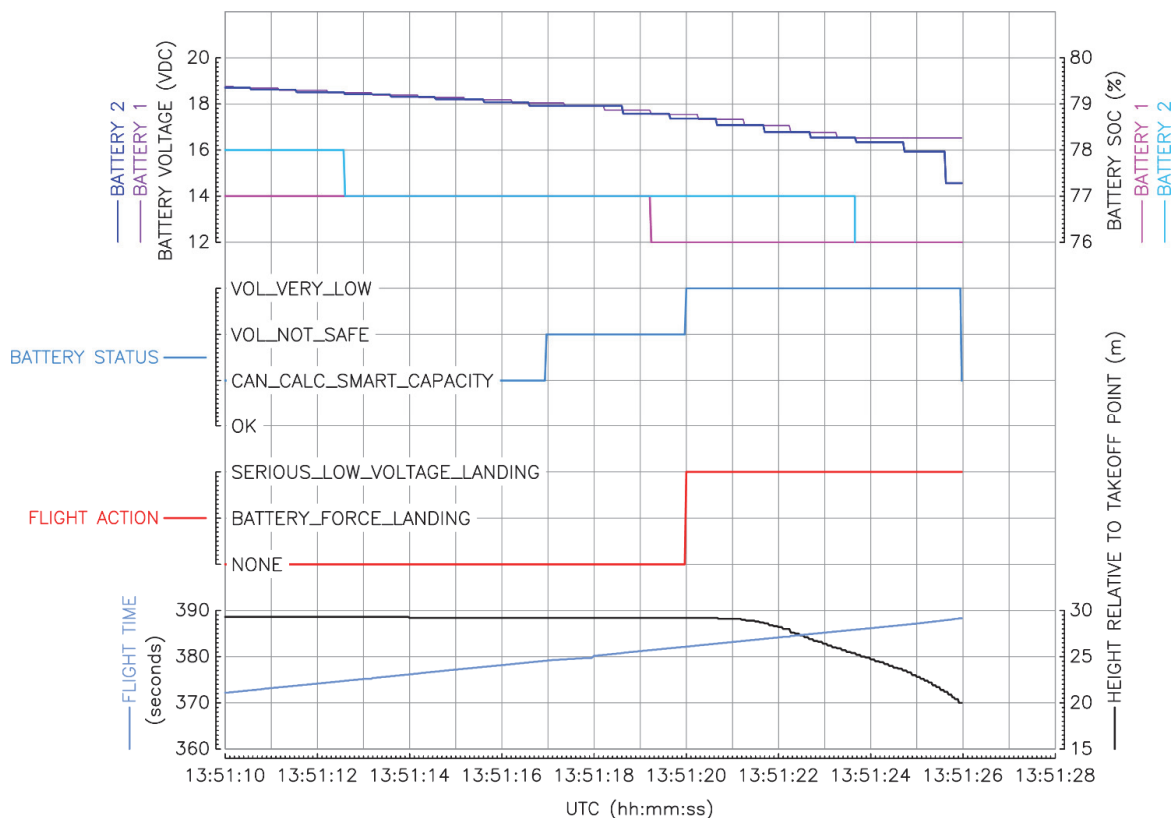
Figure 2

The recorded data showed that at the start of the flight, both batteries had a voltage of 22.5 VDC but an erroneous SOC of 100% which is normally associated with a battery voltage of 26.3 VDC. Nine seconds before the end of the flight, with both battery voltages at about 18 VDC (but indicating a SOC of 77%), a battery low-voltage condition was detected by the aircraft causing it to go into an automatic landing mode three seconds later. The aircraft powered down and the motors stopped while it was still airborne at a height of 20 m above the ground. The manufacturer's initial analysis concluded that landing was initiated 'due to critically low voltage'. This was confirmed by the AAIB's separate analysis of the recorded data (Figure 2).

Plot of salient data for last 16 seconds of the recorded data

aircraft to continue flying until the battery low-voltage condition was detected triggering an RTH quickly followed by an Automatic Landing command. There was, however, insufficient voltage to continue powering the aircraft as the low-voltage RTH condition was set too low. At this point the motors stopped and the aircraft fell to the ground.

Battery firmware version v01.00.00.77 was subsequently released in November 2018 that forcibly set the 'DoDWT' bit to 0 to enable OCV correction in the battery capacity algorithm for all TB50 and TB55 batteries.

As an additional redundant safety mechanism to the v01.00.00.77 battery firmware update, aircraft firmware v01.02.0000 was also released in November 2018 that introduced within the aircraft's flight controller a method to estimate the SOC. With the updated firmware, the software compared the controller-estimated SOC at the trigger points for an RTH or Automatic Landing with that calculated by the battery and, in the event of a difference of greater than 10%, trigger an RTH or Automatic Landing.
