ACCIDENT

Aircraft Type and Registration:	Luscombe 8A Silvaire, G-AKVP	
No & Type of Engines:	1 Continental Motors Corp A65-8 piston engine	
Year of Manufacture:	1948 (Serial no: 5549)	
Date & Time (UTC):	19 April 2019 at 1225 hrs	
Location:	Baxterley Aerodrome, Warwickshire	
Type of Flight:	Private	
Persons on Board:	Crew - 1	Passengers - None
Injuries:	Crew - None	Passengers - N/A
Nature of Damage:	Aircraft destroyed	
Commander's Licence:	Private Pilot's Licence	
Commander's Age:	60 years	
Commander's Flying Experience:	2,366 hours (of which 1,500 were on type) Last 90 days - 3 hours Last 28 days - 2 hours	
Information Source:	Aircraft Accident Report Form submitted by the pilot

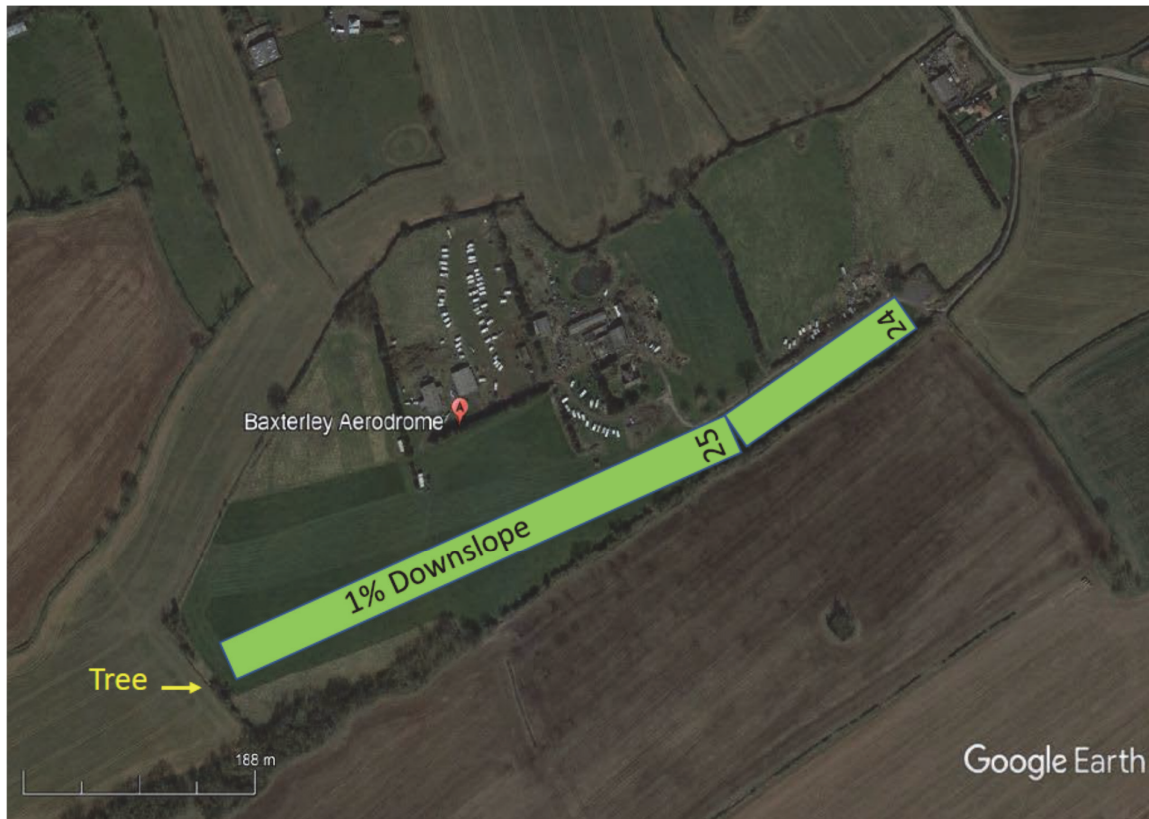
Figure 1

Aerodrome plan showing the runway alignment and the tree struck by the aircraft's left wingtip
