ACCIDENT

Aircraft Type and Registration:	Airbus A320-214, G-EZWC	
No & Type of Engines:	2 CFM56-5B4/3 turbofan engines	
Year of Manufacture:	2012 (Serial no: 5236)	
Date & Time (UTC):	3 April 2019 at 1410 hrs	
Location:	Belfast International Airport	
Type of Flight:	Commercial Air Transport (Passenger)	
Persons on Board:	Crew - 6	Passengers - 180
Injuries:	Crew - None	Passengers - None
Nature of Damage:	Damage to leading edge of No 2 engine nacelle, underside of fuselage, leading edge of right wing, nose landing gear, and to tyre	
Commander's Licence:	Airline Transport Pilot's Licence	
Commander's Age:	56 years	
Commander's Flying Experience:	11,886 hours (of which 7,943 were on type) Last 90 days - 58 hours Last 28 days - 9 hours	
Information Source:	Aircraft Accident Report Form submitted by the pilot and a report into the incident by the ground handling agent

Synopsis

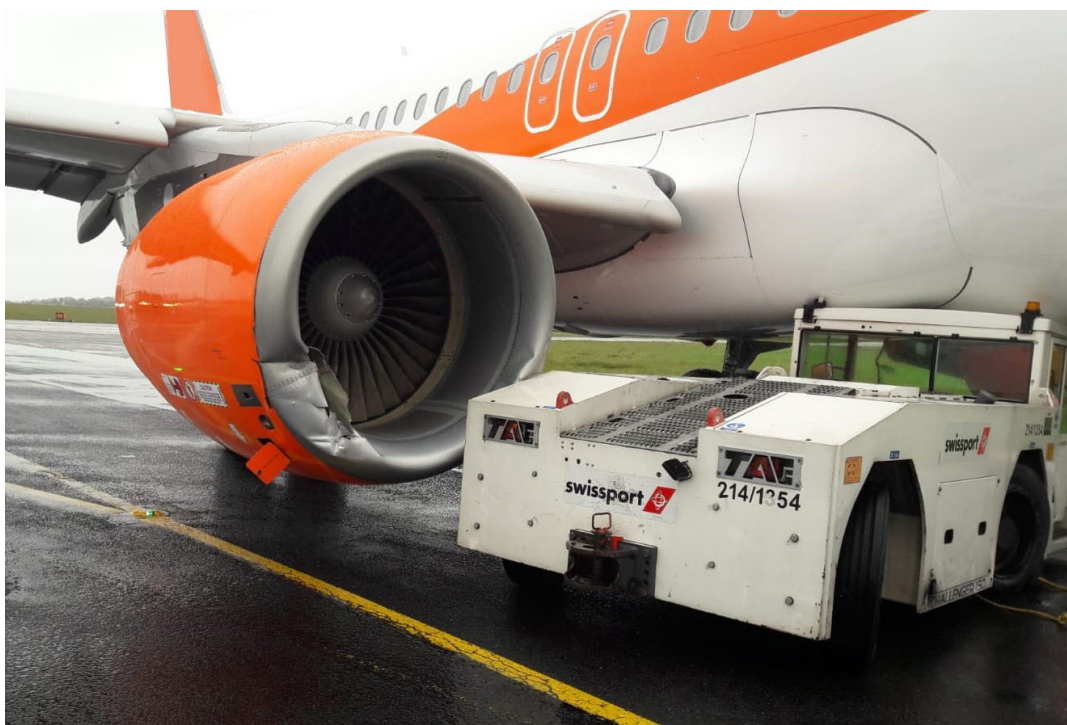
Figure 3

The damage to the right engine intake caused by the initial impact with the tug

With the aircraft's brakes released, the combination of the aircraft facing downslope and both engines running at idle, meant that it moved forward impacting the tug with the right engine nacelle, which caused the aircraft to yaw to the right as it moved forward and overran the tug, wedging it under the aircraft. Given the unusual situation, the headset man and tug driver were slow to react but the rate of forward movement of the aircraft was at a speed consistent with towing and the tow bar disconnect may not have been immediately apparent.

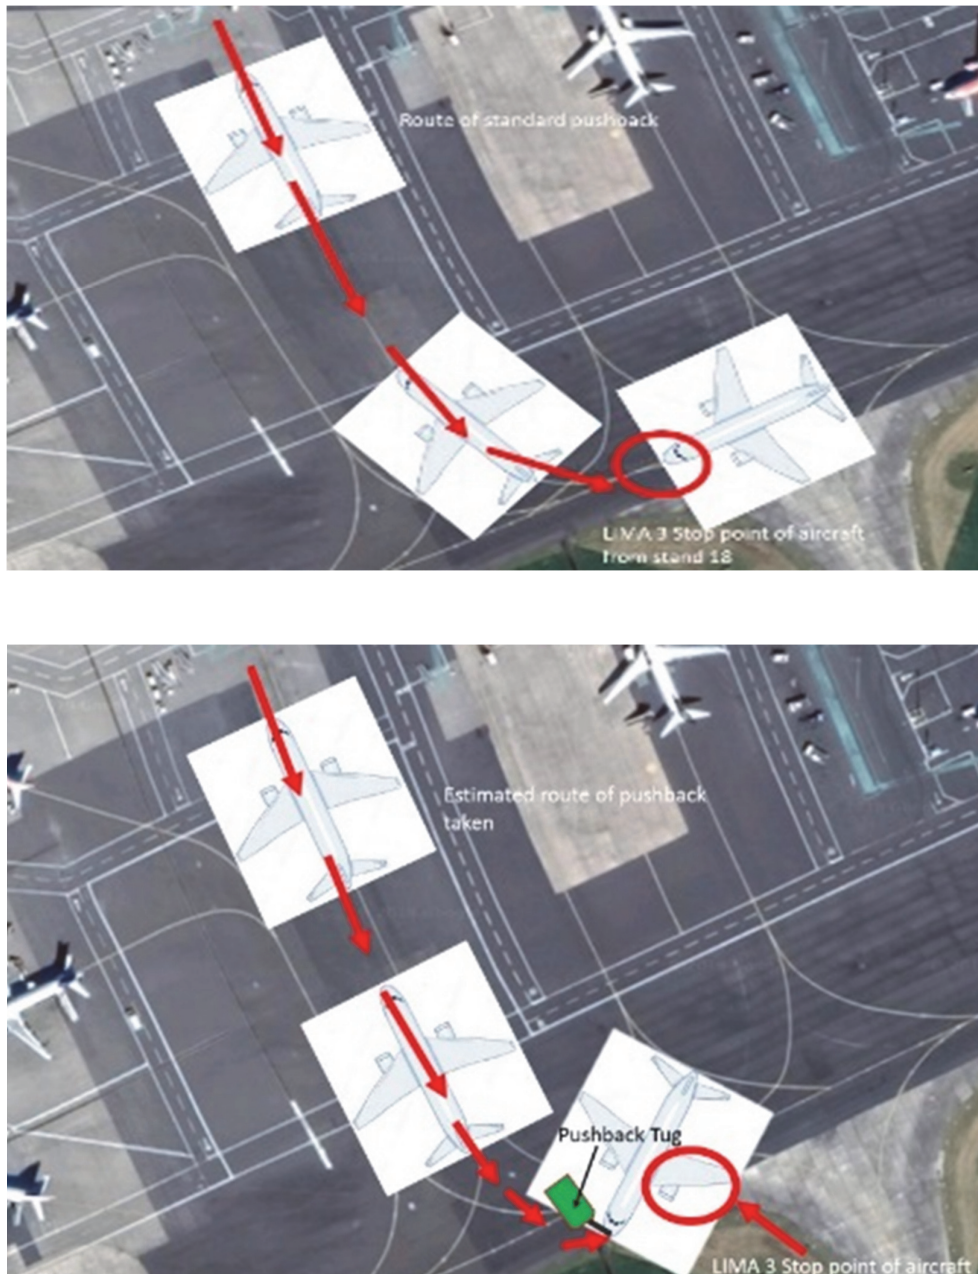
Figure 4

The pushback groundcrew comprised a tug driver and headset man who was in direct contact with the aircraft's flight crew, but there was no radio communication between the tug driver and the headset man. There was also a third person who was observing the pushback for training purposes. The aircraft was close to maximum all up weight and the latter part of the pushback was uphill which, when combined with the engine start and wet surface, increased the workload on the pushback groundcrew. The tug driver had difficulty seeing the taxi line due to the wet reflective surface of the apron and the tug was struggling to move the aircraft due to a high gear having been selected. The turn to L3 was made late and the aircraft's position was closer to the edge of the apron than normal (Figure 4).

Images showing the normal and incident pushbacks

The pushback was a frequently-conducted procedure with two experienced groundcrew members performing it. The late turn towards L3 was caused by the tug driver not being able to see the taxi line clearly due to the wet reflective surface of the apron. The commander, who had been monitoring the engine start as well as the progress of the pushback, was concerned with the closeness to the edge of the apron but was reassured by the headset man responding that the situation was "OK".

1. A Safety Alert was issued to all staff regarding the incident.
2. A training awareness training module was developed covering the use of pushback tugs and gear selection.
3. Refresher training was instigated for headset procedures and action to be taken in the event of a shear pin to bar head separation.
4. A Safety App was developed that all managers and supervisory assessment staff could use on pushback and/or headset evaluation.
5. Bluetooth headsets would be issued to tug drivers to improve communication with the flight deck.
