ACCIDENT

Aircraft Type and Registration:	Guimbal Cabri G2, G-PERH
No & Type of Engines:	1 Lycoming O-360-J2A piston engine
Year of Manufacture:	2016 (Serial no: 1164)
Date & Time (UTC):	8 June 2018 at 1433 hrs
Location:	Goodwood Aerodrome, Sussex
Type of Flight:	Training
Persons on Board:	Crew - 2 Passengers - None
Injuries:	Crew - 2 (Serious) Passengers - N/A
Nature of Damage:	Damaged beyond economic repair
Commander's Licence:	Commercial Pilot's Licence
Commander's Age:	59 years
Commander's Flying Experience:	8,920 ¹ hours (of which 69 were on type) Last 90 days - 30 hours Last 28 days - 7 hours
Information Source:	AAIB Field Investigation

Synopsis

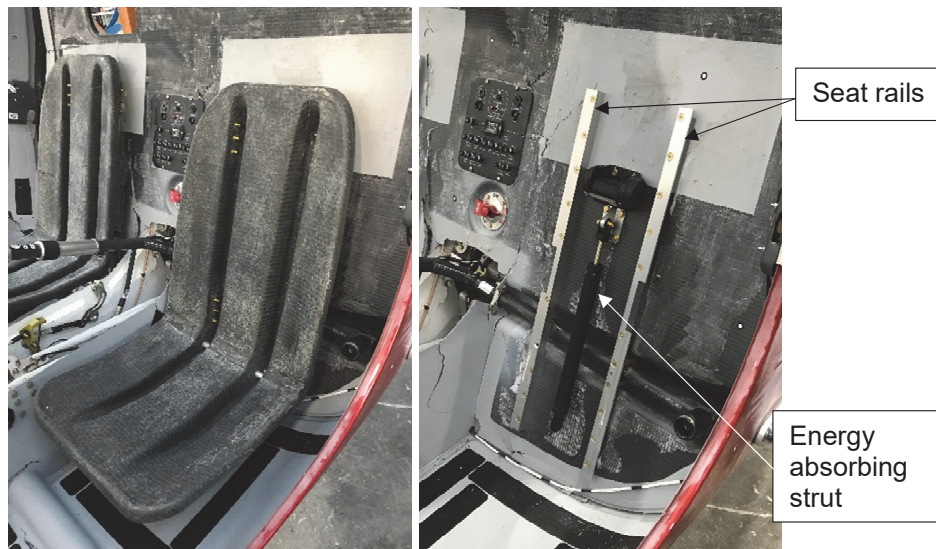
Figure 2

Left seat composite shell and seat rails with energy absorbing strut

The energy absorbing struts in the seat system are designed to reduce the loads on the occupants in the event of a vertical impact. The manufacturer states that in certification testing the '*occupants would survive a 2000 ft/min impact, equivalent to a 5 m free fall*'. In this accident the left seat strut extended to 116% whereas the right seat strut extended to 101%. However, the injuries sustained by both occupants were similar and so it is judged that the impact energy was absorbed by a different mechanism for the right seat occupant.

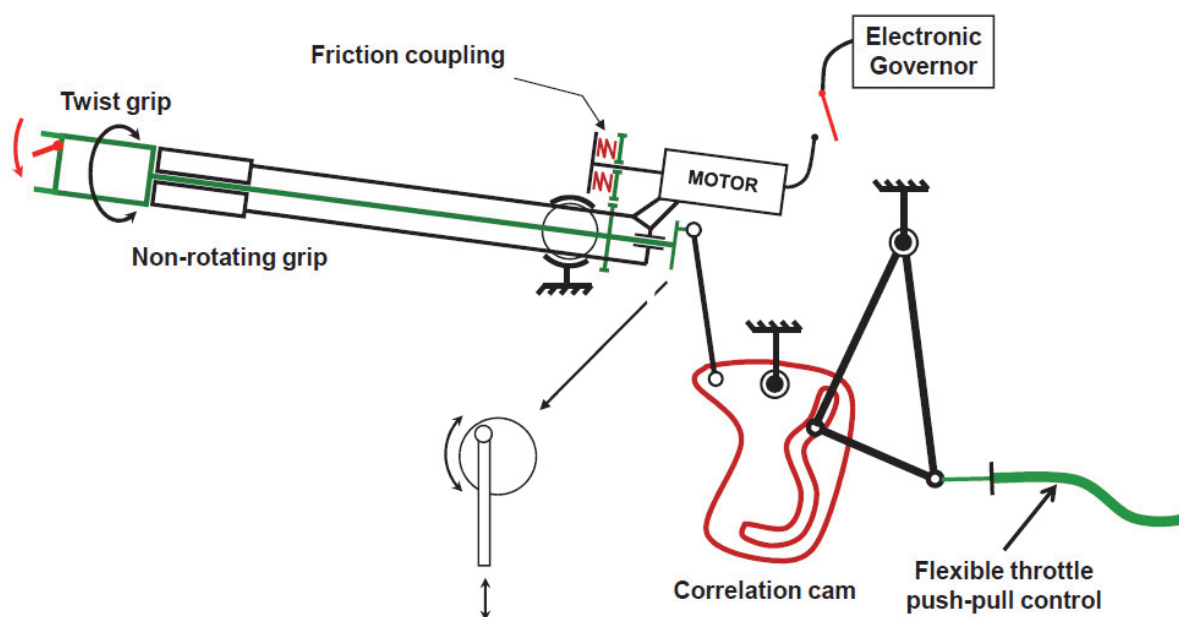
Figure 3
Engine throttle control system

The engine throttle control is on the collective lever and is operated by a conventional twist-grip (Figure 3). The twist grip rotates a shaft which, through a system of cams and levers, operates the engine throttle cable. At the extreme clockwise rotation of the twist grip, a detent gives the pilot a physical indication that the throttle has fully closed. A motor, controlled by the governor, is connected to the twist grip shaft and there is a friction coupling which allows the pilot to overcome the governor if required. A switch on the end of the collective activates or deactivates the engine governor.

in engine speed resulting in the high rate of yaw and climb, which the student felt. Had the throttle been fully closed the correlator cam profile would have had no effect on the engine speed when the collective was raised.

This service letter provides an explanation of the engine governor / correlator system and the need to ensure the twist grip throttle is fully closed whilst practicing certain manoeuvres. It provides advice to flight instructors on how to position the hand on the throttle grip to enable the throttle to be closed in one movement and therefore ensuring the engine throttle does not open when the collective is raised.
