ACCIDENT

Aircraft Type and Registration:	Ikarus C42 FB100 Bravo, G-IRED	
No & Type of Engines:	1 Rotax 912ULS piston engine	
Year of Manufacture:	2012 (Serial no: 1207-7210)	
Date & Time (UTC):	16 July 2019 at 1735 hrs	
Location:	3 miles west of Popham Airfield, Hampshire	
Type of Flight:	Private	
Persons on Board:	Crew - 1	Passengers - None
Injuries:	Crew - None	Passengers - N/A
Nature of Damage:	Nose landing gear bent rearwards and vertical stabiliser damaged	
Commander's Licence:	Private Pilot's Licence	
Commander's Age:	50 years	
Commander's Flying Experience:	74 hours (of which 64 were on type) Last 90 days - 21 hours Last 28 days - 5 hours	
Information Source:	Aircraft Accident Report Form submitted by the pilot

Synopsis

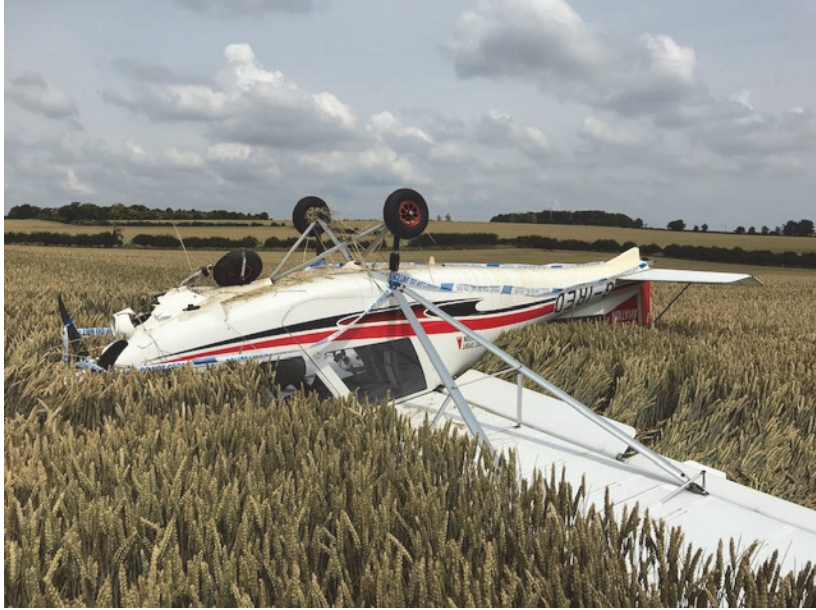
Figure 1
G-IRED accident site

The aircraft was being flown from Clench Common Airfield (near Marlborough) back to its home base at Deanland Airfield after engine maintenance. The pilot carried out a five minute engine run and completed preparations for takeoff during which everything was normal. Approximately 16 minutes after takeoff the pilot observed the engine oil pressure fall to zero on the gauge. The pilot informed ATC of his intention to divert to Popham Airfield. After a further 30 to 45 seconds the engine abruptly stopped, and the pilot carried out a forced landing in a wheat field. During the landing the aircraft nosed over and came to rest inverted as shown in Figure 1. The pilot vacated the upturned aircraft uninjured.

A film of engine oil covered the underside of the fuselage. An initial examination of the engine found there had been a complete loss of engine oil during the short flight. The pilot was later informed that there was an unspecified problem with one of the engine pushrod tube seals, which had resulted in the oil loss.
