ACCIDENT

Aircraft Type and Registration:	Cameron A-400, G-VBAJ	
No & Type of Engines:	4 x Stratus Quad Burner	
Year of Manufacture:	2015 (Serial no: 11869)	
Date & Time (UTC):	12 May 2019 at 0725 hrs	
Location:	Hargham Hall, Attleborough, Norfolk	
Type of Flight:	Commercial Air Transport (Passenger)	
Persons on Board:	Crew - 1	Passengers - 16
Injuries:	Crew - None	Passengers - 1 (Serious)
Nature of Damage:	None	
Commander's Licence:	Commercial Pilot's Licence	
Commander's Age:	59 years	
Commander's Flying Experience:	2,320 hours (of which 410 were on type) Last 90 days - 32 hours Last 28 days - 5 hours	
Information Source:	Aircraft Accident Report Form submitted by the pilot

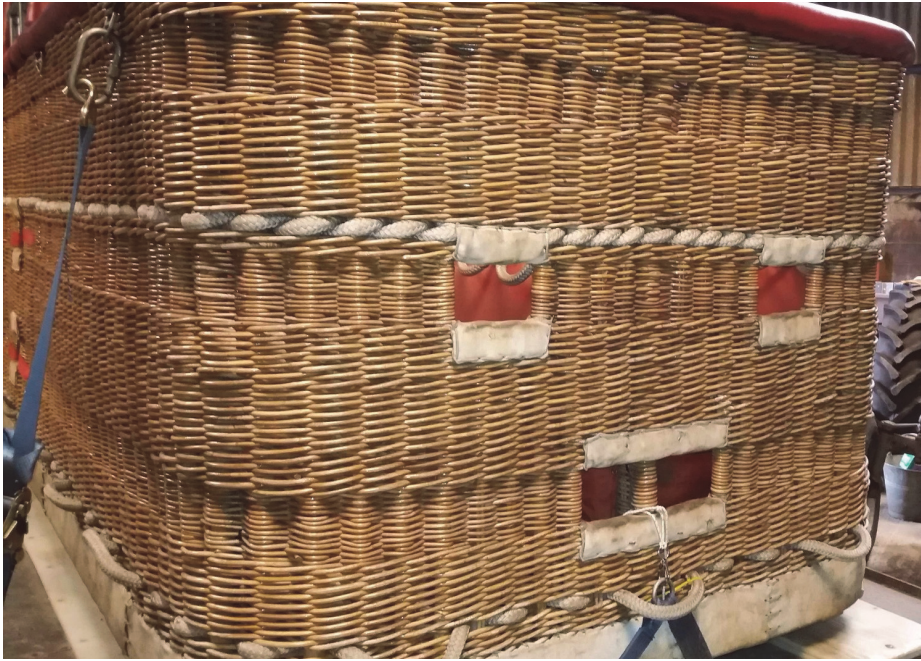
Figure 1

Alighting from the basket in the upright position required passengers to put one leg over the side and climb down steps inset in the side of the basket (Figure 1). One of the passengers placed his left foot in the top step but could not locate the bottom step with his other foot. He attempted to alight by placing his right foot straight down to the floor but fell. He was wearing a large boot and his left foot was stuck in the top step when he fell, resulting in a serious injury.

The basket steps

Prior to this the passenger had felt comfortable to exit the balloon unaided and to assist with the ground tasks. Following the accident, the operator has changed procedure to enable ground crew to assist all passengers with disembarkation.
