ACCIDENT

Aircraft Type and Registration:	Cessna FA152 Aerobat, G-WACH
No & Type of Engines:	1 Lycoming O-235-N2C piston engine
Year of Manufacture:	1986 (Serial no: 425)
Date & Time (UTC):	7 May 2019 at 0950 hrs
Location:	Field near Quainton, Buckinghamshire
Type of Flight:	Training
Persons on Board:	Crew - 2 Passengers - None
Injuries:	Crew - None Passengers - N/A
Nature of Damage:	Nose and wings damaged
Commander's Licence:	Private Pilot's Licence
Commander's Age:	59 years
Commander's Flying Experience:	1,890 hours (of which 480 were on type) Last 90 days - 87 hours Last 28 days - 35 hours
Information Source:	Aircraft Accident Report Form submitted by the pilot, AAIB enquiries and examination of the engine

Synopsis

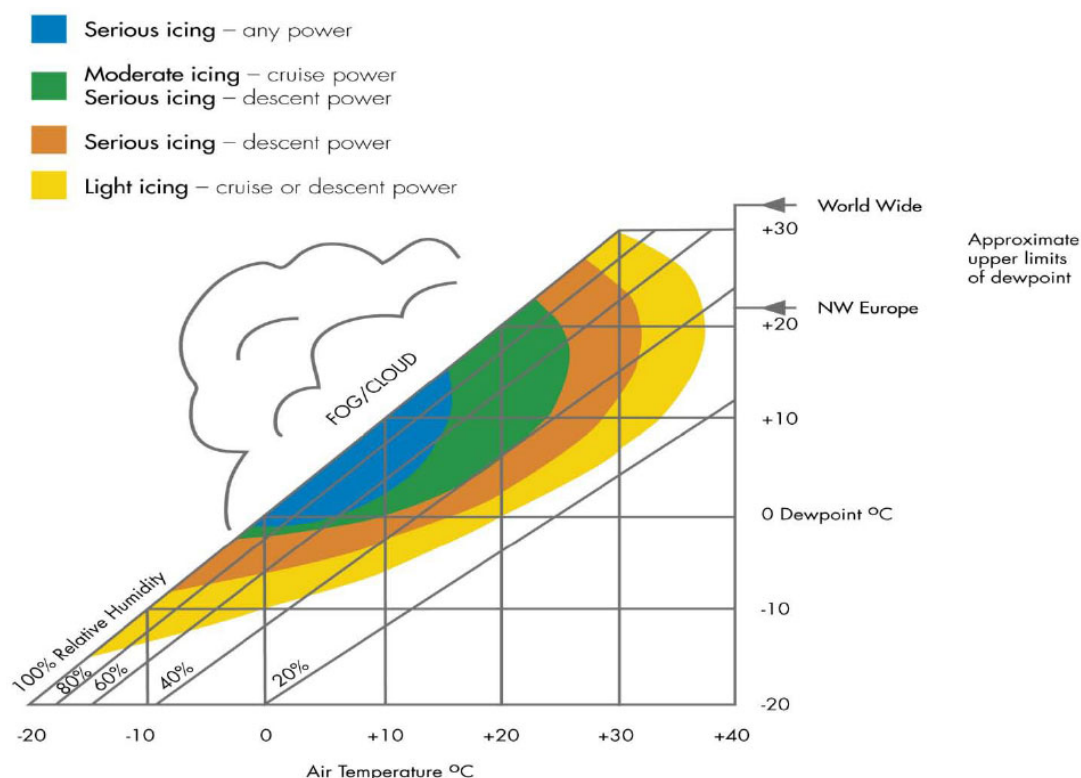
Although not specifically noted by the instructor in his report, weather information provided by Oxford ATC indicated that at the time of the accident the surface temperature was 12°C and the dewpoint was 5°C. Figure 2 illustrates the probability of carburettor icing for values of air temperature and dewpoint. Assuming a reducing temperature and similar dewpoint above the surface, this indicates that the flight was operating in the blue region: 'serious icing at any power'.

Carburettor icing probability chart

The weather conditions prevalent at the time of the accident were conducive to the formation of serious carburettor icing at any power setting. Although the instructor reported the use of carburettor heat both prior to, and following the onset of engine speed fluctuations, the possibility that carburettor icing may have contributed to the loss of engine power could not be excluded.

CAA Safety Sense Leaflet 14, '*Piston Engine Icing*', contains useful information and guidance concerning induction system icing, including the recommend technique for use of carburettor heat in different phases of flight.
