**SERIOUS INCIDENT**

<b>Aircraft Type and Registration:</b>	Boeing 737-4Q8, G-JMCR	
<b>No &amp; Type of Engines:</b>	2 CFM56-3C1 turbofan engines	
<b>Year of Manufacture:</b>	1992 (Serial no: 25372)	
<b>Date &amp; Time (UTC):</b>	12 October 2018 at 0155 hrs	
<b>Location:</b>	En-route to East Midlands Airport	
<b>Type of Flight:</b>	Commercial Air Transport (Cargo)	
<b>Persons on Board:</b>	Crew - 2	Passengers - None
<b>Injuries:</b>	Crew - None	Passengers - N/A
<b>Nature of Damage:</b>	None reported	
<b>Commander's Licence:</b>	Airline Transport Pilot's Licence	
<b>Commander's Age:</b>	50 years	
<b>Commander's Flying Experience:</b>	8,418 hours (of which 6,314 were on type) Last 90 days - 112 hours Last 28 days - 46 hours	
<b>Information Source:</b>	AAIB Field Investigation

**Synopsis**

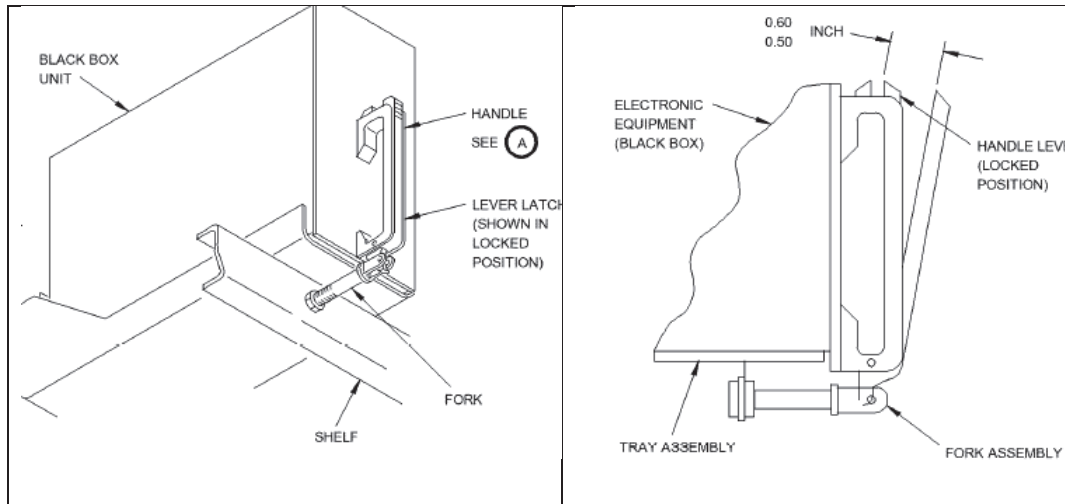
**Figure 3**

The GCUs are mounted in the electrical equipment rack and are fitted by sliding the unit rearwards into the tray with the handle lever in the open position and ensuring that the guide pins at the back of the tray engage in the frame (Figure 3). Once the unit has been pushed in far enough, the hook at the bottom of the handle lever will engage with the fork assembly that is attached to the shelf. The handle lever is then moved into the locking detent securing the box in the tray. The Aircraft Maintenance Manual<sup>3</sup> (AMM) provides further instructions to ensure that the handle and fork assembly have been correctly adjusted.

Racking of Generator Control Unit

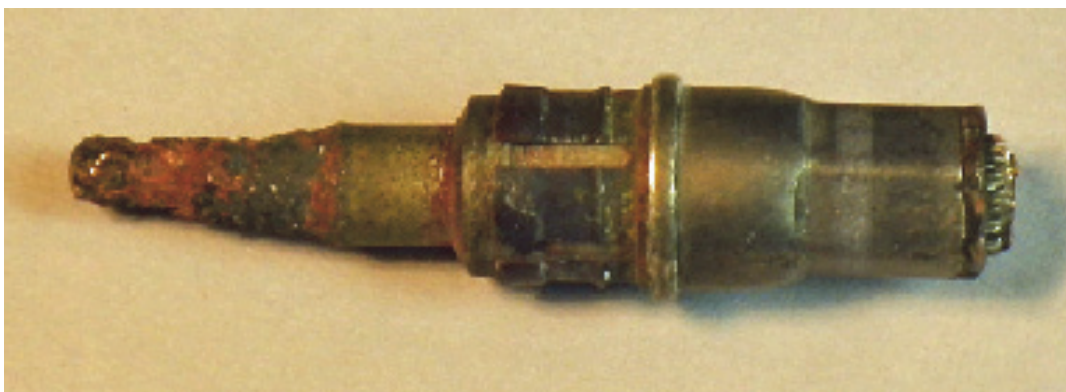
**Figure 4**

The fault in the left engine electrical generation system was traced to an open phase on one of the three power feeder cables that run from Gen 1 to its generator circuit breaker. The cause of the open phase was a burnt pin on connector C at the wing / pylon disconnect (Figure 4 and 5). The operator reported that there was no evidence of arcing between the pin and either the adjacent pins or the body of the connector; both the socket and pin appeared to be formed correctly at the crimp. Due to the extensive damage to the pin, it was not possible to establish the cause of the damage.

Burnt pin from connector C

The aircraft manufacturer advised that previous occurrences of burnt pins had usually been caused by the connector having not been correctly torqued, or because the wire spacer was missing, which created excessive load on the connector pins. When incorrectly torqued, vibration can cause the connector shell to move in relation to the receptacle connector shell. Relative motion between the connector shells would allow similar motion between the pin and socket contacts. This promotes wear and fretting corrosion that degrades the pin to socket contact interface, resulting in increased resistance and a rise in temperature. The aircraft manufacturer issued a Service Letter<sup>6</sup> to operators with suggested actions to ensure the best possible connection of these pins and connectors. This was a known problem.

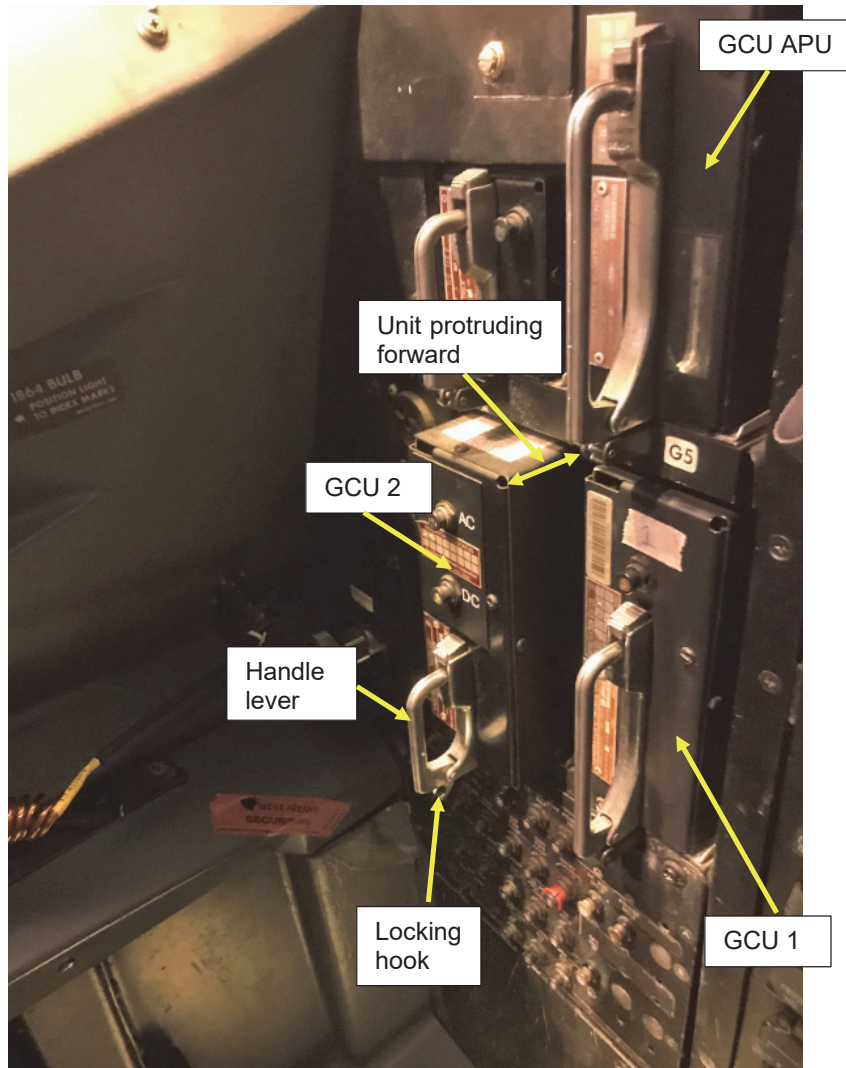
**Figure 6**

After the incident flight, GCU 2 was found to be protruding from the equipment shelf by approximately 3 cm. This would have been sufficient for the contacts at the rear of the electrical unit to disengage with the contacts in the shelf (Figure 6). The handle lever, which was in the locked position, was found to be serviceable and the locking hook and fork intact. There was no visible damage to the electrical shelf, tray or its connectors. The electrical unit was re-racked and the right engine electrical generating system was tested and found to be serviceable.

GCU 2 protruding forward

The electrical failures that occurred during the landing at Amsterdam and on the subsequent flight to East Midlands were caused by GCU 2 moving forward in its rack far enough to cause the electrical connectors to disconnect. The flickering lights and screens indicate that initially there was a partial connection that was intermittent, but on landing at East Midlands the GCU appears to have moved forward sufficiently for the connector to fully disconnect. This would have resulted in the loss of: Gen 2; Gen Bus 2; Transfer Bus 2; 115V AC Electronic Bus 2; 28V DC Bus 2; and 28V DC Electronic Bus 2. Electrical System 1 would still have been powered by the APU generator through Gen Bus 1.
