**ACCIDENT**

| <b>Aircraft Type and Registration:</b> | Team Minimax 91, G-BZOR | |

**Synopsis**

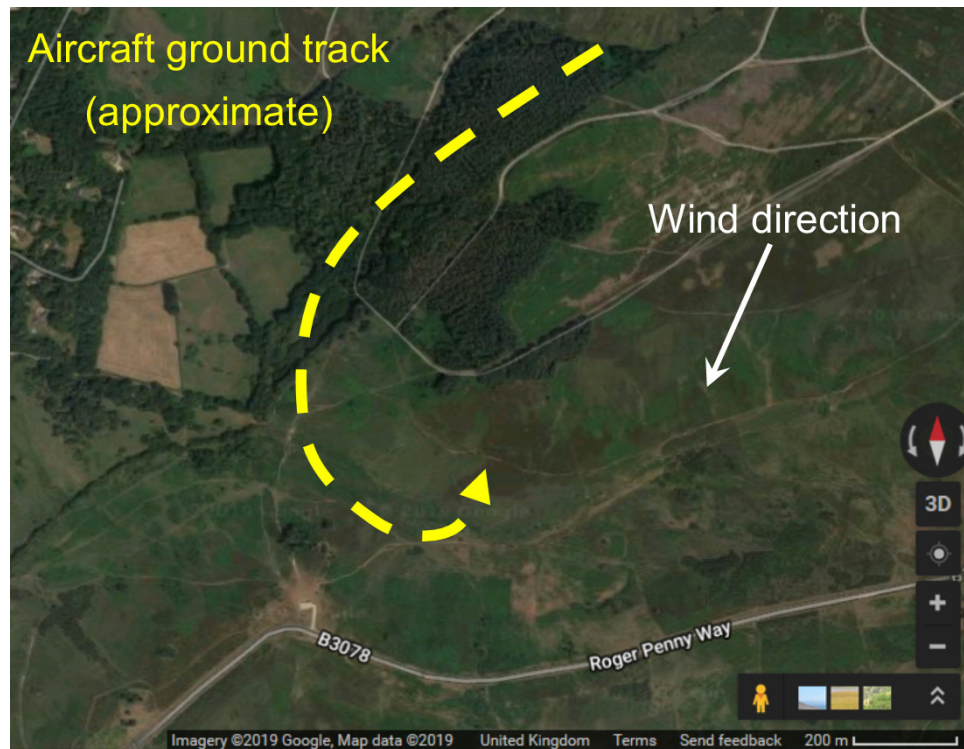
**Figure 1**

Initially over a copse of trees, the pilot selected a suitable landing site south of the woods, on an uphill slope in open heathland (Figure 1). Aware that he would have to execute a tight turn into wind on finals, he increased his airspeed from 55 to 75 mph to give a higher stall margin in the turn.

Approximate ground track of G-BZOR during the forced landing

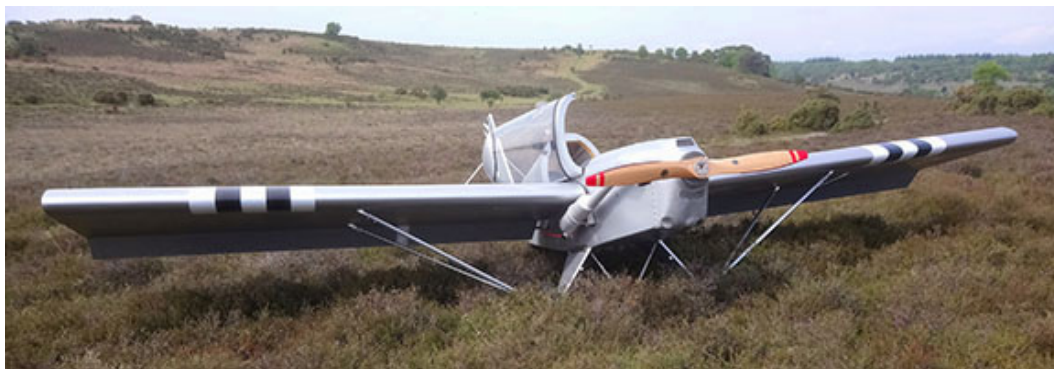
**Figure 2**

Having rolled out into the light north-north-easterly breeze the pilot reduced speed and achieved a gentle touchdown. As G-BZOR came to a halt its front axle fouled in heather and the aircraft tipped forwards, resulting in minor damage to the airframe (Figure 2) and a brake cable.

G-BZOR after the forced landing with minor damage evident on the engine cowling
