**ACCIDENT**

<b>Aircraft Type and Registration:</b>	Ace Aviation As-tec 13, G-CKUL	
<b>No &amp; Type of Engines:</b>	1 Simonini Mini 3 piston engine	
<b>Year of Manufacture:</b>	2017 (Serial no: AA13264)	
<b>Date &amp; Time (UTC):</b>	15 May 2019 at 0935 hrs	
<b>Location:</b>	Shotteswell Airfield, Oxfordshire	
<b>Type of Flight:</b>	Private	
<b>Persons on Board:</b>	Crew - 1	Passengers - None
<b>Injuries:</b>	Crew - None	Passengers - N/A
<b>Nature of Damage:</b>	Propeller detached from aircraft	
<b>Commander's Licence:</b>	National Private Pilot's Licence	
<b>Commander's Age:</b>	63 years	
<b>Commander's Flying Experience:</b>	700 hours (of which 540 were on type) Last 90 days - 6 hours Last 28 days - 5 hours	
<b>Information Source:</b>	Aircraft Accident Report Form submitted by the pilot

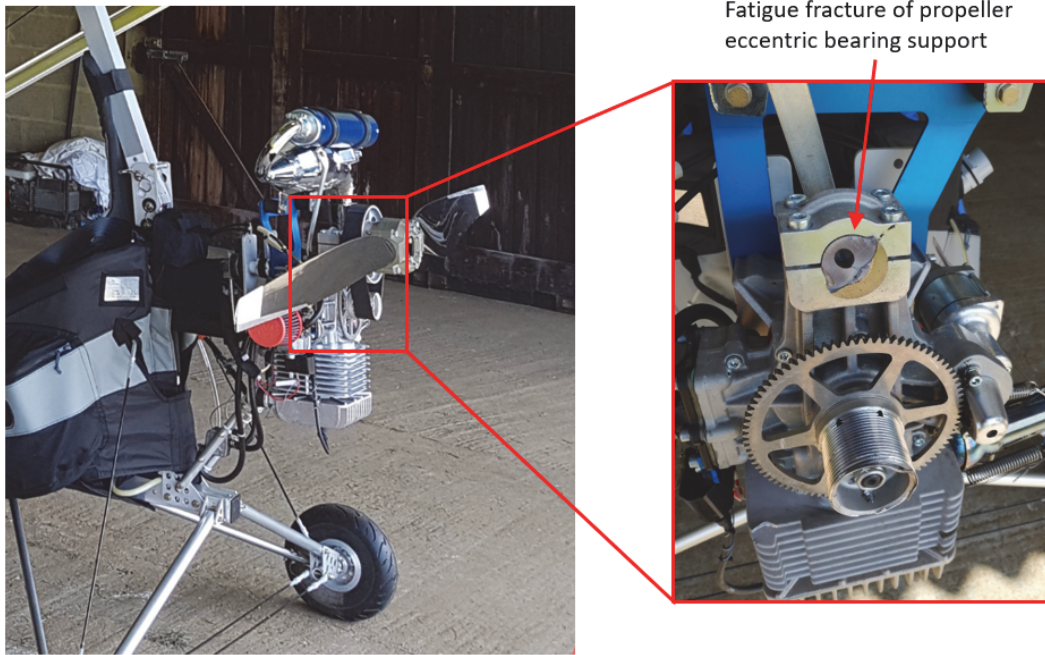
The flex-wing aircraft's single-cylinder engine rotates a pusher propeller using a reduction drive belt, driven by a pulley on the engine crankshaft. Drive belt tension may be adjusted using an eccentrically-mounted bearing on the propeller driveshaft. Inspection of the engine revealed that the eccentric bearing assembly and propeller had detached at the support bracket due to a fatigue failure of the bearing support, Figure 1. The propeller was not located following the event.

**Figure 1**  
Fatigue fracture of eccentric bearing support

Following this event the engine manufacturer issued a safety notice<sup>1</sup> to all owners and operators of the Mini 3 engine, requiring the eccentric bearing support to be replaced before the next flight.
