ACCIDENT

Aircraft Type and Registration:	Replica Fokker DR1, G-DREI	
No & Type of Engines:	1 Superior XP-IO-360-B1AC2 piston engine	
Year of Manufacture:	2017 (Serial no: LAA 238-14848)	
Date & Time (UTC):	19 April 2019 at 1410 hrs	
Location:	Old Buckenham Airfield, Norfolk	
Type of Flight:	Private	
Persons on Board:	Crew - 1	Passengers - None
Injuries:	Crew - 1 (Minor)	Passengers - N/A
Nature of Damage:	Damage to the upper wing, cowling, rudder, engine and propeller	
Commander's Licence:	Private Pilot's Licence	
Commander's Age:	56 years	
Commander's Flying Experience:	390 hours (of which 41 were on type) Last 90 days - 3 hours Last 28 days - 2 hours	
Information Source:	Aircraft Accident Report Form submitted by the pilot and a report submitted by the airfield operator

Synopsis

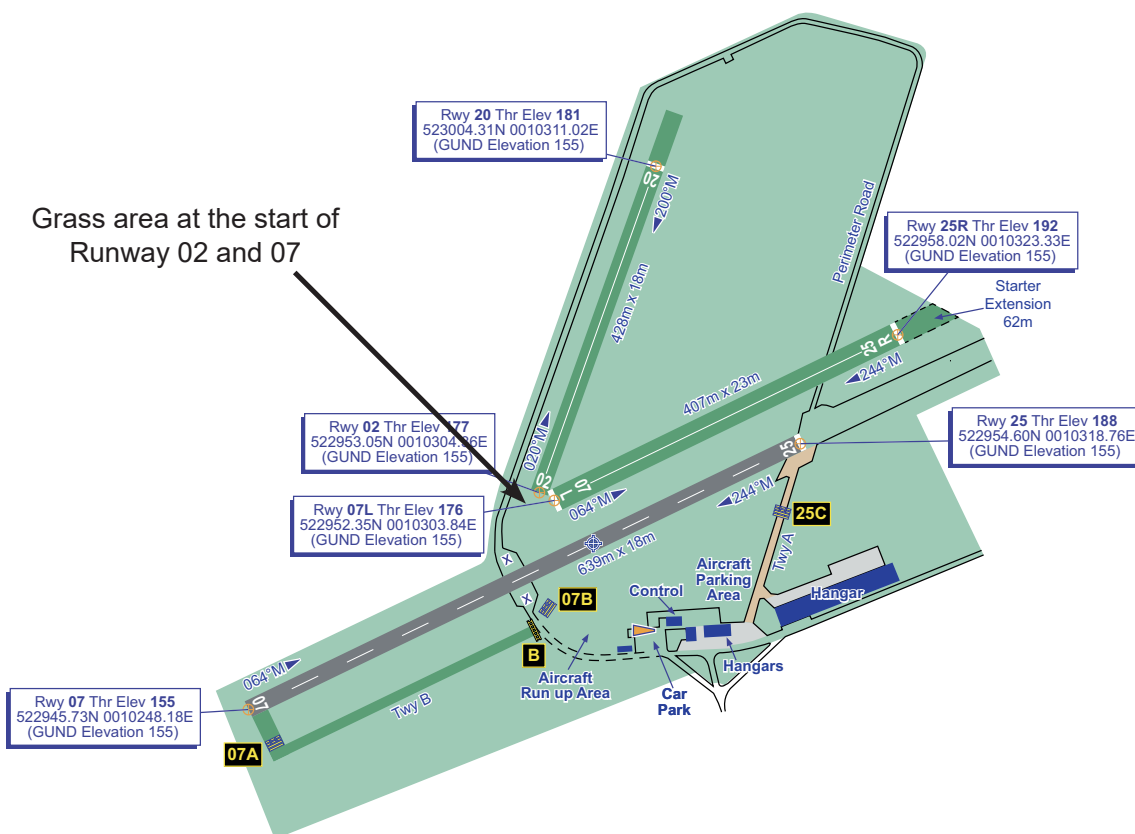
Figure 1

On the day of the accident the pilot flew the replica Fokker tri-plane from Felthorpe Airfield to Old Buckenham Airfield, both near Norwich. It was the first time he had operated to Old Buckenham. Whilst on the ground he spoke to the airfield radio operator to determine the taxi route and departure procedure in preparation for his flight back to Felthorpe. He then returned to the aircraft and taxied to the grass area at the start of Runway 02 and 07 (Figure 1).

The pilot had observed from the windsock that the wind was from the north-east so thought he could takeoff from either Runway 02 or 07. He positioned the aircraft in the centre of what he believed to be Runway 07. After the accident he discovered he had actually been aligned with Runway 02 and had been unable to see Runway 07 to his right as it was obscured by the wing. He reported that the tri-plane had very poor forward visibility when on the ground making it difficult to see directly forward.

Old Buckenham Aerodrome Chart (from UK AIP)

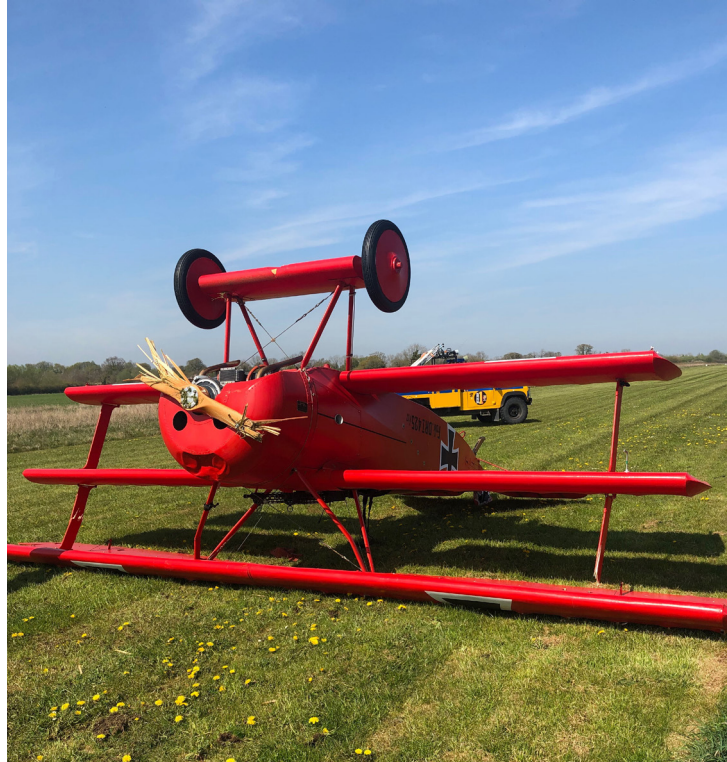
As the pilot started the takeoff roll, he reported that the right wheel collided with a runway edge marker causing the aircraft to rotate forward and invert (Figure 2).

The accident occurred because the aircraft started its takeoff roll on the right side of Runway 02 and collided with an edge marker. The limited forward visibility from the tri-plane meant that the pilot could not see the edge markers.

The air/ground operator had tried to assist the pilot in aligning with Runway 07 but this advice had been misinterpreted by the pilot. He thought he was advised to move to the right side of the runway. This confusion resulted in the pilot aligning with the edge of the runway.

Figure 2
G-DREI inverted on Runway 02
