SERIOUS INCIDENT

Aircraft Type and Registration:	Airbus A330-243, G-TCCF	
No & Type of Engines:	2 Rolls-Royce Trent 772B-60 turbofan engines	
Year of Manufacture:	1998 (Serial no: 248)	
Date & Time (UTC):	6 February 2019 at 1720 hrs	
Location:	In flight over North Atlantic Ocean, west of the Republic of Ireland	
Type of Flight:	Commercial Air Transport (Passenger)	
Persons on Board:	Crew - 11	Passengers - 326
Injuries:	Crew - None	Passengers - None
Nature of Damage:	VHF radio unit damaged	
Commander's Licence:	Airline Transport Pilot's Licence	
Commander's Age:	49 years	
Commander's Flying Experience:	13,135 hours (of which 1,050 were on type) Last 90 days - 98 hours Last 28 days - 45 hours	
Information Source:	Aircraft Accident Report Form submitted by the pilot and operator investigation

Synopsis

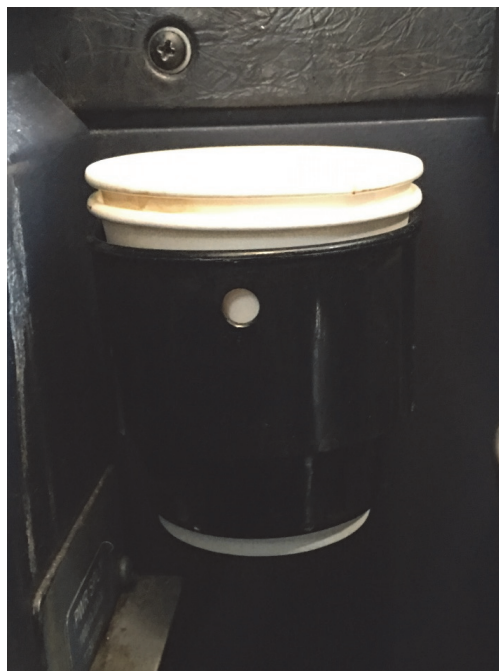
Figure 1

The flight departed from Frankfurt airport in Germany and was scheduled to fly to Cancun in Mexico. Approaching position N5500.0 W02000.0 the flight crew were served coffee in cups without lids (Figure 1). This was normal for this operator and route.

Example of cup used in the aircraft cup holder

The aircraft manufacturer recommends using the cup holder. The size of cups used by this operator on this route made it more difficult to take cups in and out of the cup holder than larger cups that have a bigger area at the top of the cup holder to grasp. This incompatibility generally discouraged use of the cup holder, despite the policy. In the A330, flight crew were provided with a table in front of them, and it was a natural place to put a drink momentarily. However, objects here are vulnerable to being knocked over because it is a fold out table in a small space. It is also a convenient place to put other things that are likely to be moved during flight, such as the pilot's log. A lid properly secured on the top of the cup may have reduced the amount of liquid spilled on the centre console.

The operator changed their procedure to ensure that cup lids are provided for flights on all routes and reminded cabin crew of the requirement to use them. The operator also issued a flight crew notice reminding pilots to be careful with liquids. The operator raised an action to source and supply appropriately sized cups for the aircraft's cup holders.

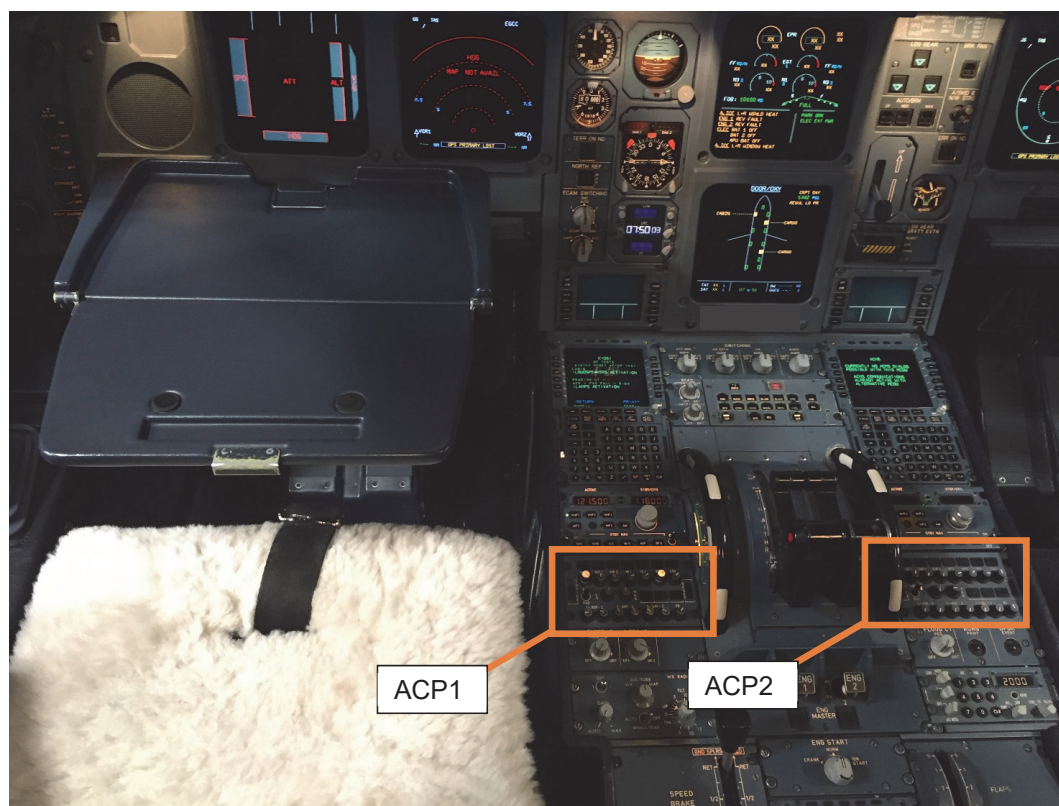
Figure 2

The commander was pilot monitoring. He put the coffee on his tray table while he completed tasks required due to approaching a waypoint. At approximately 1620 hrs, the cup was knocked over. Most of the liquid fell onto the commander's lap and a small amount spilled onto the commander's ACP (ACP1, see Figure 2).

Location of the ACP1 and ACP2 boxes

The coffee on the centre console was dried quickly but resulted in immediate malfunction of ACP1 that affected VHF transmissions and public address announcements from this unit. The crew attempted to isolate ACP1 but it was not possible to do this from the flight deck. Subsequently, at approximately 1700, the ACP1 unit became very hot and failed and there was an electrical burning smell in the cockpit.

ACPs 1 and 2 were removed and stripped by the vendor. The strip report for ACP1 confirmed component failures attributed to liquid contamination. The strip report for ACP2 listed the failed components but did not offer potential causes these failures. The area below the centre console was inspected and no further areas were found that had been affected by liquid contamination.

The strip report indicated that the failure of ACP1 and the smoke and fumes were the result of electrical shorting caused by liquid contamination. The reason for the failure of ACP2 was unclear from the strip report.

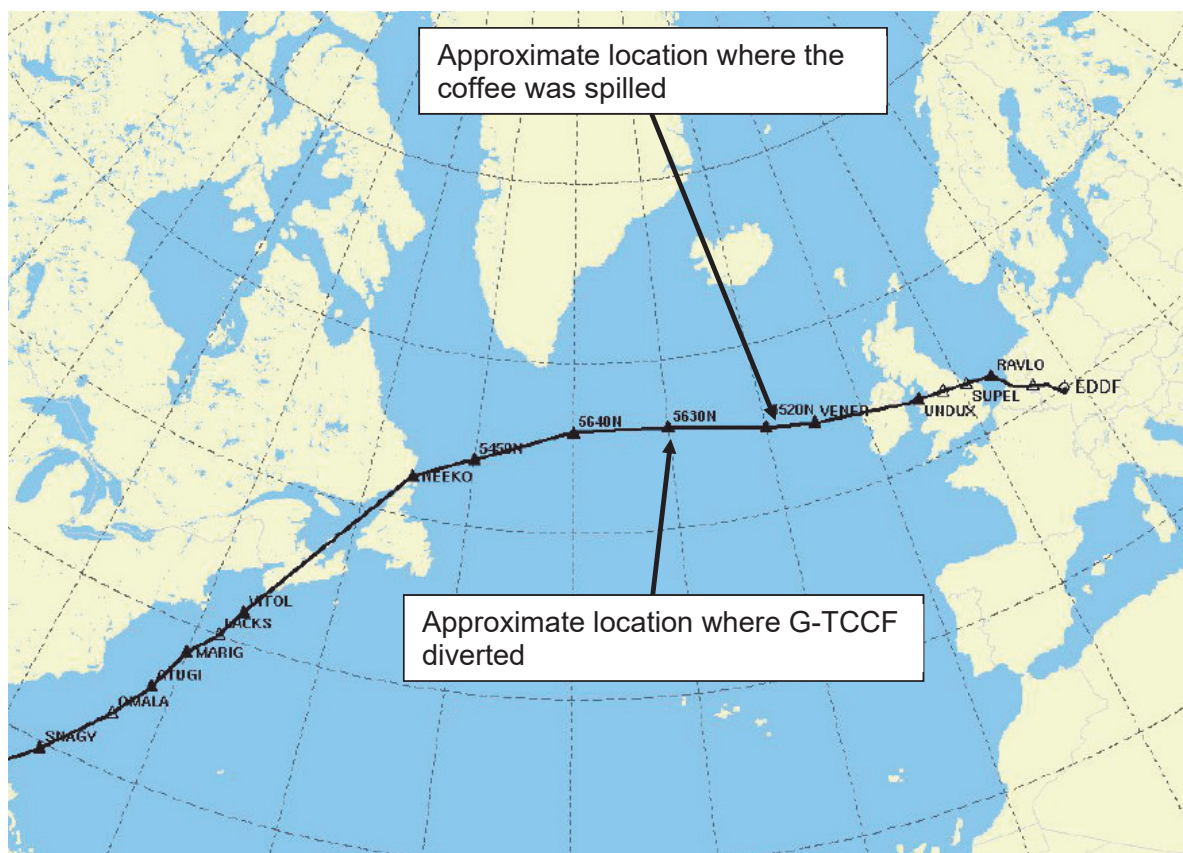
Figure 3

At approximately 1720 hrs, approaching N5600.0 W03000.0, the audio control panel on the co-pilot's side (ACP2) became hot enough to start melting one of its buttons, and failed. A small amount of smoke was observed coming from the ACP1. The commander decided to divert to Shannon, Republic of Ireland. During the diversion, the flight crew alternately used supplementary oxygen, with one pilot on oxygen at all times.

Planned route and approximate location where the commander decided to divert
