ACCIDENT

Aircraft Type and Registration:	Reims Cessna F172N Skyhawk, G-BGSV	
No & Type of Engines:	1 Lycoming O-320-H2AD piston engine	
Year of Manufacture:	1979 (Serial no: 1830)	
Date & Time (UTC):	10 October 2018 at 1825 hrs	
Location:	Wilfholme, East Yorkshire	
Type of Flight:	Private	
Persons on Board:	Crew - 1	Passengers - 1
Injuries:	Crew - 1 (Fatal)	Passengers - 1 (Fatal)
Nature of Damage:	Aircraft destroyed	
Commander's Licence:	Private Pilot's Licence	
Commander's Age:	76 years	
Commander's Flying Experience:	586 hours (of which 546 were on type) Last 90 days - 8 hours Last 28 days - 3 hours	
Information Source:	AAIB Field Investigation

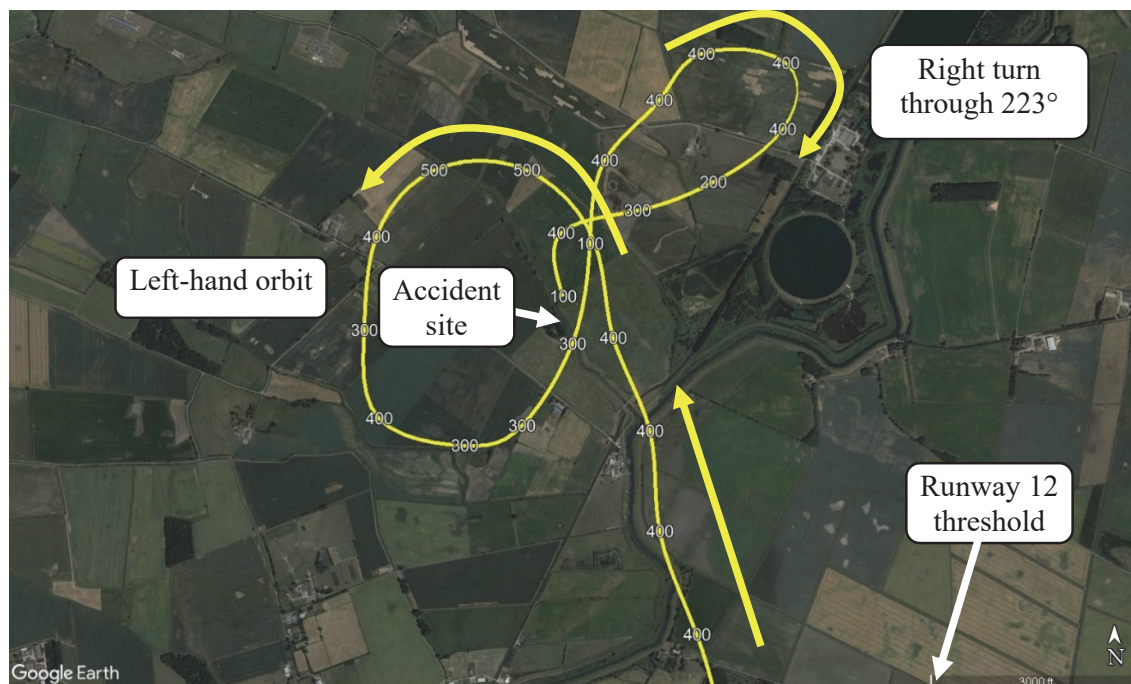
G-BGSV radar track from 1822:37 hrs showing altitudes amsl (± 50 ft)
(Note that the earlier position information has been removed for clarity and track has been smoothed).

The final recorded position was at 1825:14 hrs with the aircraft at 100 ft, having descended from 400 ft over the 8 second radar sweep. Considering the radar altitude accuracy, this represented a vertical speed of $-2,250 \pm 750$ ft/min. The final recorded radar position was approximately 90 m from the accident site and 1.2 nm north-west of the Runway 12 threshold. The aircraft had been circling in the region of Beverley Airfield for 11 minutes 14 seconds.

The evidence from the eyewitness, and the aircraft wreckage, suggest that there was a sudden loss of control and then an impact in a nose-down, left-wing-low attitude. The radar data indicated that during the last forty seconds of flight, prior to the final left turn, the aircraft was flying at an average speed which should have given a comfortable margin above the stall, even in a turn with flaps retracted. It is likely therefore that the pilot became disorientated when in a descending turn near the final approach and allowed the nose to pitch down too steeply.

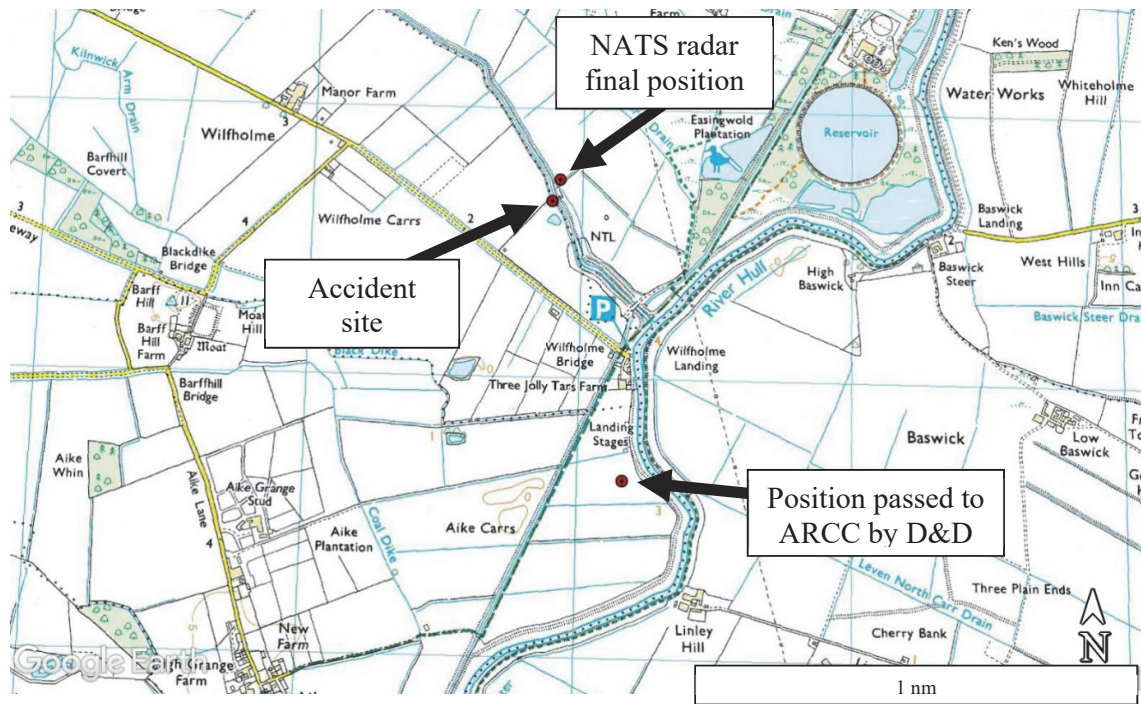
Final radar positions and G-BGSV accident site location

For G-BGSV, the last known position acquired by D&D was from the Claxby radar head which was 'coasted' a further 1 km to the south of the accident site. D&D confirmed that they corroborated this position with Humberside Airport who were using the same data.

Analysis of radar data after the accident showed the final radar position as 90 m from the accident site. The position passed to the ARCC by D&D was 1 km to the south of this site; a position which was confirmed by D&D with Humberside Airport. The difference in position was due to information being sourced from different sources within NATS and that the D&D

information was affected by coasting. D&D were unaware of this at the time but have since discussed this with NATS. Search conditions were challenging, and the accident site was not seen from the air due to the tree coverage at night. As a result, uncoasted position information was unlikely to have reduced the search time for the aerial assets. D&D have commenced a review to consider the use and the feasibility of uncoasted data and whether it is available at short notice.
