**SERIOUS INCIDENT**

| <b>Aircraft Type and Registration:</b> | Sikorsky S-92A, G-CKXL | |
| <b>Location:</b> | On Approach to the Brae Bravo platform, northern North Sea | |

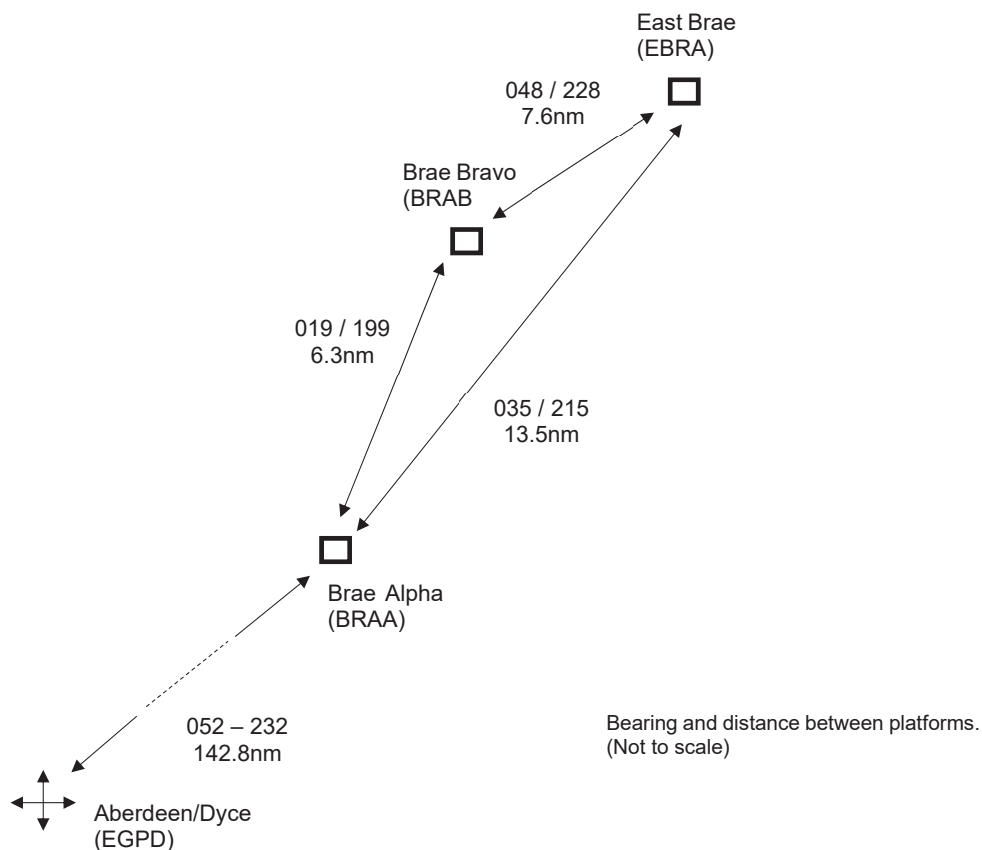
**Figure 1**  
Brae Field

The Brae field consists of 3 platforms - Brae Alpha (BRAA), Brae Bravo (BRAB), and East Brae (EBRA) – roughly aligned in a north-east/south-west direction.

1. **Platform alignment.** Although the FMS routing was correct and the display of the FMS needle pointing in the correct direction was checked by the pilots, the alignment of the BRAB and the BRAA platforms, coincident with the routing, undermined the assurance of this check; the BRAB, being the nearest platform, was the most salient target. This alignment may also have contributed to the BRAA being obscured behind the BRAB. This deprived the pilots of adequate situational awareness following departure from the EBRA at the point which the PIC visually acquired the BRAB and selected it incorrectly as the destination, as well as the ability of the pilots subsequently to identify this error.

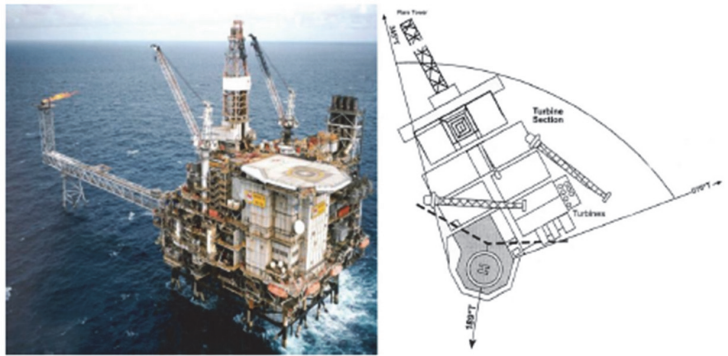
**Figure 2**  
Brae Bravo Platform (HCA)

3. **Helicopter Directory.** The limitations of the HD hinder the use of the plates by pilots to identify key features for the purpose of visual identification of the platform. The helidecks are reviewed on a 2-year inspection cycle and the photographs used are not routinely updated and may therefore present a visual image that is many years old. Visual aspects, such as platform colour, and the location and visual aspect of the name signs may have changed in the intervening period from when the photograph was taken. The direction from which the photographs were taken is not consistent throughout the HD. There is no reference to the skidded nature of the derricks in the plates. Together, these undermine the ability of the crew to use the plates as a means for establishing visual identification cues.

The differences between the platforms are not obvious from the plates and require closer scrutiny to identify key identification features. While the pilots did discuss the flare stacks, the plates were not drawn upon primarily for means of identification; the PIC considered the pictures are only of benefit if approaching from the same direction as that of the photograph of the plate. He noted some plates do not even provide photographs and many platforms look very similar.
