## ACCIDENT

<b>Aircraft Type and Registration:</b>	DJI Phantom 3 Pro (UAS)	
<b>No &amp; Type of Engines:</b>	4 Electric motors	
<b>Year of Manufacture:</b>	Unknown	
<b>Date &amp; Time (UTC):</b>	22 May 2018 at 0830 hrs	
<b>Location:</b>	Railworld, Oundle Road, Peterborough	
<b>Type of Flight:</b>	Commercial activity	
<b>Persons on Board:</b>	Crew - None	Passengers - None
<b>Injuries:</b>	Crew - N/A	Passengers - N/A
<b>Nature of Damage:</b>	Motor mounting damaged and aircraft destroyed	
<b>Commander's Licence:</b>	Other	
<b>Commander's Age:</b>	50 years	
<b>Commander's Flying Experience:</b>	10 hours (of which n/k were on type) Last 90 days - n/k hours Last 28 days - n/k hours	
<b>Information Source:</b>	Aircraft Accident Report Form submitted by the pilot

## Synopsis

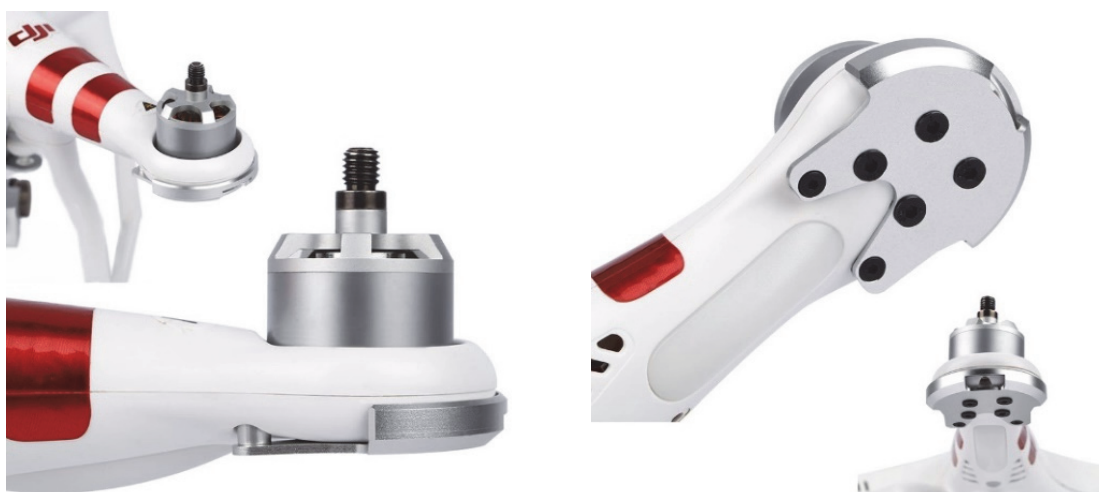
**Figure 3**

A poll<sup>1</sup> of over 1,000 users, taken in 2015 on the manufacturer's official forum, showed that 30% of respondents had an issue with structural cracking of their UA through normal flying and had not been the subject of an impact. It appears that these cracks are generally detected before the motor detaches and a variety of repairs and reinforcement methods are available in the on-line forums. One such reinforcement method is to fit aluminium strengthening plates to the exterior of the structure through the motor attachment screws (Figure 3). These are readily available from third party suppliers but are not an endorsed modification by the manufacturer. The manufacturer has a warranty and replacement scheme which covers any manufacturing defects.

Example of motor attachment reinforcement plate
