ACCIDENT

Aircraft Type and Registration:	DHC-8-402 Dash 8 Q400, G-JEDU
No & Type of Engines:	2 Pratt & Whitney Canada PW150A turboprop engines
Year of Manufacture:	2004 (Serial no: 4089)
Date & Time (UTC):	10 November 2017 at 1330 hrs
Location:	Belfast International Airport
Type of Flight:	Commercial Air Transport (Passenger)
Persons on Board:	Crew - 4 Passengers - 53
Injuries:	Crew - None Passengers - 2 (Minor)
Nature of Damage:	Forward underside of the nose, front pressure bulkhead, nose landing gear and landing gear doors damaged
Commander's Licence:	Airline Transport Pilot's Licence
Commander's Age:	47
Commander's Flying Experience:	9,112 hours (of which 8,734 were on type) Last 90 days - 208 hours Last 28 days - 40 hours
Information Source:	AAIB Field Investigation

Synopsis

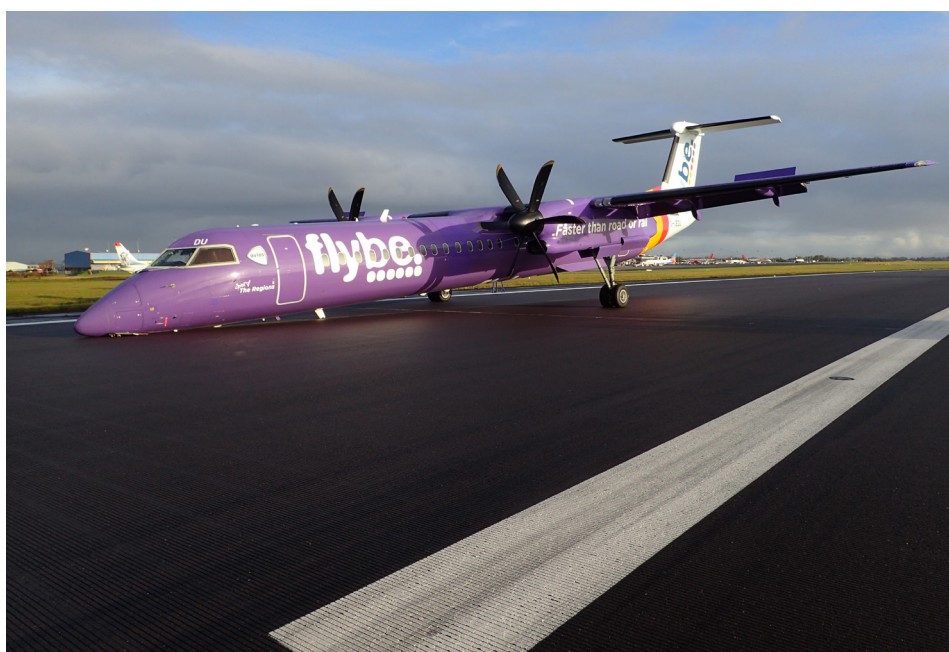
Figure 1

The aircraft had suffered abrasion damage to skin panels and structure on the lower surface of the forward fuselage and the VHF antenna. The NLG forward doors had also separated from the fuselage.

G-JEDU on Runway 25 at Belfast International Airport

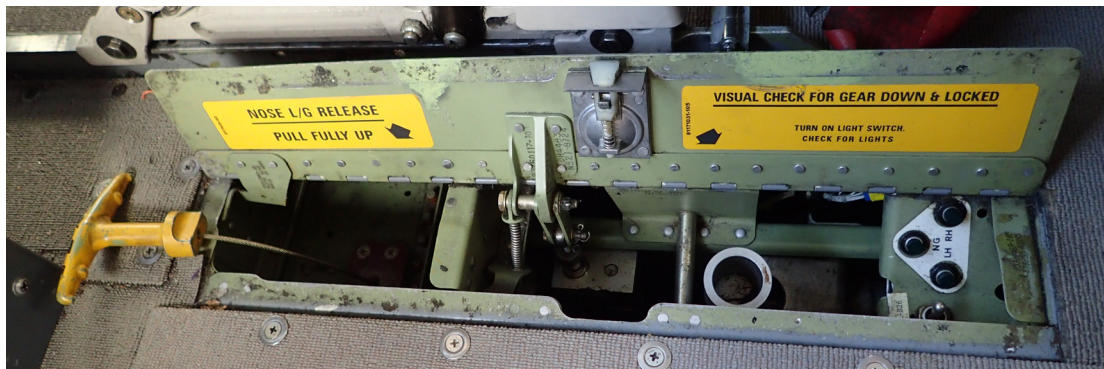
Figure 2

Examination of the cockpit showed that the landing gear selector lever was in the DOWN position, the overhead MLG release door was opened and the handle was stowed. The guard on the L/G DOWN SELECT INHIBIT switch was lifted and the toggle switch was in the INHIBIT position. The landing gear alternate extension door on the cockpit floor was open. It was evident that the nose landing gear alternate release handle had been pulled. The cable had not retracted into its spool and approximately 12 cm of cable was exposed lying on the cockpit floor (Figure 2). The lock release button was in the UP position.

Position of nose landing gear alternate release handle following the accident

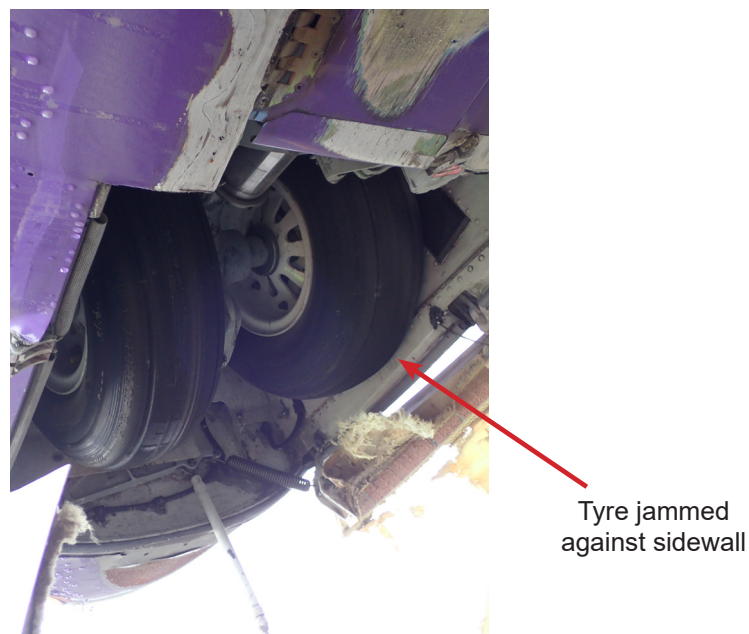
Figure 3

The aircraft nose was raised using airbags until a jack could be positioned on the forward jacking point. The NLG remained in the retracted position when the aircraft was lifted. It was evident that the NLG was not correctly centred, instead the wheels were turned to the right. The upper outside surface of the right tyre appeared to be jammed against the wall of the NLG bay (Figure 3).

View looking up and forward, showing nose landing gear retracted and off-centre

Following the accident, the nose landing gear was found to be retracted but not unlocked. It was off-centre, having rotated about the shock strut axis and the right tyre was jammed against the sidewall of the NLG bay, preventing the gear from extending. Ground marks and damage to the aircraft indicated that the forward NLG doors had been open at landing.

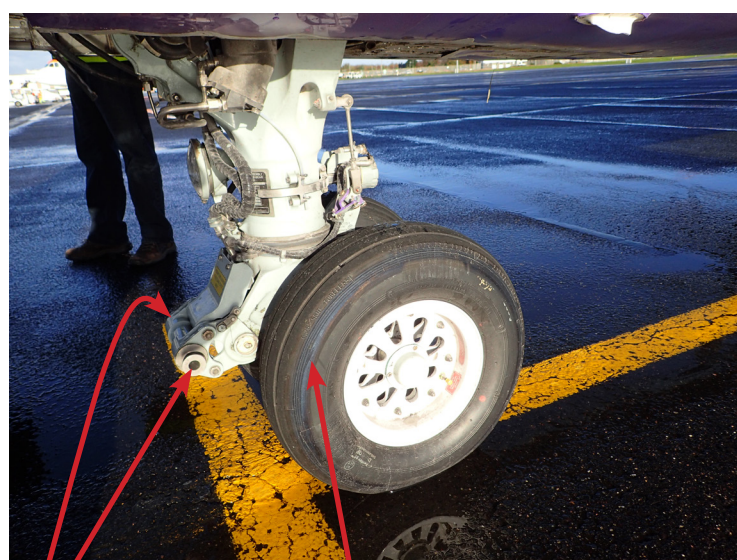
Examination of the NLG identified evidence of blue paint on the outboard shoulders of both tyres, indicating that each tyre had come into contact with the outer painted surface of the respective forward NLG doors (Figure 4).

Blue paint on the tyre shoulder of left nose landing gear wheel

Both NLG tyres and forward doors exhibited evidence of having contacted each other. The position and shape of the mechanical damage on the seal-retaining strip indicated that it had likely been caused by contact with the NLG tow spigot. Retraction logic prevents retraction commencing unless the nosewheel is correctly centred, so it was determined that the nose landing gear rotated off-centre after retraction commenced, most probably as a result of contacting the forward NLG doors.

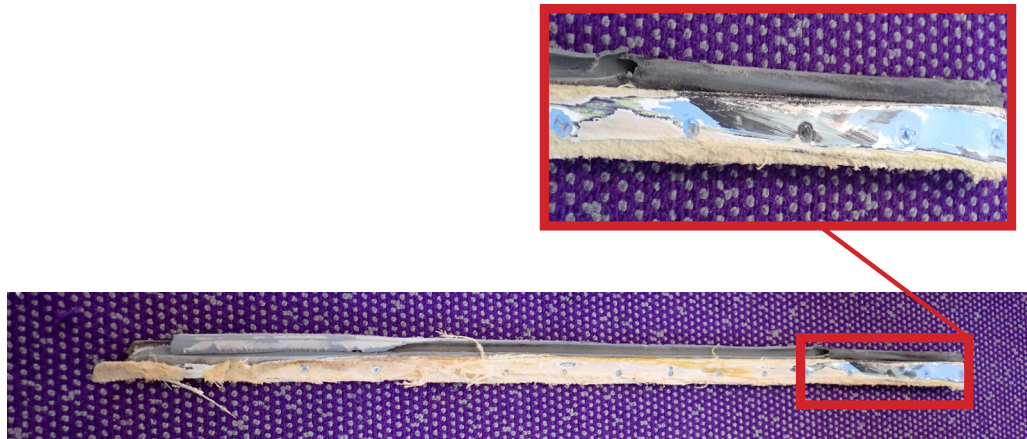
Figure 5(a)

Both forward NLG doors exhibited extensive abrasion damage. The rubber seal and metal retaining strip from the lower edge of the forward right door were recovered from the runway. The seal had worn through as a result of ground contact and the attached remnants of the outer door skin showed evidence of tyre contact (Figure 5a). Additionally, the bottom edge of the seal-retaining strip exhibited mechanical damage in one location where a curled lip of metal had peeled upwards (Figure 5b). The location of this damage was approximately in line with the position of the tow spigot on the NLG.

Outer surface lower edge of forward right NLG door, showing abrasion damage to rubber seal and tyre contact marks

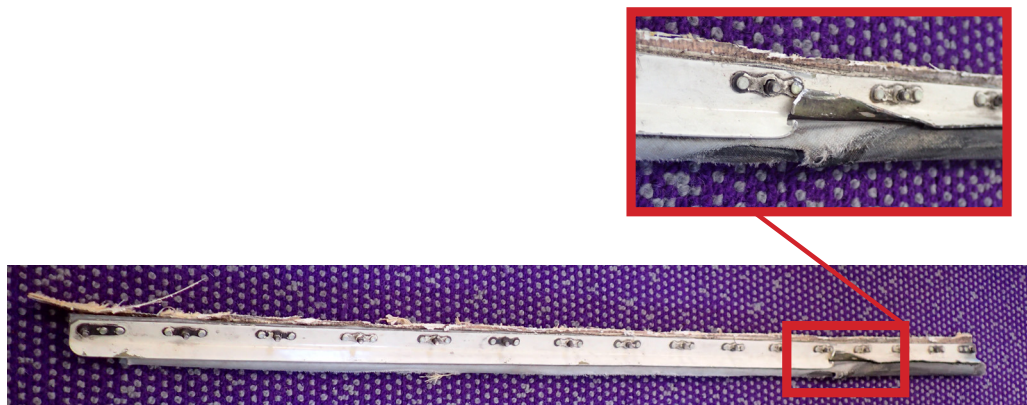
Figure 5(b)

Inner surface lower edge of forward right NLG door, showing mechanical damage to metal seal-retaining strip

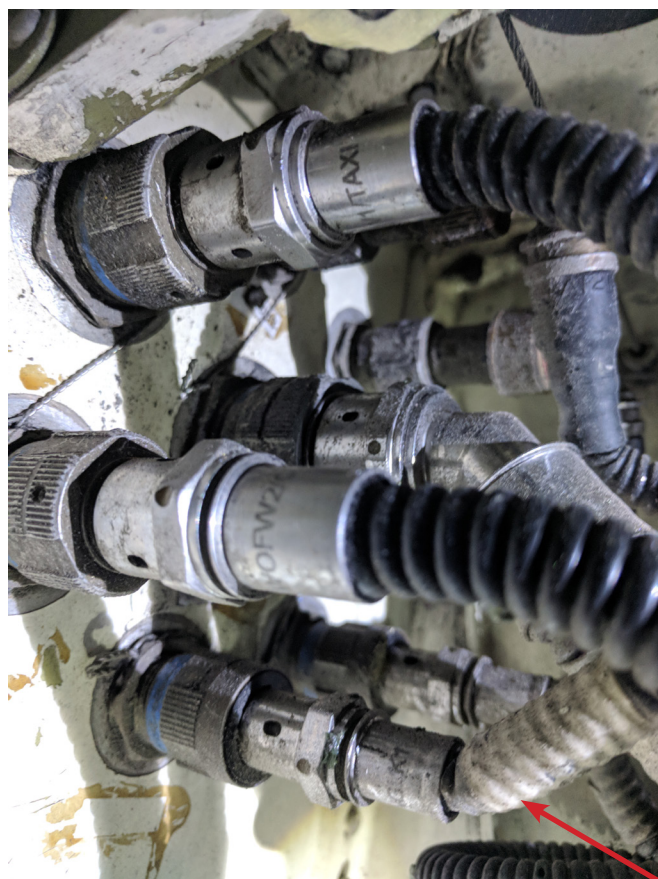
Figure 7

During removal of the NGLK1 harness from the aircraft it was noted that there appeared to be little slack in the harness and there was a tight bend where it entered the airframe connector (Figure 7).

Tight bend radius

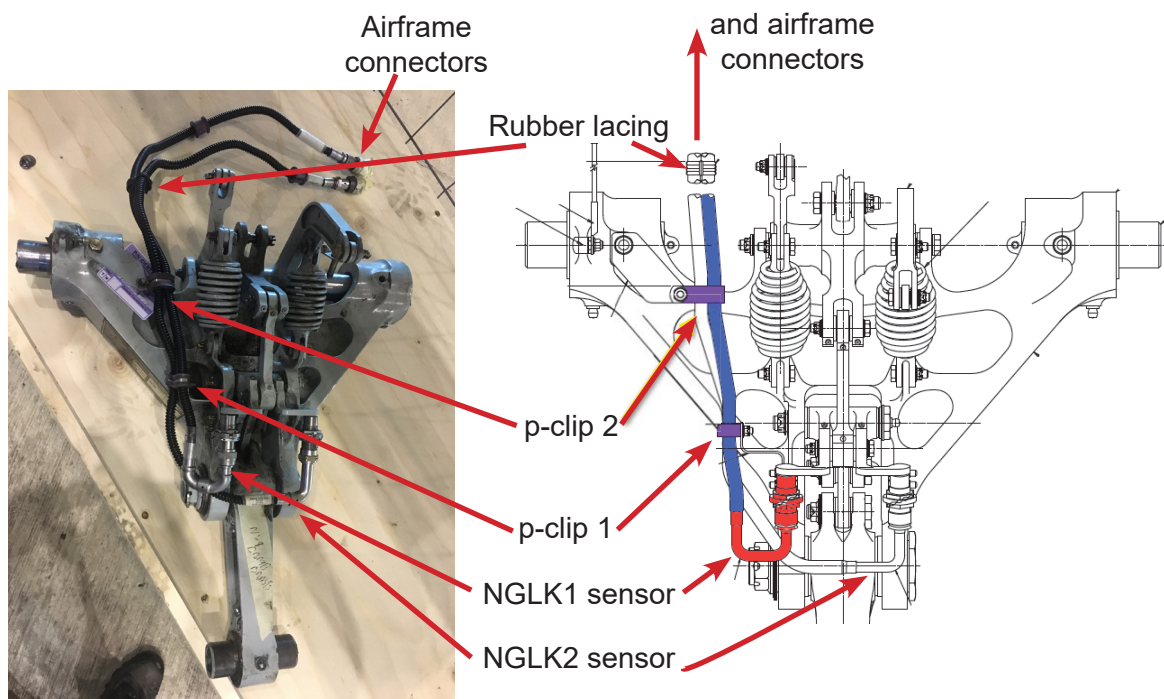
Figure 8

The NGLK sensors are mounted on the aft face of the NLG drag strut and their associated harnesses run vertically up the drag strut, secured by p-clips at two locations (Figure 8). Above p-clip 2, flexible rubber lacing holds both harnesses together. The harnesses then route horizontally aft along the top of the NLG bay, where they are secured to a bracket by a third p-clip, before terminating at their respective airframe connectors on the front pressure bulkhead.

NGLK1 and NGLK2 harness routing on drag strut

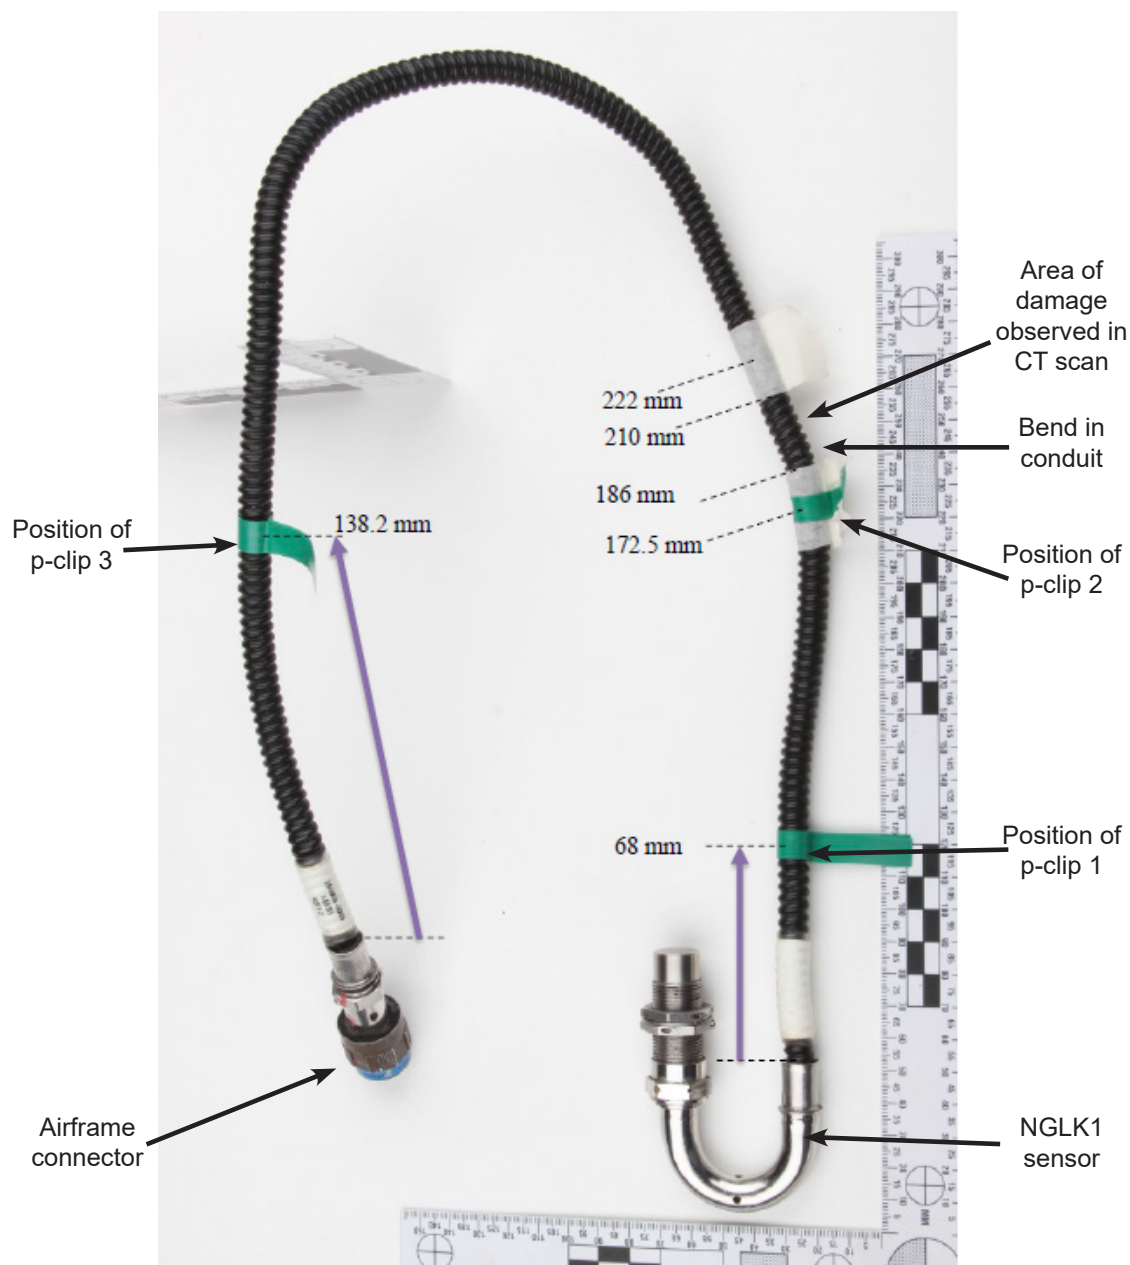
Figure 9

Visual examination of the harness revealed a distinct bend above the p-clip 2 location. The harness did not lie flat but exhibited a permanent deformation. A kink in the black corrugated conduit was evident at the joint with the airframe connector (Figure 9).

NGLK1 harness. Note: p-clip positions marked with green tape, and the area of damage identified on the initial CT scan was marked with white tape

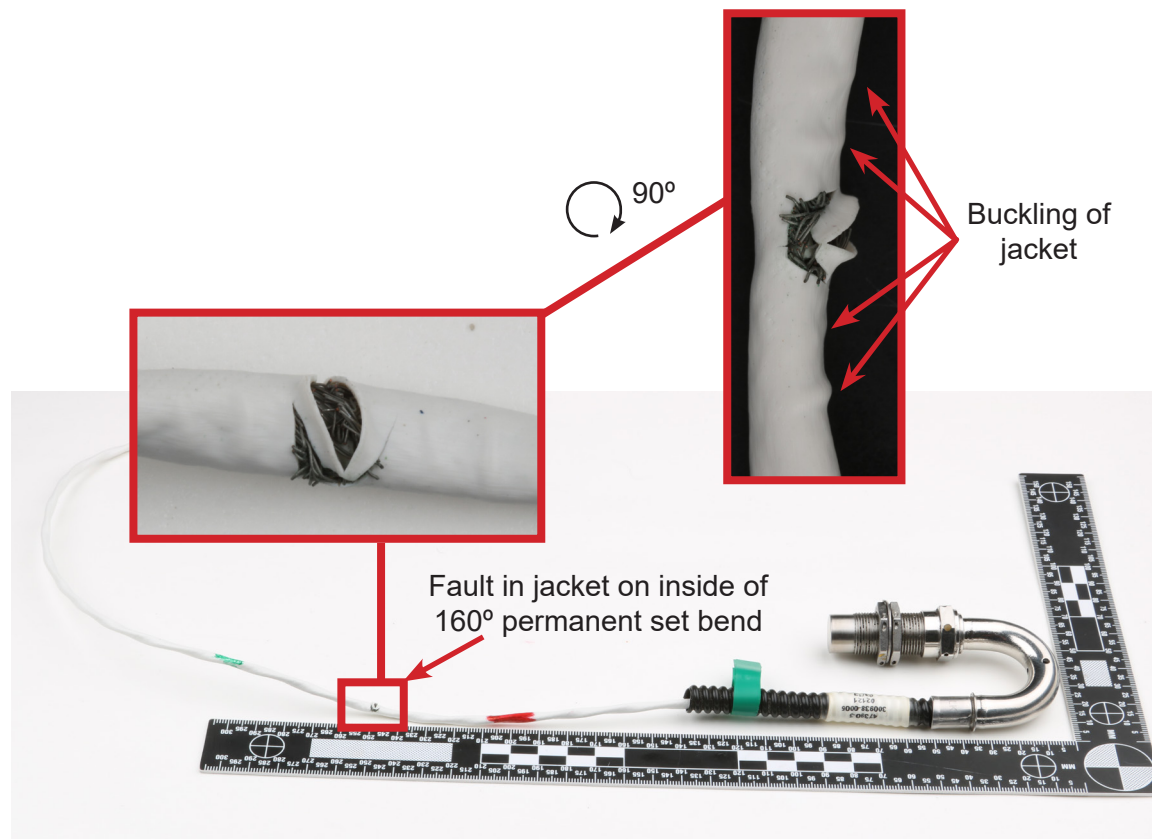
Figure 10

When the corrugated conduit was removed to expose the cable, a split in the white polymer jacket was apparent (Figure 10), coincident with the concave side of the ‘permanent set’⁷ bend highlighted in Figure 9. The jacket also exhibited permanent set suggesting it had been held at a tight angle. There was evidence of buckling on the white jacket, either side of the split which was indicative of compressive loading. Broken strands of woven metal

braiding were visible protruding through the split and the line of fractures was consistent with the point of maximum compression of the bend. Scratch marks were noted on the inner surface of the corrugated conduit, indicating that the exposed strands had made contact in this area and that the cable was moving relative to the conduit.

NGLK1 harness partially disassembled showing split in polymer jacket

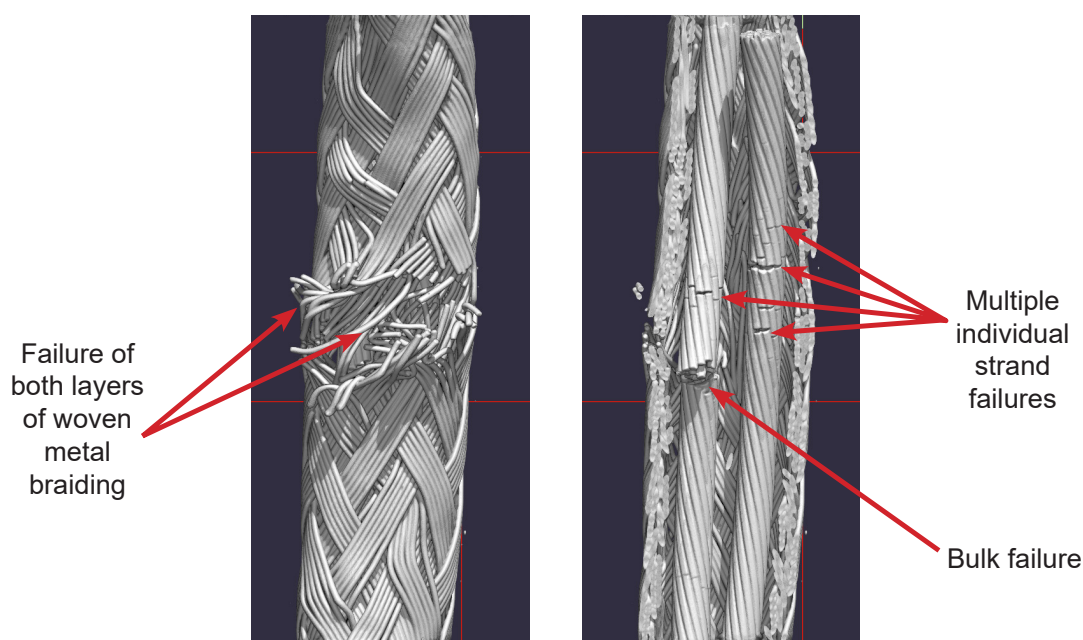
Figure 11

A 100 mm section of cable was cut from the harness for additional examination, CT scanning and disassembly. The CT scan showed that one of the central multi-stranded conductors (white with blue stripe) had completely fractured at one location including through the two layers of insulation (Figure 11). It also exhibited multiple transverse fractures on individual wire strands either side of the bulk fracture, resulting in numerous short strand lengths. It was apparent that an electrical path could still have existed across the bulk fracture, bridged by short lengths of wire strands. The second wire (white) also displayed many transverse fractures on individual wire strands, predominantly on the concave side of the cable but was still contained within its insulation and was capable of making an electrical circuit.

CT images of the concave side of the wire, orientation sensor down.

Left image shows deformation and damage to the metal braiding (with polymer jacket 'virtually' removed).

Right image shows the damage to both conductor (with polymer jacket, both layers of metal braiding and wire insulation 'virtually' removed)

The fracture surfaces of the failed wire strands from both conductors were flat and displayed evidence of fretting damage but were too corroded to find striations. However, the features that were present, including the general flat shape, indications of crack arrest and ratchet marks, were consistent with a cyclically-driven fatigue propagation failure mechanism initiating at sites of fretting damage.

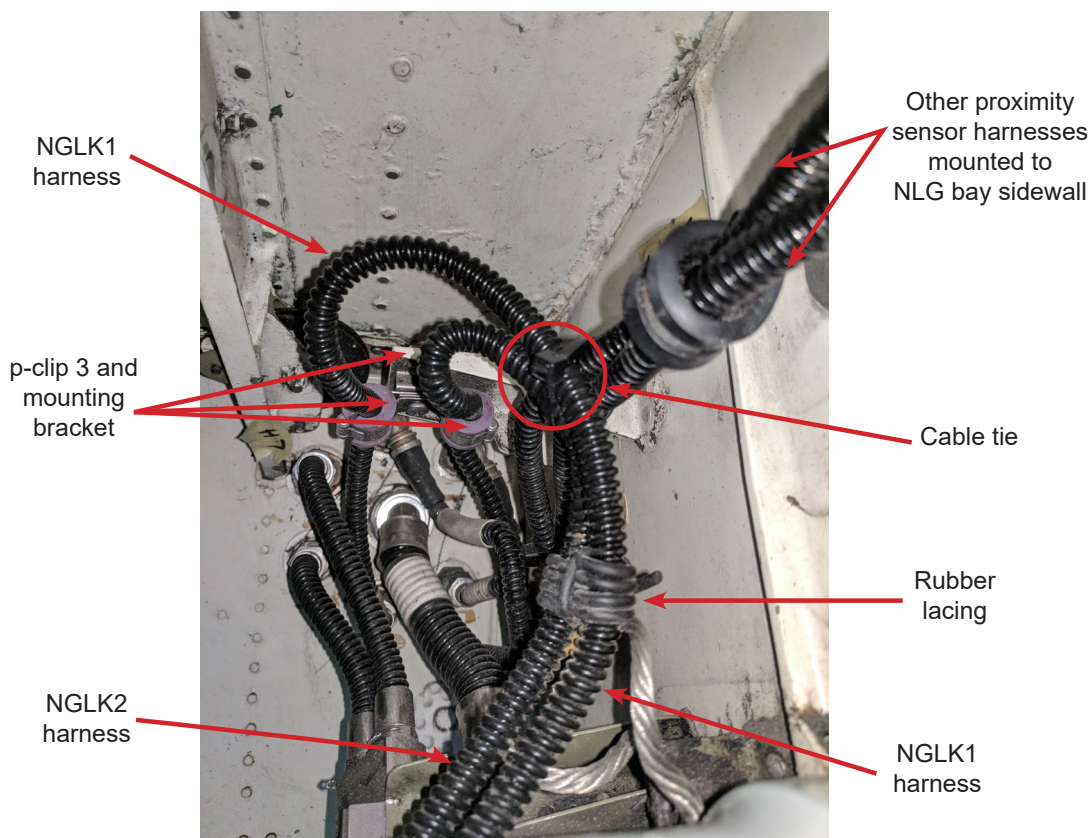
Figure 12

The damage to the harness resulted from a cyclically-driven fatigue failure mechanism, which occurred because the harness had been secured with a non-flexible cable tie which restricted it from flexing during normal nose landing gear operation.

Further to the findings of the forensic examination, a retrospective review of photographs of the NGLK1 and NGLK2 harness routing on G-JEDU identified that both harnesses had been secured to neighbouring harnesses mounted on the sidewall of the NLG bay using a non-flexible cable tie (Figure 12).

NGLK1 and 2 harness routing on G-JEDU, showing cable tie

- In October 2018, issued a Service Letter to inform Dash 8 Q400 operators of the correct routing of the nose landing gear lock (NGLK) sensor harnesses. The Service Letter emphasises that correct routing and retention, using rubber lacing, ensures no interference with surrounding harnesses and structure while maintaining freedom of movement during the retraction and extension. It refers to in-service occurrences where the sensor harnesses have been secured to neighbouring harnesses using cable ties, which have resulted restricted movement and subsequent damage to the harness conduit and the internal sensor wire, which can contribute to poor sensor operation. It includes photographs of correct versus incorrect installation.

- In November 2018, issued Service Bulletin 84-32-157 '*Landing gear – Nose landing gear – Drag strut – Special inspection and rectification – electrical harness re-routing*' to inspect the NGLK sensors for correct routing and signs of wear, abrasion or fretting.
