SERIOUS INCIDENT

Aircraft Type and Registration:	Agusta AW139, G-MCSD	
No & Type of Engines:	2 Pratt & Whitney Canada PT6C-67C turboshaft engines	
Year of Manufacture:	2014 (Serial no: 41375)	
Date & Time (UTC):	6 May 2018 at 1634 hrs (UTC)	
Location:	Offshore from Aberdeen	
Type of Flight:	Commercial Air Transport (Non-Revenue)	
Persons on Board:	Crew - 4	Passengers - None
Injuries:	Crew - None	Passengers - N/A
Nature of Damage:	Tail rotor blades damaged and tail rotor gearbox required replacement	
Commander's Licence:	Airline Transport Pilot's Licence	
Commander's Age:	52 years	
Commander's Flying Experience:	8,000 hours (of which 854 were on type) Last 90 days - 48 hours Last 28 days - 23 hours	
Information Source:	Aircraft Accident Report Form submitted by the pilot and additional information from the helicopter manufacturer

Synopsis

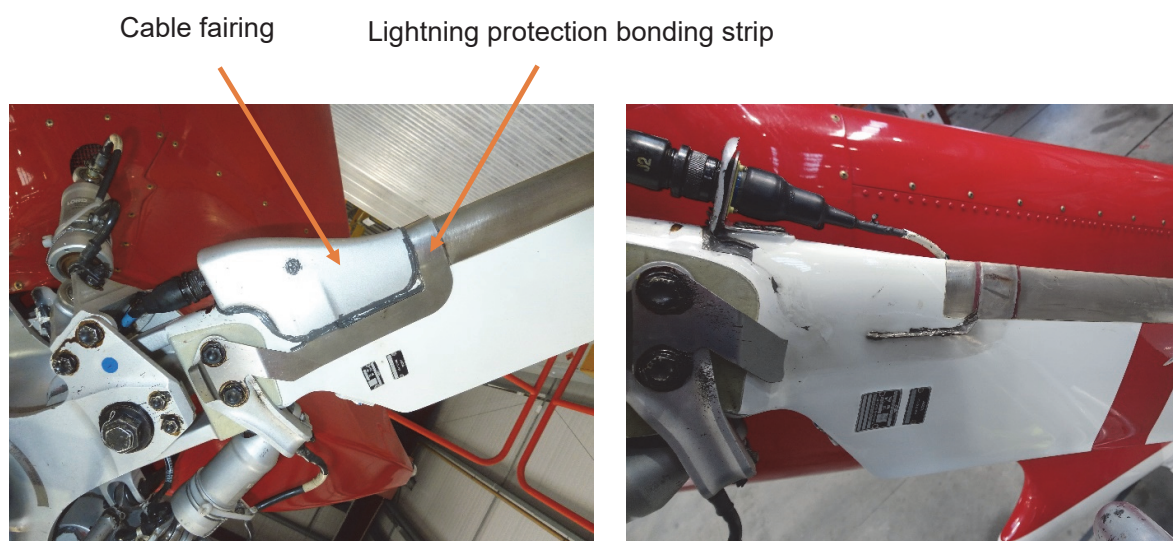
Figure 1

Visual examination of the helicopter found that a bonding strip and cable fairing had detached from one of the tail rotor blades (Figure 1). The missing parts were not recovered.

Examination of the other three tail rotor blades found that two more bonding strips were cracked.

Tail rotor blade fairing and lightning protection bonding strip installation
(left image shows an undamaged blade;
right image shows the damaged blade on G-MCSD)

The manufacturer concluded that the loss of the root fairing was secondary to, and a direct consequence of the loss of the broken bonding strip.

Inspection of the bonding strip will be added to Maintenance Task 64-01, to be performed every 300 flying hours/1 year. The manufacturer is also reviewing the bonding strip manufacturing process.

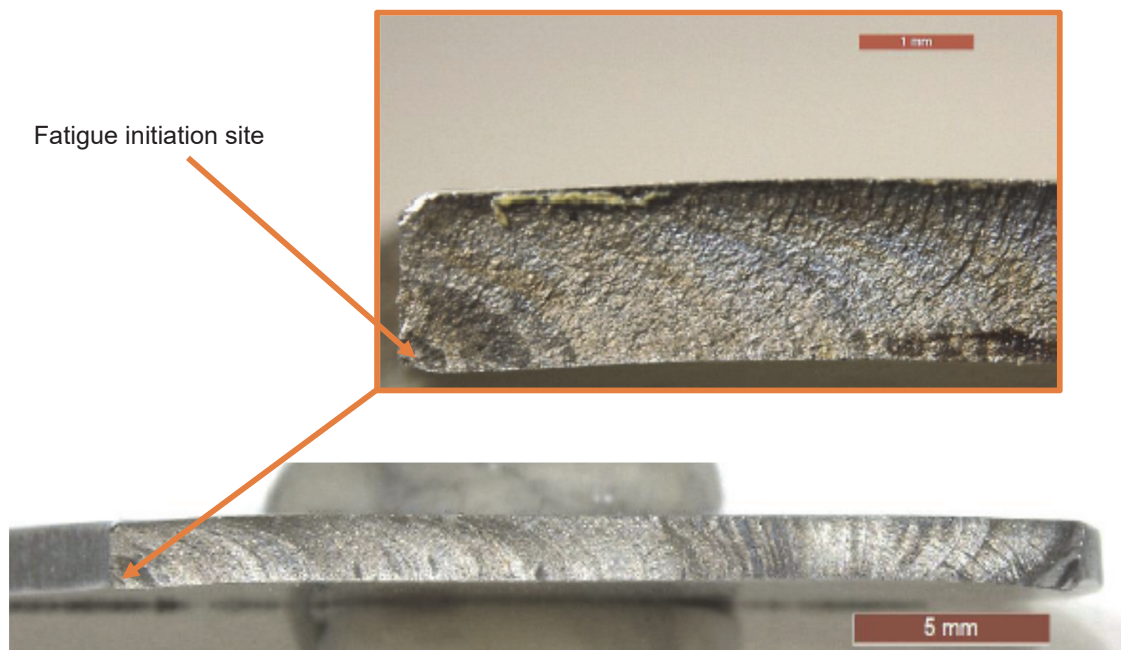
Figure 2

Microscopic examination established that all three bonding strips had cracked because of fatigue. The fatigue originated in the same location on all three items (Figure 2).

Fracture surface (fatigue originated from the lower left corner)

Investigation established that the bonding strips had cracked due to fatigue and loss of the root fairing was secondary to the loss of the bonding strip.
