## ACCIDENT

<b>Aircraft Type and Registration:</b>	Beech 58 Baron, G-BYDY	
<b>No &amp; Type of Engines:</b>	2 Continental Motors Corp IO-550-C piston engines	
<b>Year of Manufacture:</b>	1998 (Serial no: TH-1852)	
<b>Date &amp; Time (UTC):</b>	8 September 2018 at 1130 hrs	
<b>Location:</b>	Haydock Park Airfield, Newton-Le-Willows	
<b>Type of Flight:</b>	Private	
<b>Persons on Board:</b>	Crew - 1	Passengers - 4
<b>Injuries:</b>	Crew - None	Passengers - None
<b>Nature of Damage:</b>	Damage to left flap and left side of fuselage	
<b>Commander's Licence:</b>	Commercial Pilot's Licence	
<b>Commander's Age:</b>	63 years	
<b>Commander's Flying Experience:</b>	4,950 hours (of which 2,500 were on type) Last 90 days - 80 hours Last 28 days - 25 hours	
<b>Information Source:</b>	Aircraft Accident Report Form submitted by the pilot

## Synopsis

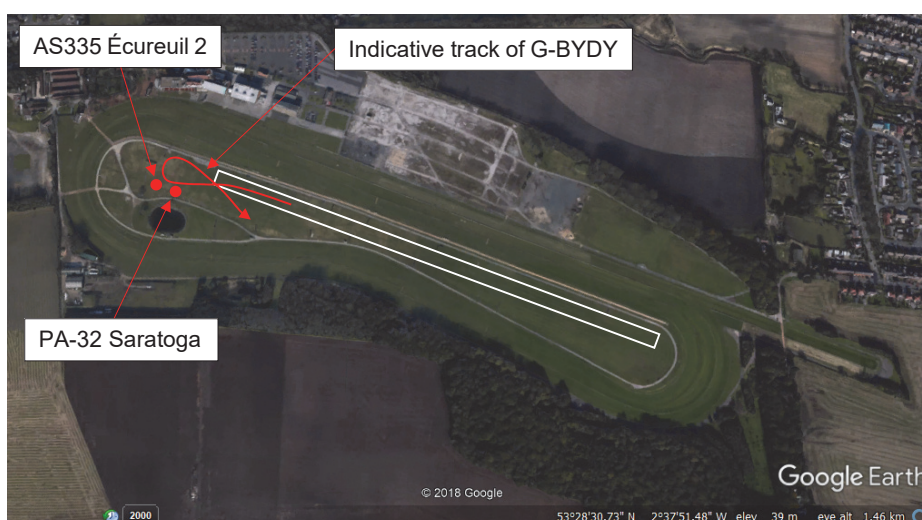
**Figure 1**

The wind was 230° at 8 kt as the aircraft touched down on the threshold of the westerly runway (290°). The pilot allowed the aircraft to roll initially and then gently applied the brakes, but the wet conditions resulted in the aircraft maintaining speed over the last third of the runway. The pilot realised there was insufficient runway remaining to come to a stop and decided to deliberately ‘ground-loop’ the aircraft, as a go-around was not possible at this stage of the landing roll. The intended manoeuvre was to steer the aircraft to the left and then apply left engine power and right rudder to swing the aircraft. Right engine power would then be applied to straighten the aircraft and finally braking to bring the aircraft to a stop. But whilst steering to the left, the aft fuselage and left flap contacted the right wing of the parked PA-32 Saratoga. The aircraft continued with the manoeuvre and came to rest as intended. All the passengers and the pilot exited the aircraft unaided and without injury. There were no occupants in the parked aircraft.

Haydock Park – Indicative track of ground loop
