ACCIDENT

Aircraft Type and Registration:	Aerospatiale SA341G Gazelle, YU-HMC	
No & Type of Engines:	1 Turbomeca (Safran) Astazou 3A turboshaft engine	
Year of Manufacture:	1974	
Date & Time (UTC):	14 July 2018 at 1540 hrs	
Location:	Private landing field, Enfield, Greater London	
Type of Flight:	Private	
Persons on Board:	Crew - 1	Passengers - None
Injuries:	Crew - None	Passengers - N/A
Nature of Damage:	Helicopter destroyed by fire	
Commander's Licence:	Private Pilot's Licence (Helicopters)	
Commander's Age:	65 years	
Commander's Flying Experience:	266 hours (of which 266 were on type) Last 90 days - 17 hours Last 28 days - 7 hours	
Information Source:	Aircraft Accident Report Form submitted by the pilot and further enquiries by the AAIB

Synopsis

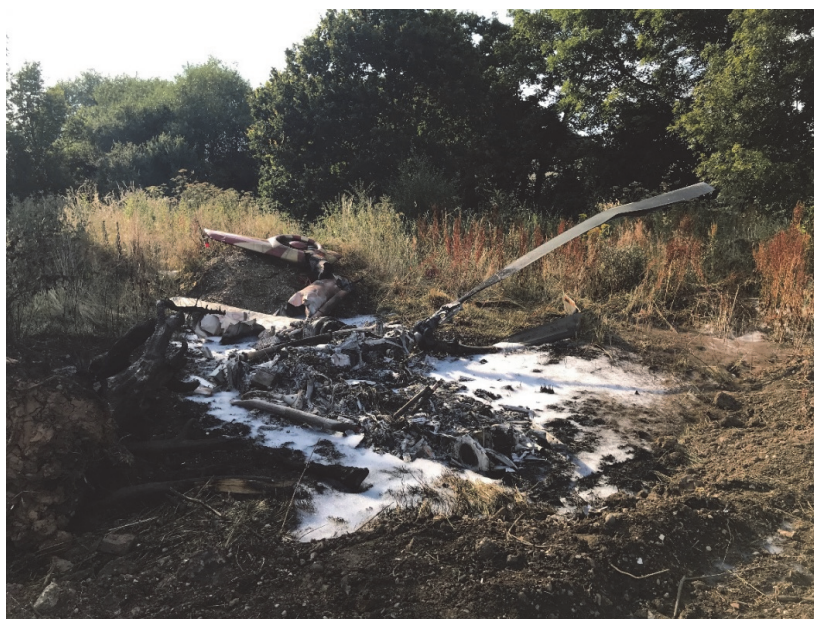
After the fire had subsided, there was very little remaining of the helicopter (Figure 1). The maintenance organisation recovered the helicopter wreckage to their facility and conducted an investigation but were unable to establish a cause of a loss of power. There was no evidence that the engine had suffered an uncontained failure and the turbine was intact and could be rotated through about 30°, but no further due to impact damage to the combustion chamber. There was very little remaining of the fuel system that could be examined. The engineer at the maintenance organisation thought that the fuel tank had probably been punctured by a pallet or metallic materials on the ground where the helicopter came down, resulting in the post-crash fire.

Figure 1
Remains of YU-HMC at the accident site
(image used with permission)
