**ACCIDENT**

<b>Aircraft Type and Registration:</b>	CZAW Sportcruiser, G-CGJS	
<b>No &amp; Type of Engines:</b>	1 Jabiru 3300A piston engine	
<b>Year of Manufacture:</b>	2011 (Serial no: LAA 338-14962)	
<b>Date &amp; Time (UTC):</b>	18 August 2018 at 1314 hrs	
<b>Location:</b>	Near Clacton-on-Sea, Essex	
<b>Type of Flight:</b>	Private	
<b>Persons on Board:</b>	Crew - 1	Passengers - 1
<b>Injuries:</b>	Crew - None	Passengers - None
<b>Nature of Damage:</b>	Landing gear, engine cowling and minor damage to firewall	
<b>Commander's Licence:</b>	Private Pilot's Licence	
<b>Commander's Age:</b>	61 years	
<b>Commander's Flying Experience:</b>	715 hours (of which 550 were on type) Last 90 days - 27 hours Last 28 days - 5 hours	
<b>Information Source:</b>	Aircraft Accident Report Form submitted by the pilot

**Synopsis**

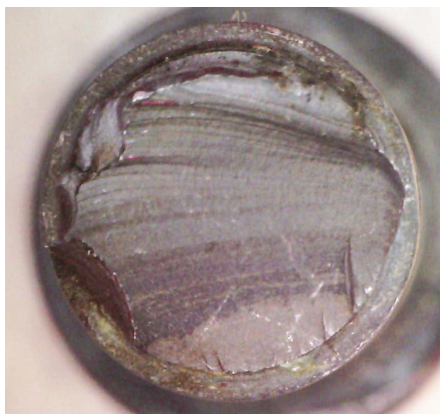
**Figure 1**

A post-accident examination of the engine found that the flywheel had detached due to fatigue failure of at least one of its mounting bolts (Figure 1). Jabiru 2200 engines, which have the same flywheel mounting arrangement, have experienced similar failures.

Fatigue striations on flywheel attachment bolt

The flywheel attachment bolts had been installed for 447 hours. Although there are a number of propeller installation risk factors described by the manufacturer in JSB 014, the failure is likely to have been as a result of the inadvertent exceedance of the intended life of these bolts.

The engine manufacturer made a series of improvements to the configuration of the flywheel attachment system on this engine type. The improvements included the introduction of Nordloc washers, which the manufacturer stated '*should be implemented on existing engines whenever flywheel bolts are replaced*'. The various configurations that have been used, and the installation process for Nordloc washers are detailed in Service Bulletin JSB 012.

On 12 February 2019, the engine manufacturer issued Service Bulletin JSB 014-3, which aligned the maintenance requirement for '*non-approved propellers*' to that described in the Maintenance Manual.
