SERIOUS INCIDENT

Aircraft Type and Registration:	ERJ 190-100 SR Embraer 190, G-LCYZ	
No & Type of Engines:	2 General Electric Co CF34-10E5A1 G07 turbofan engines	
Year of Manufacture:	2010 (Serial no: 19000404)	
Date & Time (UTC):	11 December 2018 at 0655 hrs	
Location:	On takeoff from London City Airport	
Type of Flight:	Commercial Air Transport (Passenger)	
Persons on Board:	Crew - 4	Passengers - 86
Injuries:	Crew - None	Passengers - None
Nature of Damage:	None	
Commander's Licence:	Airline Transport Pilot's Licence	
Commander's Age:	34 years	
Commander's Flying Experience:	4,971 hours (of which 4,813 were on type) Last 90 days - 121 hours Last 28 days - 51 hours	
Information Source:	Aircraft Accident Report Form submitted by the pilot and further enquiries by the AAIB

Synopsis

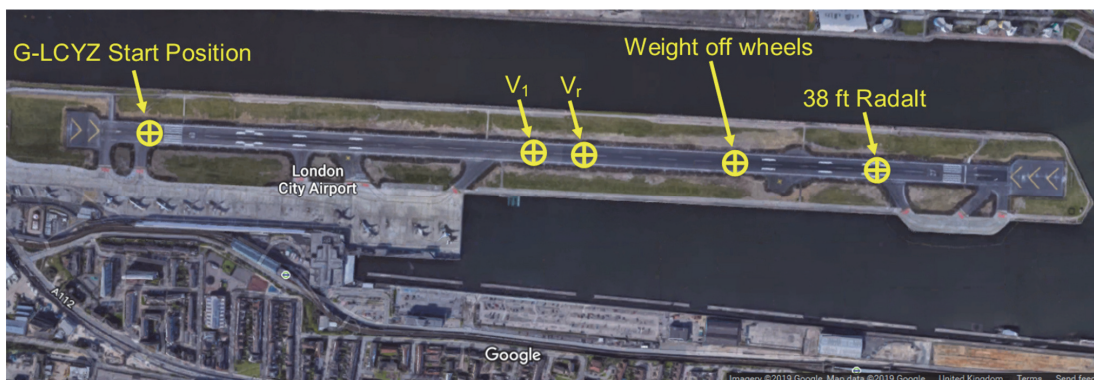
Figure 1

With no appreciable headwind, the aircraft reached V_1 after a ground roll of 560 m, using approximately 41% of the 1,360 m runway length available. Data from a previous departure using T/O-1 at a comparable AUW, but with an unknown headwind component, required a 440 m ground run to achieve V_1 .

Overview of G-LCYZ's takeoff roll from LCY

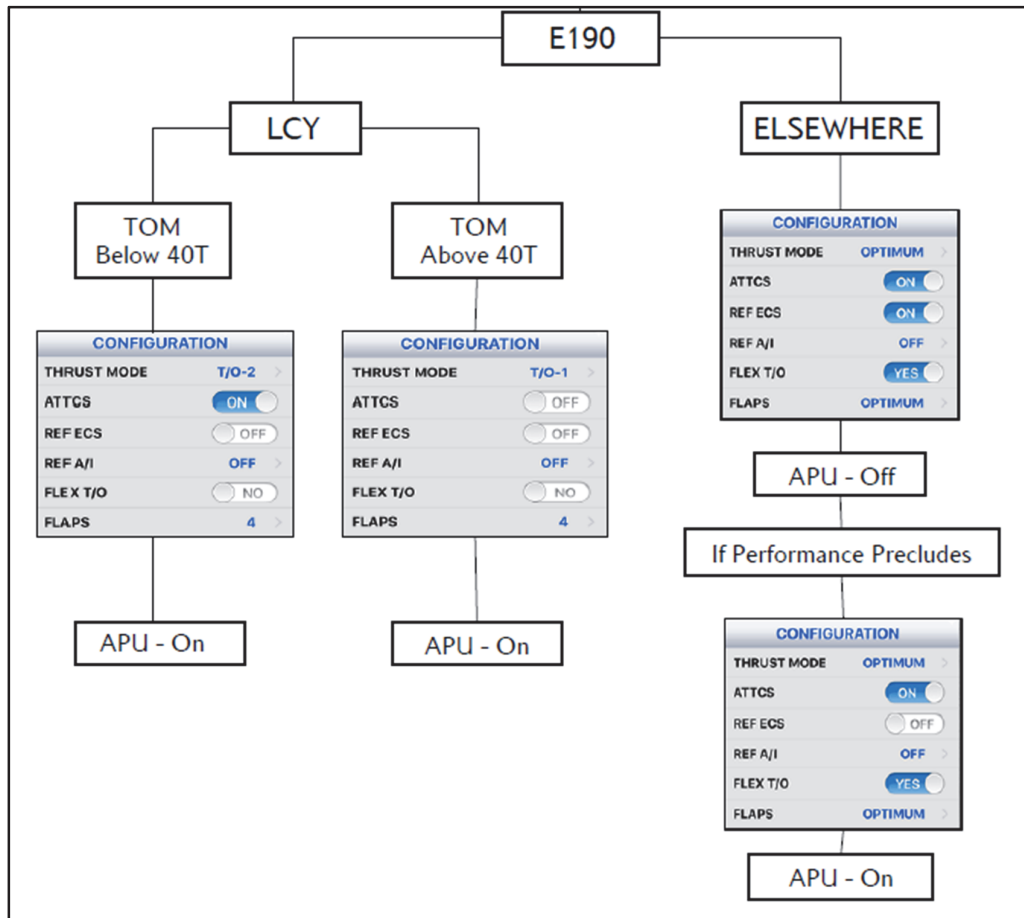
Figure 2

The Company SOP takeoff thrust mode for all E170 and E190 flights is 'Optimum', except E190 departures from LCY. For an Embraer E190 departing LCY with a takeoff mass (TOM) above 40,000 kg, T/O-1 thrust is used. At lower masses T/O-2 is standard (Figure 2). Where Optimum is specified, the thrust setting calculated by the EFB performance software is not artificially limited and the EFB calculates the most appropriate engine de-rate for the environmental conditions. On the incident flight G-LCYZ's TOM was 41,118 kg.

The Airline's SOP takeoff thrust settings for E190 aircraft
