ACCIDENT

Aircraft Type and Registration:	Spitfire Mk.T IX (Modified), G-CTIX	
No & Type of Engines:	1 Packard Motor Car Co MERLIN 224 piston engine	
Year of Manufacture:	1944 (Serial no: PT462)	
Date & Time (UTC):	27 February 2019 at 1255 hrs	
Location:	Denham Airfield, Buckinghamshire	
Type of Flight:	Private	
Persons on Board:	Crew - 1	Passengers - 1
Injuries:	Crew - None	Passengers - None
Nature of Damage:	Broken propeller blades, left undercarriage detached and minor structural damage	
Commander's Licence:	Airline Transport Pilot's Licence	
Commander's Age:	55 years	
Commander's Flying Experience:	12,992 hours (of which 101 were on type) Last 90 days - 113 hours Last 28 days - 43 hours	
Information Source:	Aircraft Accident Report Form submitted by the pilot

Synopsis

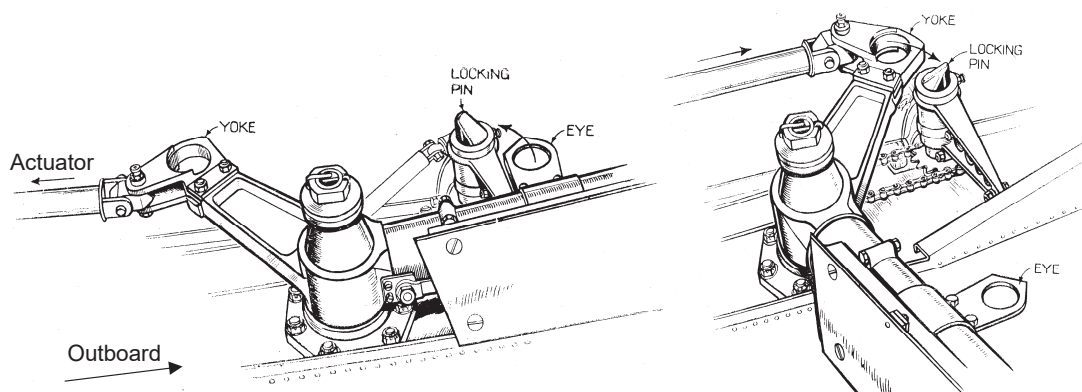
Figure 3

Undercarriage locking pin

Left – Undercarriage UP. Right – Undercarriage DOWN

The right locking pin had not been displaced by the yoke and the left leg was fully locked down, resulting in the DOWN indication being lit in the cockpit.

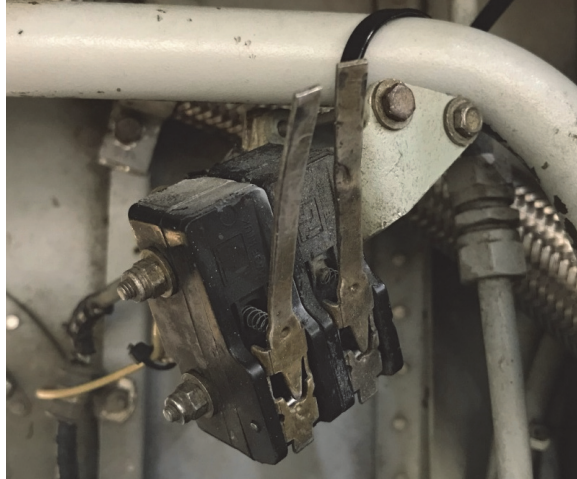
Figure 4

down position and undercarriage warning horn switches (partially disassembled)

The aircraft was recovered from Denham Airfield to the Repair Organisation where it was inspected by the AAIB. The primary undercarriage attachment and the locking pin fitting were detached however, as the attachment bolts had failed, there was minimal damage to the wing spar. The inboard end of the left wing had been deformed by the landing leg. There was further damage to the hydraulic retraction actuators and their attachment to the fuselage firewall. The various indication system switches were inspected, and it was found that the DOWN position switch on the right undercarriage was stuck in the closed (DOWN) position. Manipulation of the switch released the switch, but the fault could not be replicated.

Following an earlier retraction of the undercarriage, the right DOWN position switch became stuck in the closed (DOWN) position and during the accident landing sequence, the pilot was unaware that the right undercarriage leg was not locked down.

The undercarriage warning horn operated as intended but the right undercarriage DOWN switch was stuck closed, providing an incorrect indication that the undercarriage was safe. The pilot's previous experience and incomplete knowledge of the systems fitted to G-CTIX led him to believe that the green DOWN indication alone confirmed that the undercarriage was safe.

Individual switches for the undercarriage DOWN position and the warning horn have been replaced with a single switch for both purposes.

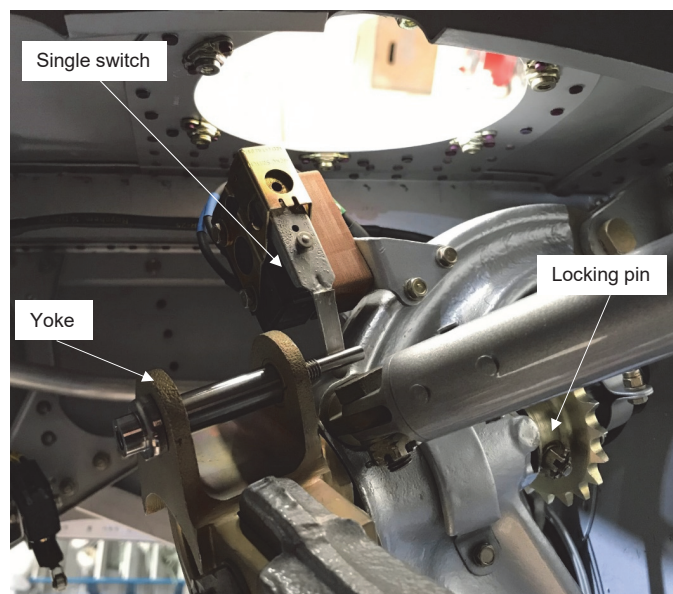
Figure 5

The trailing edges of both wings are flitted with pneumatically operated flaps for low speed flight. They are operated by an electrical switch on the left side of the instrument panel and there is a warning horn fitted which sounds if the flaps are extended and the undercarriage is not locked DOWN. On G-CTIX there is a second, separate, switch located adjacent to the undercarriage DOWN position switch which is activated by the same mechanical means for the undercarriage warning horn system. There is a modification which has been embodied on some Spitfires to replace the individual undercarriage DOWN and warning horn switches with a single dual-pole switch to increase reliability (Figure 5). The modification was not fitted to G-CTIX.

Single dual-pole switch for DOWN position and flap horn (not fitted to G-CTIX)

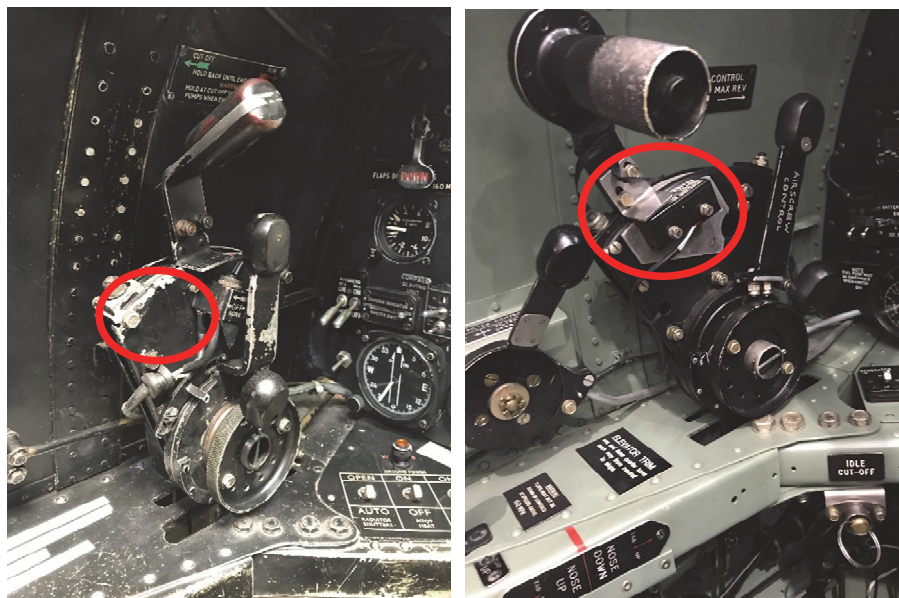
Figure 6

Some Spitfires are fitted with an additional switch on the throttle control which results in the undercarriage warning horn sounding if the throttle is not closed when the flaps are deployed, and the undercarriage is not locked down (Figure 6). This additional switch was not fitted to G-CTIX.

Comparison of throttle controls showing the undercarriage warning switch.
G-CTIX shown in left image

A switch has been added to the throttle quadrant so that the undercarriage warning horn will sound if the throttle is closed, flaps are DOWN and the undercarriage position switch is not closed.
