ACCIDENT

Aircraft Type and Registration:	Cessna 150M, N66778	
No & Type of Engines:	1 Continental O-200-A piston engine	
Year of Manufacture:	1974 (Serial no: 15076271)	
Date & Time (UTC):	18 July 2018 at 2017 hrs	
Location:	Terrance B. Lettsome International Airport, Beef Island, Tortola, British Virgin Islands	
Type of Flight:	Private	
Persons on Board:	Crew - 1	Passengers - None
Injuries:	Crew - 1 (Fatal)	Passengers - N/A
Nature of Damage:	Aircraft destroyed	
Commander's Licence:	FAA Private Pilot Licence	
Commander's Age:	33	
Commander's Flying Experience:	343 hours (of which 17 were on type) Last 90 days - 19 hours Last 28 days - 17 hours	
Information Source:	AAIB Field Investigation

Synopsis

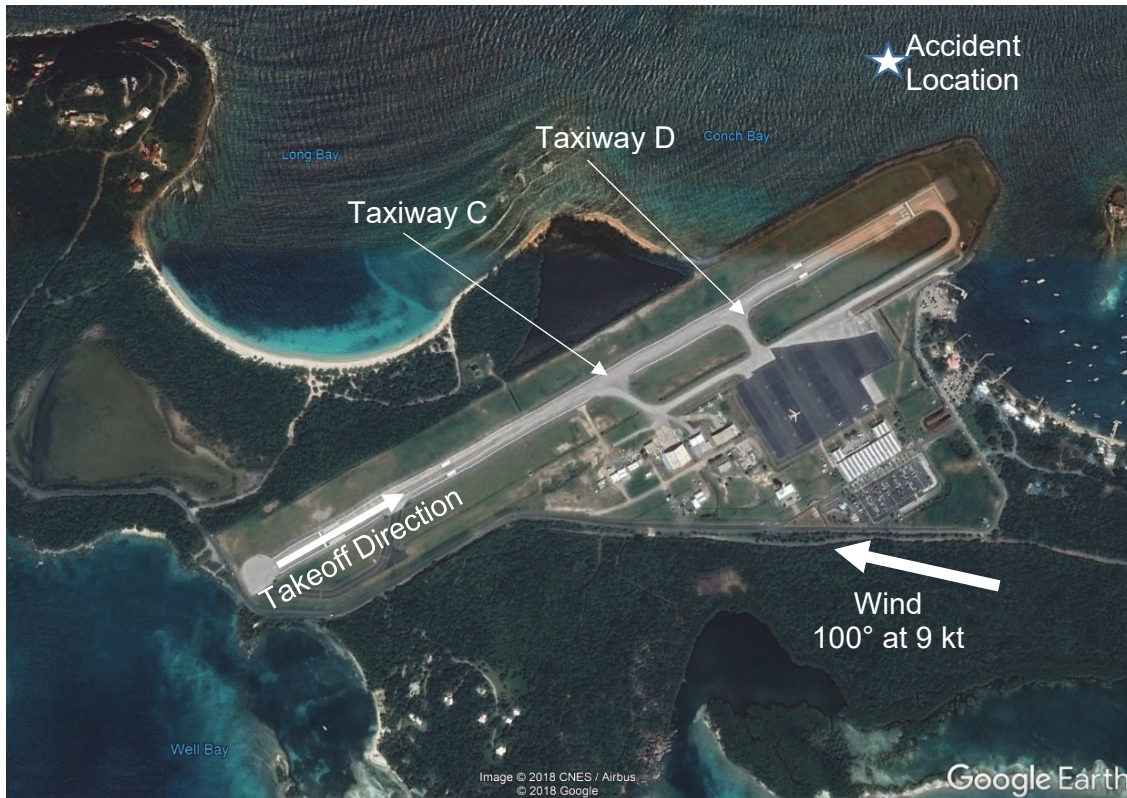
Figure 2

The pilot of N66778 started his takeoff roll from the start of Runway 07. The pilot of another aircraft, who was holding on Taxiway C, reported seeing N66778's rear fuselage touch the runway as the aircraft rotated. He described seeing the aircraft then climb with slight oscillations in pitch. He reported that the aircraft was at approximately 50 ft when it passed Taxiway C and the flaps were up¹ (Figure 2).

Terrance B. Lettsome International Airport (Beef Island) showing the accident location

The aircraft had come to rest in approximately 5 m of water, 250 m north of the Runway 25 threshold (Figure 2). The wreckage was recovered to shore by local salvage personnel on the day of the accident; this was overseen by representatives of the BVIAA. It was raised to the surface using floatation bags before being pulled to the shore and loaded onto a truck by crane. The wreckage was moved to a secure location within the airport grounds where detailed examination of the wreckage could be carried out.

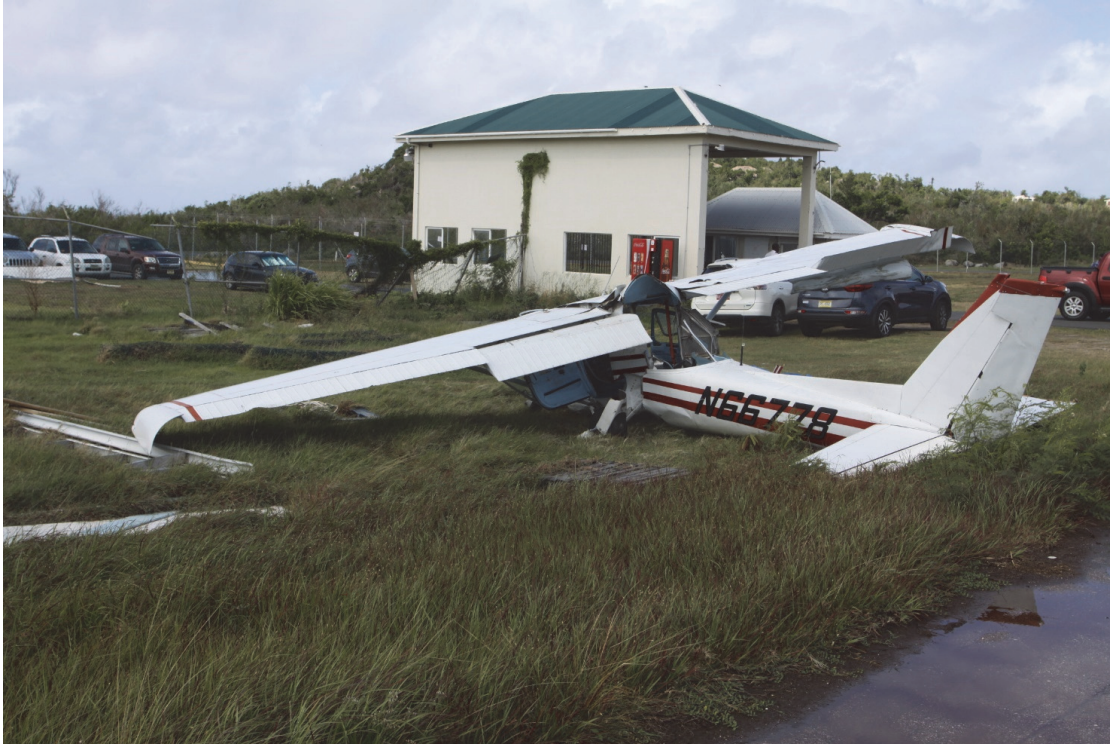
Figure 4

The aircraft had been recovered to an area of grass within the airport grounds (Figure 4). The rear fuselage structure had separated from the front fuselage aft of the seats and was only connected by control cables. Significant leading edge crumpling on the right wing

was consistent with the aircraft striking the water at a near vertical attitude, right wing first. Hydrostatic forces were sufficient to rupture the lower surface of the right wing as it struck the water.

N66778 after recovery

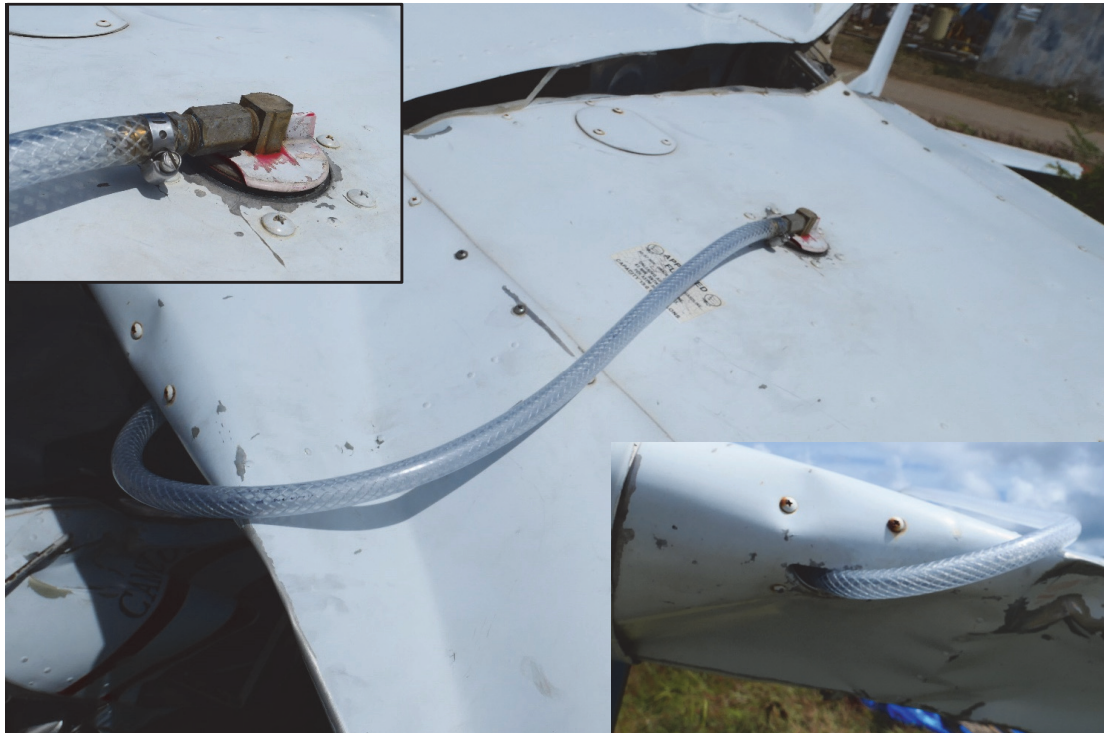
Figure 6

The pump outlet was connected to an inline filter which in turn was connected to tubing that ran under the left door sill, up the left door forward pillar, through the left cockpit air vent and out of the air scoop on the leading edge of the left wing. The tube then ran from the leading edge to an elbow union connected to a modified over wing fuel tank cap (Figure 6). The tubing was still in position, however during the accident the auxiliary tank became dislodged from its original location, becoming disconnected at the fuel filter outlet.

Routing of auxiliary fuel tank tubing over leading edge of the left wing into the left fuel tank

N66778 had a fuel pipe positioned over the leading edge of the left wing. This pipe would disturb the airflow over the left wing and could affect the stall speed of the aircraft. If the aircraft stalled in balanced flight it is possible that this modification would cause the left wing to stall first resulting in a wing drop to the left.

When the aircraft commenced a turn, in level flight, the stall speed would have increased. The fuel pipe running over the leading edge of the left wing might also have increased the stall speed. The aircraft was also seen to 'pitch up' during the turn which would cause the airspeed to decrease. The aircraft's speed instability at these low speeds would cause the speed to further reduce. These effects are likely to have combined to cause the stall during the turn.

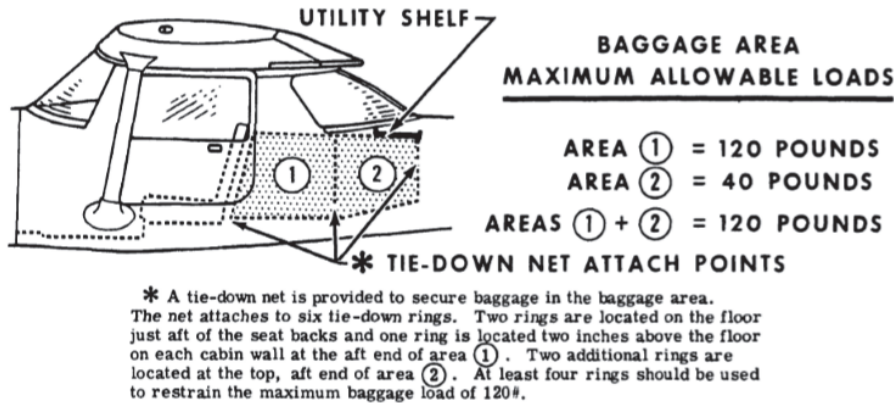
Figure 7

The baggage area behind the pilot's seat is divided into two areas for weight and balance calculations. The maximum load for the front area is 120 lbs, the maximum load for the aft area is 40 lbs, but the maximum total load for the whole baggage area is 120 lbs (Figure 7). Based on the witness reports that the auxiliary fuel tank, oil cans and the crate of water were stored behind the pilot's seat, N66778 had at least 158.8 lbs of weight in the baggage area.

Baggage Loading Restriction
