SERIOUS INCIDENT

Aircraft Type and Registration:	Airbus A319 OE-LQE
No & Type of Engines:	2 CFM56-5B5-3 turbofan engines
Year of Manufacture:	2010
Date & Time (UTC):	30 September 2018 at 0540 hrs
Location:	London Gatwick Airport
Type of Flight:	Commercial Air Transport (Passenger)
Persons on Board:	Crew - 6 Passengers - 144
Injuries:	Crew - None Passengers - None
Nature of Damage:	None reported
Commander's Licence:	Airline Transport Pilot's Licence
Commander's Age:	44 years
Commander's Flying Experience:	10,908 hours (of which 8,156 were on type) Last 90 days - 203 hours Last 28 days - 65 hours
Information Source:	Aircraft Accident Report Form submitted by the pilot and the Operator's safety investigation report

Synopsis

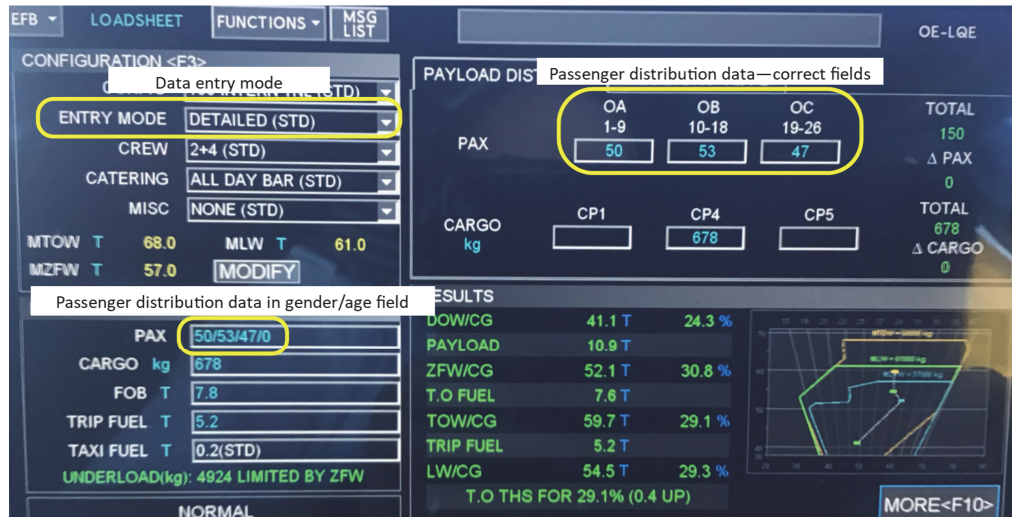
Figure 2

Once established in the cruise, the crew re-checked their loading calculations. They discovered that the Males, Females and Children data fields in the loadsheet application had been incorrectly populated. They contained the passenger cabin zone distribution figures (Figure 2) rather than the correct gender/age data (Figure 3). The resulting incorrect gender/age profile meant that the total passenger weight was underestimated by 1,962 kg. The flight continued to destination without further incident, whereupon the commander reported the loadsheet error to the Company Duty Pilot.

Software screenshot with passenger distribution data in gender/age data box

This serious incident resulted from the error of inputting incorrect data into three fields on the loadsheet application. Once the mistake had been made, human performance limitations reduced the likelihood that the slip would be detected. The crew noticed a ZFW anomaly, but despite looking for an error they could not find one. The lack of commonality between LFC and EFB formats was considered by the operator to be an exacerbating factor, as was the lack of gender/age profile information in the loadsheet application's Reduced mode.

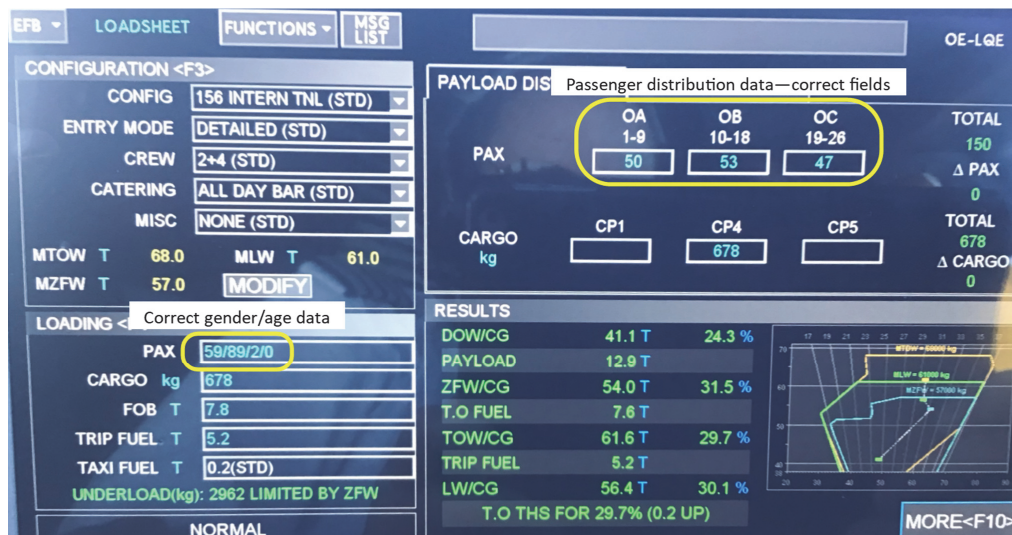
Figure 3

Software screenshot with correct gender/age data as per the LFC
