ACCIDENT

Aircraft Type and Registration:	Evolve Dynamics Sky Mantis (UAS, registration n/a)	
No & Type of Engines:	4 electric motors	
Year of Manufacture:	2019 (Serial no: ED/SM68-00212)	
Date & Time (UTC):	7 February 2019 at 1022 hrs	
Location:	Nailsea Fire Station, Somerset	
Type of Flight:	Commercial Operations	
Persons on Board:	Crew - N/A	Passengers - N/A
Injuries:	Crew - N/A	Passengers - N/A
Nature of Damage:	Aircraft destroyed	
Commander's Licence:	Other	
Commander's Age:	27 years	
Commander's Flying Experience:	7 hours (of which 4 were on type) Last 90 days - 5 hours Last 28 days - 2 hours	
Information Source:	Aircraft Accident Report Form submitted by the pilot and subsequent AAIB enquires

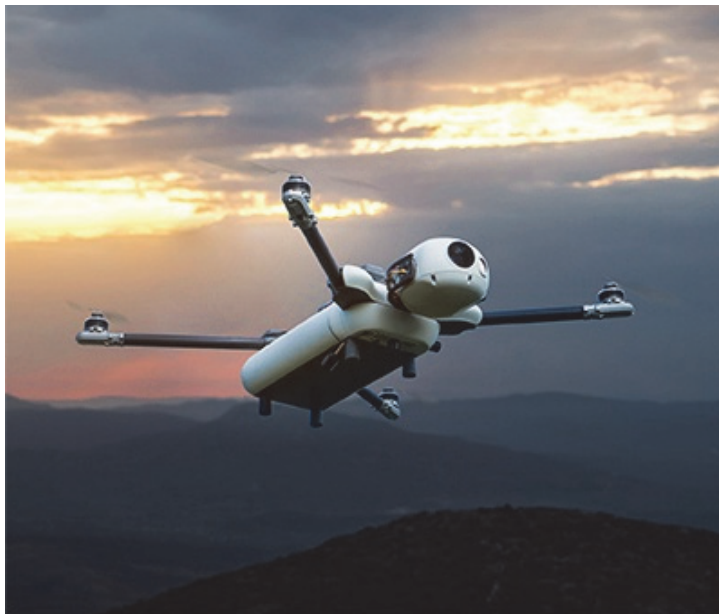
Figure 1

Evolve Dynamics Sky Mantis
