ACCIDENT

Aircraft Type and Registration:	DJI Matrice M210 RTK, (UAS, registration n/a)	
No & Type of Engines:	DJI 3515 Electric motors	
Year of Manufacture:	2017 (Serial No: EK290958468403)	
Date & Time (UTC):	14 January 2019 at 1103 hrs	
Location:	Colwyn Bay, Conwy	
Type of Flight:	Aerial Work	
Persons on Board:	Crew - N/A	Passengers - N/A
Injuries:	Crew - N/A	Passengers - N/A
Nature of Damage:	Extensive damage to aircraft and payload	
Commander's Licence:	Other	
Commander's Age:	32 years	
Commander's Flying Experience:	21 hours (of which 4 were on type) Last 90 days - 4 hours Last 28 days - 1 hour	
Information Source:	Aircraft Accident Report Form submitted by the remote pilot

Synopsis

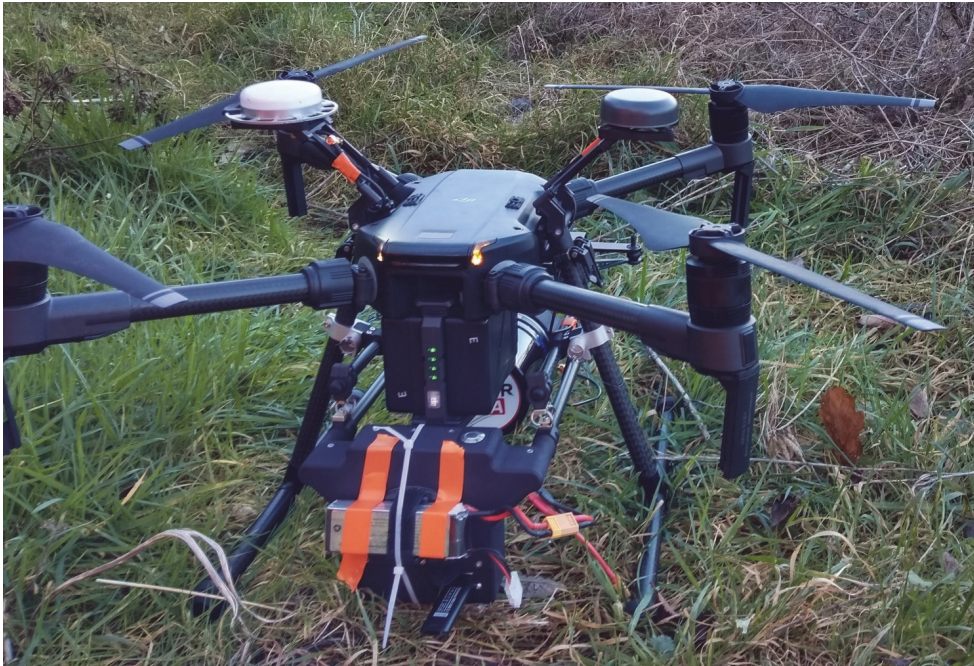
Figure 1

UAS with third-party lidar pod attached prior to flight

The pod was powered by a battery pack which, for this flight, had been attached to the end of the pod. There was a cable and connector connecting the battery to the pod. The installation can be seen in Figure 1.

Although the lidar pod had been designed not to obscure the downward looking sensors, the data suggests that the ultrasonic sensors were picking up an obstruction between 0.3 ft to 1 ft range. This could have been the red and black cable and connector, seen below and to the side of the main body in Figure 1. This unsecured cable could have been blown in to the sensors field of view by the downdraft from the propellers. The obstruction appears to move when the speed increased, perhaps due to a change in airflow which may have moved the cable out of view.

- 1/ Before any new aircraft / payload combination is flown, its actual weight will be established and recorded, by weighing, to ensure it is within specified limits.
- 2/ Before any new app or software is flown, confirmation, in writing, of its compatibility with other equipment by either the airframe manufacturer or the app developer is required.

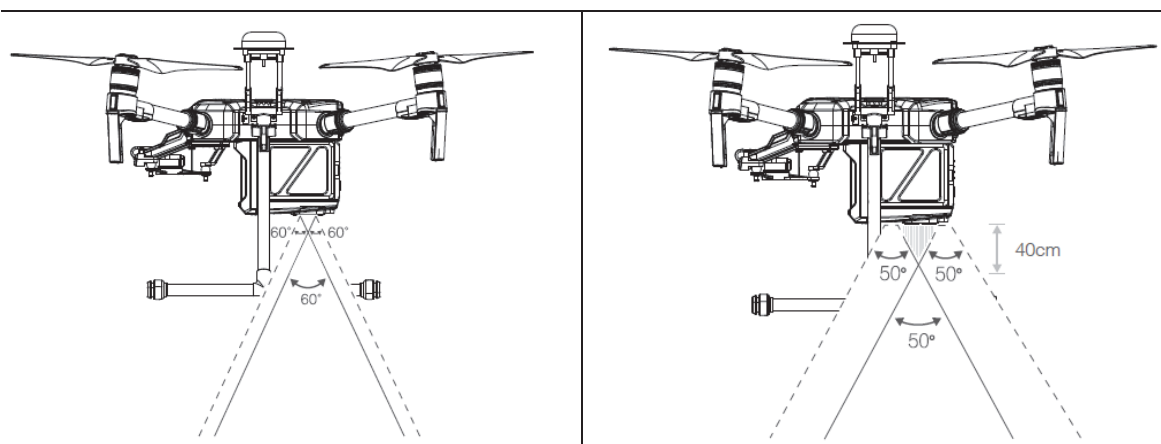
Figure 2

The downward looking vision system consists of a stereo vision sensor and two ultrasonic sensors which it uses to help the UAS maintain its current position. The system is mounted on the underside of the main body and the fields of view are shown in Figure 2.

Field of view depiction, ultrasonic sensors (left) and stereo vision system (right)
