ACCIDENT

Aircraft Type and Registration:	1) Pierre Robin DR400/180R Remorqueur, G-LGCC 2) Schleicher ASK 21, G-CFYF
No & Type of Engines:	1) 1 Lycoming O-360-A4M piston engine 2) None
Year of Manufacture:	1) 1975 (Serial no: 1021) 2) 1990 (Serial no: 21470)
Date & Time (UTC):	8 June 2018 at 1502 hrs
Location:	Dunstable Airfield, Bedfordshire
Type of Flight:	1) Private 2) Training
Persons on Board:	1) Crew - 1 Passengers - None 2) Crew - 1 Passengers - 1
Injuries:	1) Crew - None Passengers - N/A 2) Crew - None Passengers - None
Nature of Damage:	1) Top of fin sliced off, rudder detached 2) Full depth gash in outboard section of right wing
Commander's Licence:	1) EASA Private Pilot's Licence (Aeroplanes) 2) BGA Glider Pilot's Licence with Full Instructor Rating
Commander's Age:	1) 62 years 2) 69 years
Commander's Flying Experience:	1) 2,825 hours (of which 1,238 were on type and 1,324 were in gliders) Last 90 days - 23 hours Last 28 days - 8 hours 2) 1,670 hours (of which 785 were on type) Last 90 days - 15 hours Last 28 days - 6 hours

Synopsis

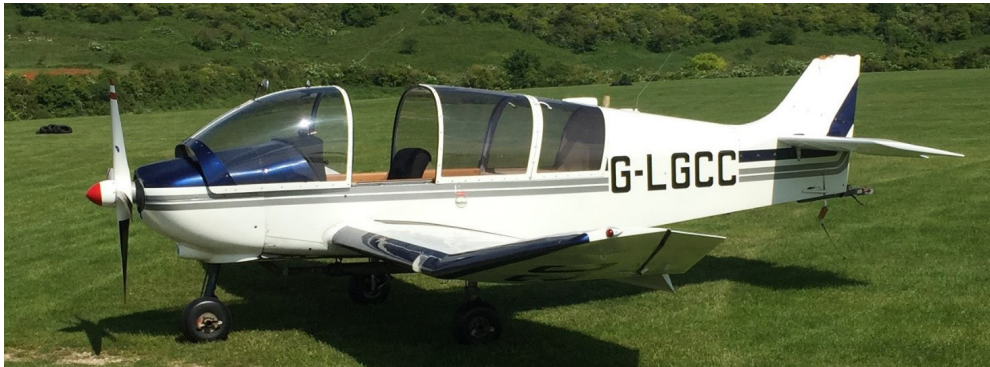
Figure 2

tug's tail fin detached along with the rudder (Figures 2 and 3). Stress marks found on the tug's right wing were consistent with damage discovered on the inner lower surface of the glider's right wing.

G-LGCC after the accident with rudder missing and damage to top edge of the fin

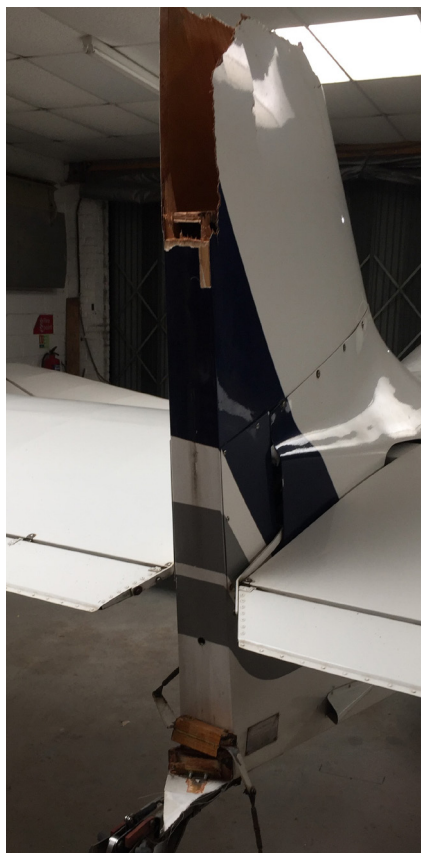
Figure 3

Damage to tail section of G-LGCC

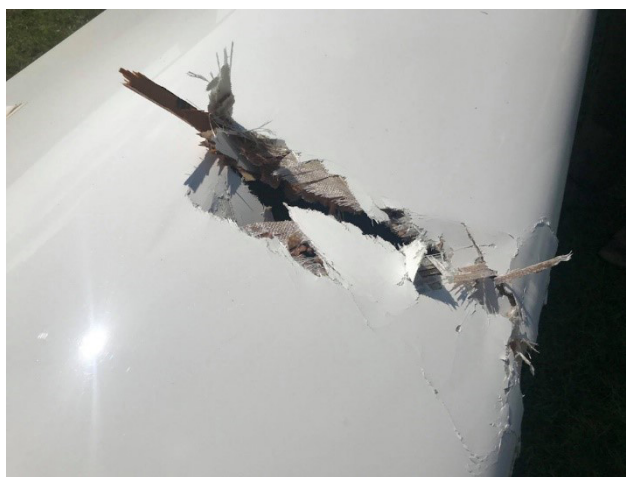
Figure 4

Immediately prior to the accident the glider was tracking north easterly at 50 kt and approximately 900 ft agl². Neither occupant saw the tug aircraft and the first they knew of the collision was a loud bang accompanied by the glider yawing violently to the right. The instructor in the rear-seat took control of G-CFYF to make an initial damage assessment. Looking to the right he could see significant disruption to the wing structure (Figures 4 and 5), but the wingtip angle looked normal, implying that the spar was intact.

Damage to the upper surface of G-CFYF's right wing

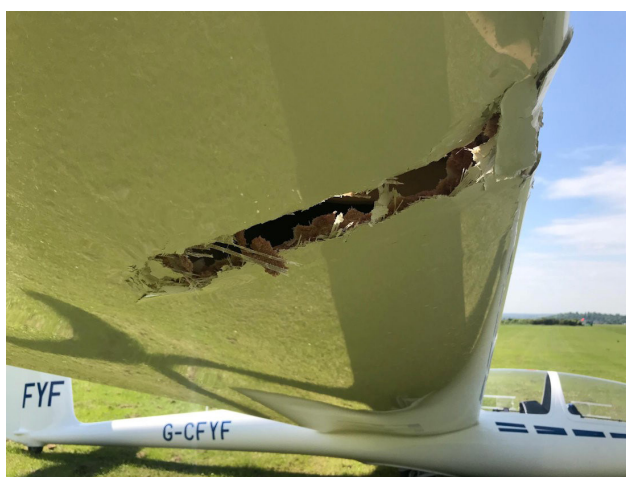
Figure 5

Damage to the lower surface of G-CFYF's right wing
