ACCIDENT

Aircraft Type and Registration:	Jodel DR1050-M1 Sicile Record, G-CIYB	
No & Type of Engines:	1 Continental Motors Corp O-200-A piston engine	
Year of Manufacture:	1965 (Serial no: 605)	
Date & Time (UTC):	8 June 2018 at 1045 hrs	
Location:	Private airstrip, Gilford, County Down	
Type of Flight:	Private	
Persons on Board:	Crew - 1	Passengers - 1
Injuries:	Crew - None	Passengers - None
Nature of Damage:	Damaged beyond economic repair	
Commander's Licence:	Private Pilot's Licence	
Commander's Age:	62 years	
Commander's Flying Experience:	546 hours (of which 424 were on type) Last 90 days - 4 hours Last 28 days - 4 hours	
Information Source:	Aircraft Accident Report Form submitted by the pilot

Synopsis

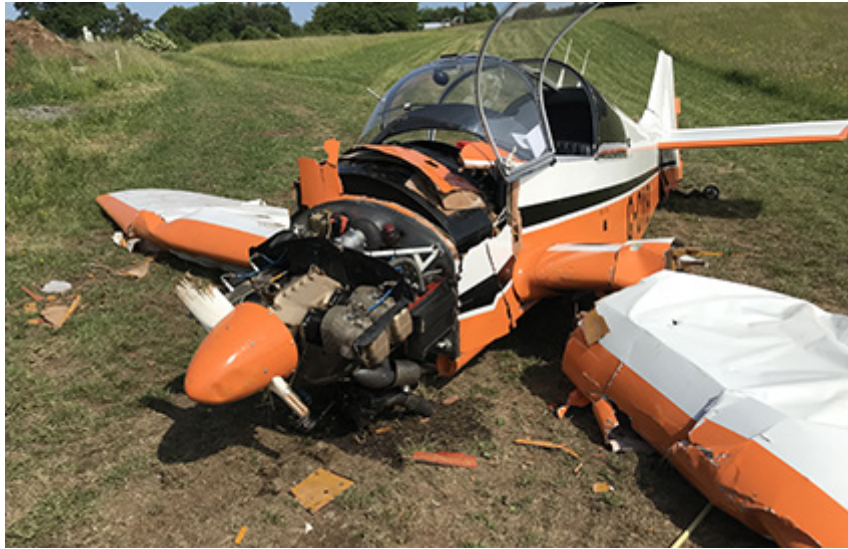
Figure 1

The pilot approached Runway 36 at his private airstrip, having estimated the wind strength as 5 kt, from a variable direction. No turbulence was apparent during the approach but, as the aircraft neared the boundary hedge, it suddenly encountered sinking air and the pilot was unable to prevent the left main landing gear from striking the hedge. He lost control and the aircraft struck the ground and travelled along the runway for a few metres. When the aircraft came to rest it had rotated left through approximately 180°, the landing gear had collapsed, the left wing had detached and the right wing and forward fuselage were extensively damaged (Figure 1). The occupants used the normal access doors to vacate the aircraft without assistance.

The aircraft was pointing back towards the threshold of Runway 36 when it came to rest. The uphill slope of the runway is apparent in the background

The pilot intends to remove the hedge along the airstrip's southern boundary and will only operate a similar aircraft from here if he succeeds in lengthening the runway.
