ACCIDENT

Aircraft Type and Registration:	Hapi Cygnet SF-2A, G-BRZD	
No & Type of Engines:	1 Volkswagen 2078 piston engine	
Year of Manufacture:	1995 (Serial no: PFA 182-11443)	
Date & Time (UTC):	1 August 2018 at 1400 hrs	
Location:	Nayland Airfield, Essex	
Type of Flight:	Private	
Persons on Board:	Crew - 1	Passengers - None
Injuries:	Crew - None	Passengers - N/A
Nature of Damage:	Substantial damage to wings, landing gear, fuselage and tailplane	
Commander's Licence:	Light Aircraft Pilot's Licence	
Commander's Age:	66 years	
Commander's Flying Experience:	Approximately 600 hours Last 90 days - 22 hours Last 28 days - 4 hours	
Information Source:	Aircraft Accident Report Form submitted by the pilot

Synopsis

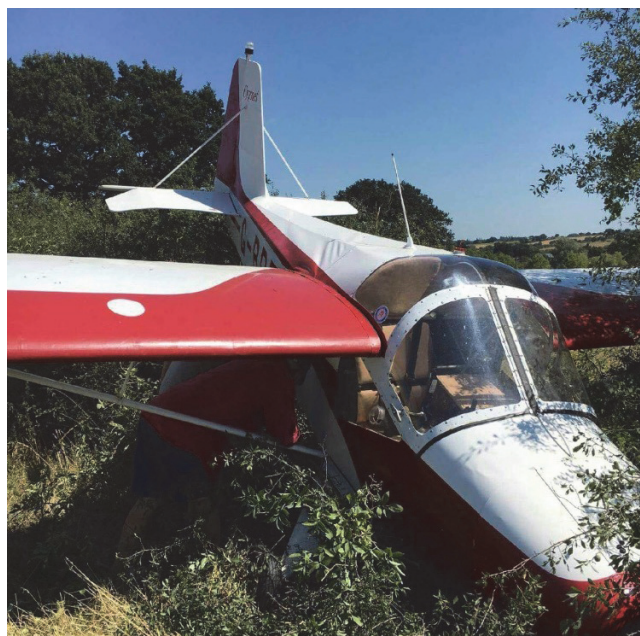
Figure 1

On short final, at approximately 140 ft above the ground, as the throttle was advanced the engine abruptly stopped. The pilot attempted to restart the engine by engaging the electric starter and the engine ran for a few seconds before stopping again as the throttle was advanced. By this time the aircraft had descended below the level of the trees on the approach and the pilot determined that he could not clear them, nor land in the available area before the trees. He turned right approximately 20°, flew beneath a set of power lines and aimed for a low hedge to cushion the impact. The aircraft came to rest in the hedge, Figure 1. The pilot, who was wearing a four-point harness, sustained a minor leg injury in the accident but was able to vacate the aircraft using the cockpit door. The aircraft sustained substantial damage to the wings, landing gear, fuselage and tailplane.

Accident site
