**ACCIDENT**

| <b>Aircraft Type and Registration:</b> | Jodel D120 (Modified), G-AVYV | |

The engine failed at 200 ft during a go-around and the pilot made a forced landing without serious injury on an adjacent golf course. The cause of the engine failure could not be determined but may have been carburettor icing or fuel vapour interrupting the fuel flow.

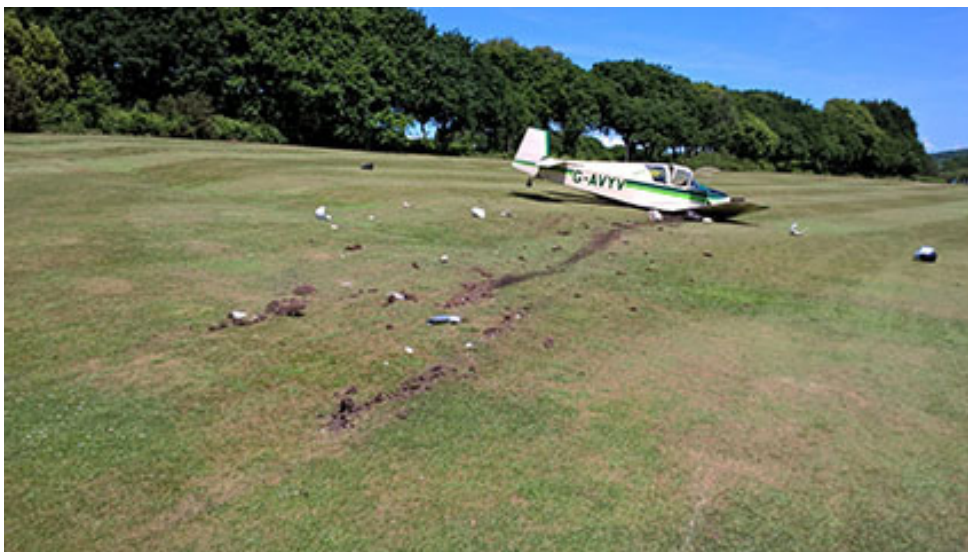
**Figure 1**

The aircraft landed on the fairway of the 8<sup>th</sup> hole at the Shanklin and Sandown golf course, on sloping ground bounded on several sides by wooded areas (Figure 1).

Aircraft and initial impact marks

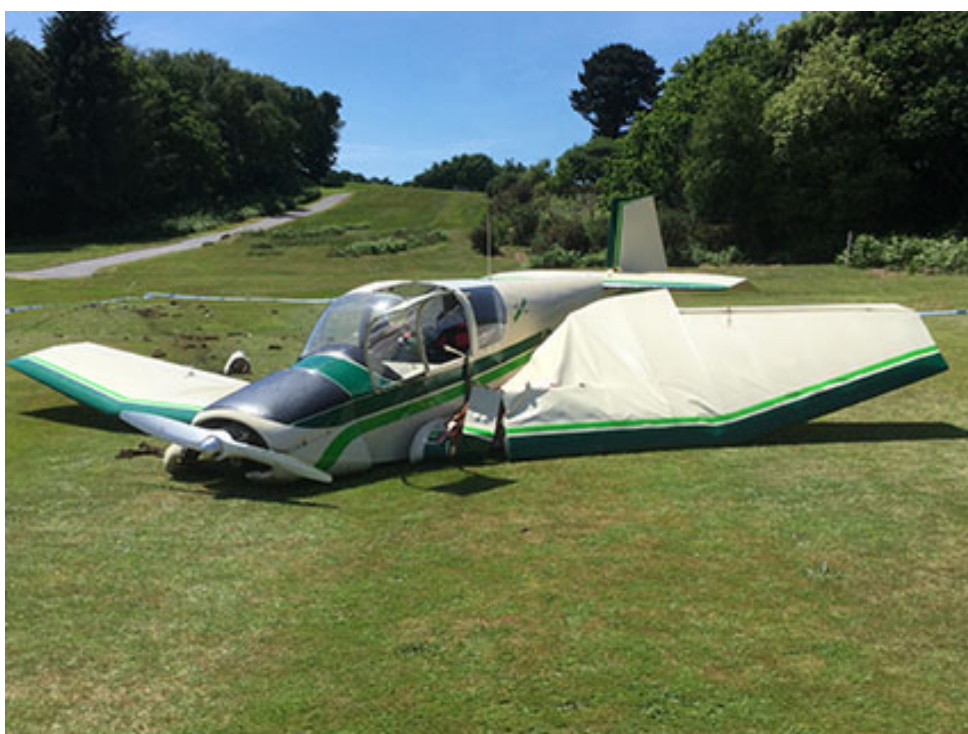
**Figure 2**

There was significant damage to the left wing, undercarriage, fuselage and engine (Figure 2).

G-AVYV after the accident
