ACCIDENT

Aircraft Type and Registration:	Morane Saulnier Rallye 150ST, G-BDWH	
No & Type of Engines:	1 Lycoming O-320-E2A piston engine	
Year of Manufacture:	1976 (Serial no: 2697)	
Date & Time (UTC):	21 August 2018 at 1247 hrs	
Location:	Blackpool Corner, Dorset	
Type of Flight:	Private	
Persons on Board:	Crew - 2	Passengers - None
Injuries:	Crew - 2	Passengers - N/A
Nature of Damage:	Aircraft destroyed	
Commander's Licence:	Private Pilot's Licence	
Commander's Age:	77 years	
Commander's Flying Experience:	700 hours Last 90 days - 6 hours Last 28 days - 1 hour	
Information Source:	Aircraft Accident Report Form submitted by the pilot and further enquiries by the AAIB

Synopsis

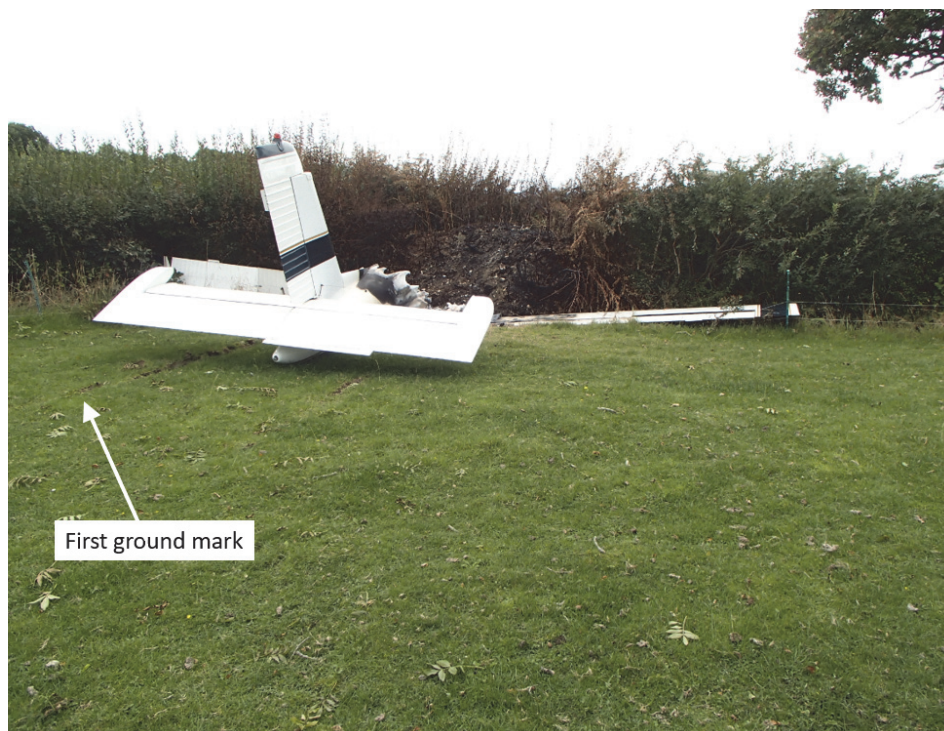
**Figure 2**

The aircraft touched down shortly before the boundary hedge with a very short ground roll that was consistent with the aircraft flying at, or close to, the stall prior to touchdown (Figure 2). The AAIB conducted an examination of the wreckage prior to its recovery in order to try to establish the cause of the fire.

Accident site

The majority of the fuselage and the engine compartment had been severely damaged by the fire. The crankcase had partially melted, exposing the sump and no oil remained in the engine. The remains of the engine compartment fuel hoses and their connections to the electric boost pump, engine-driven fuel pump and carburettor were identified in the wreckage, however fire-damage prevented assessment of their condition and security prior to the fire. It was observed that the fuel hose between the engine-driven fuel pump and the carburettor had detached from the carburettor, although this may have occurred during the ground impact.
